**FUNDING REQUEST FOR THE
TOWN OF STEVENSVILLE WATER REHABILITATION PROJECT**

I would like to thank George Thomas for assisting me during the sanitary survey inspection of the Stevensville water system. As a community water supply system, your facility is required to have a sanitary survey inspection every three years. These regular inspections offer us an opportunity to look for sanitary deficiencies that have the potential to cause contamination in the water system, as well as pointing out operation and maintenance concerns. Below are a few comments relating to the sanitary survey conducted on 6/25/2008.

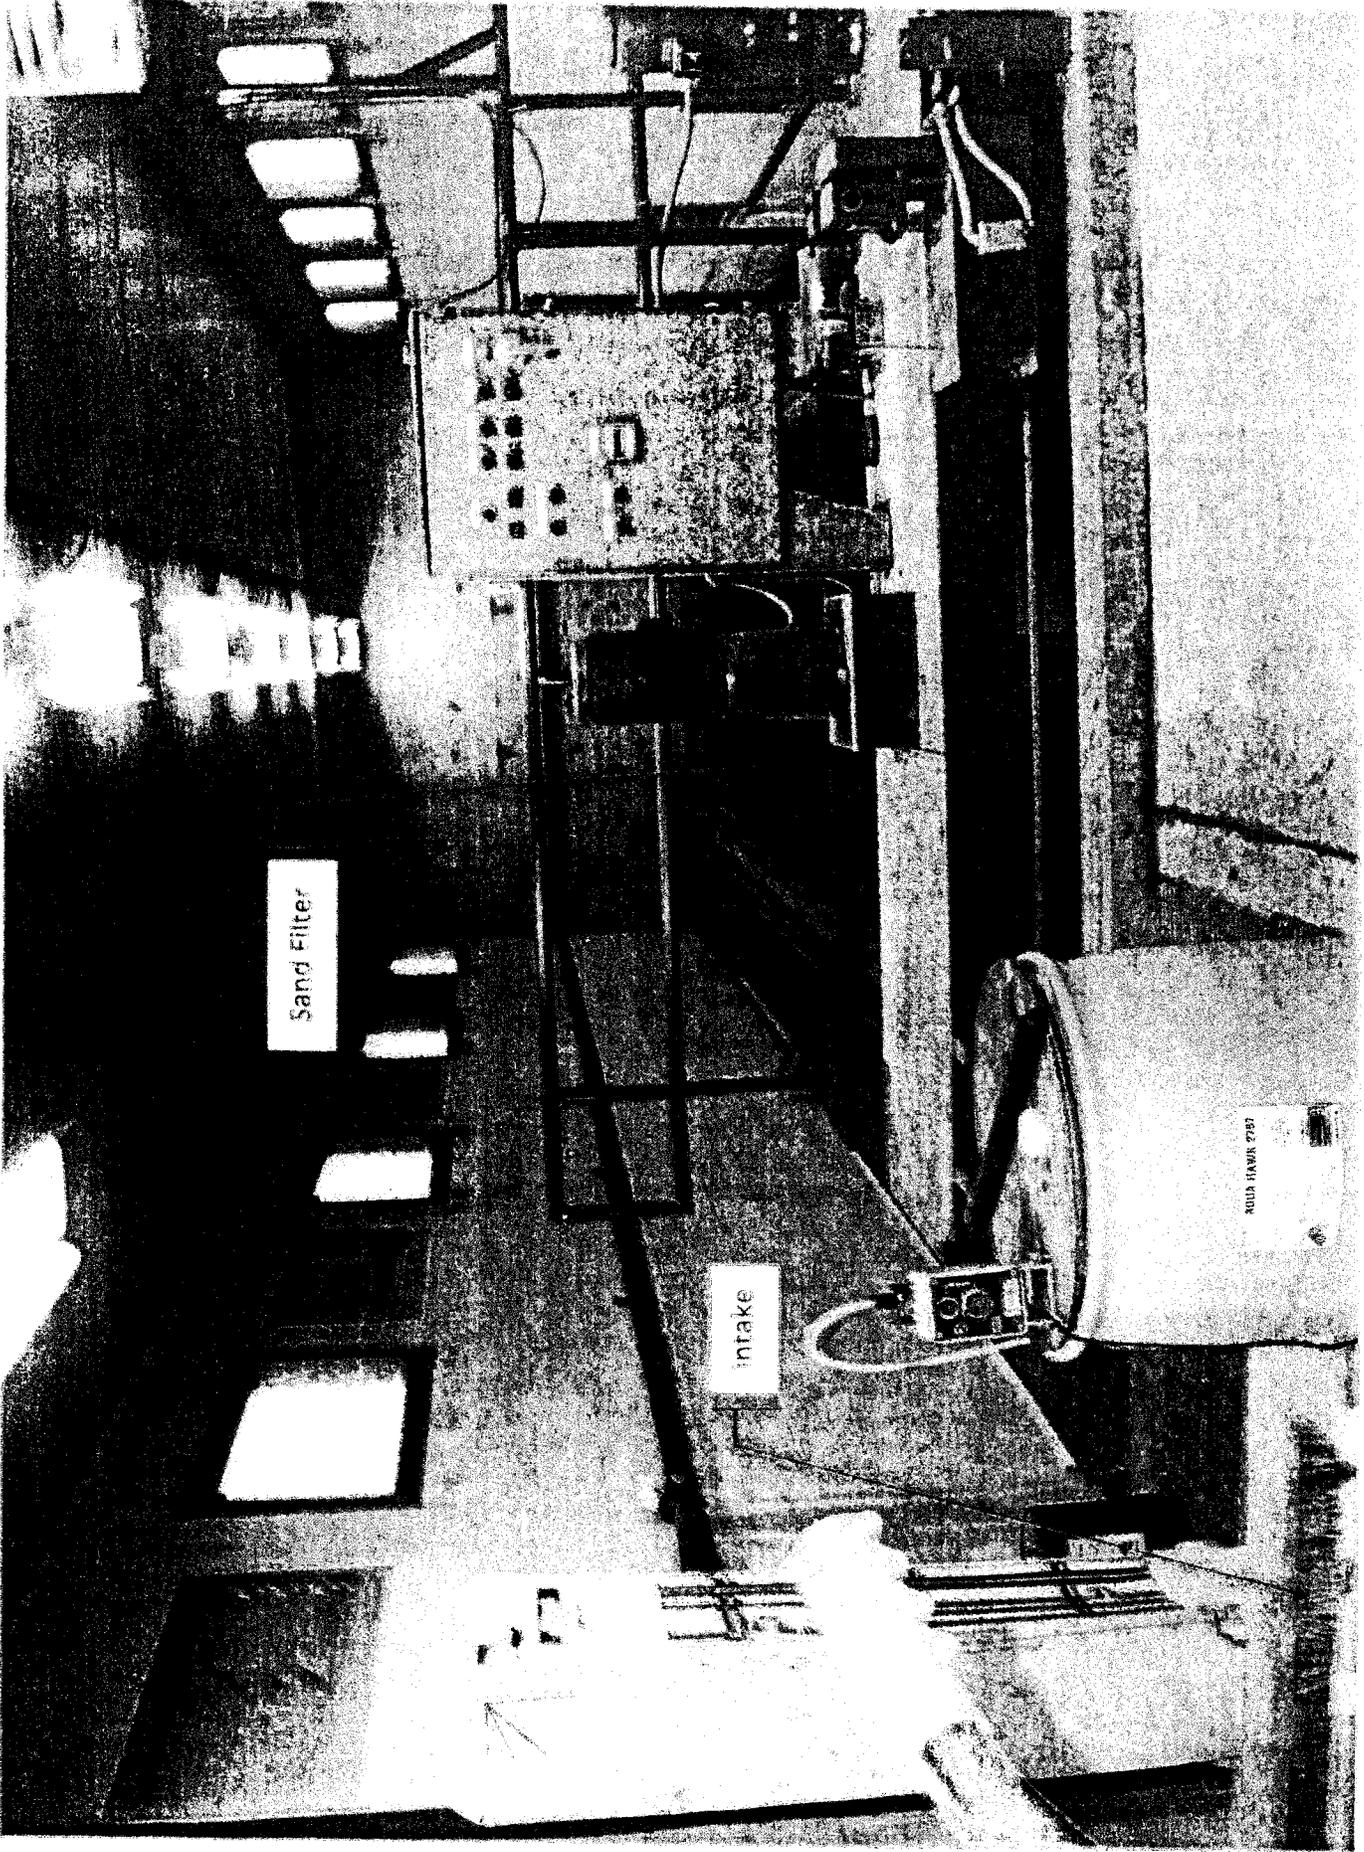
Stevensville Water Treatment Facility.

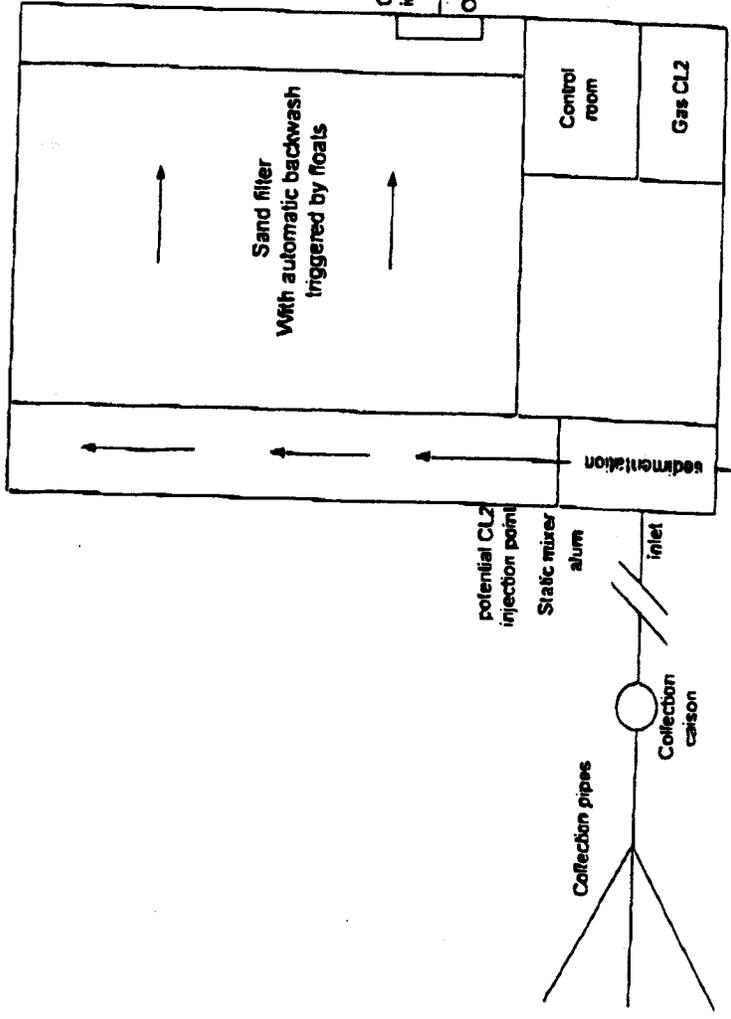
Collection caisson

Collection pipes

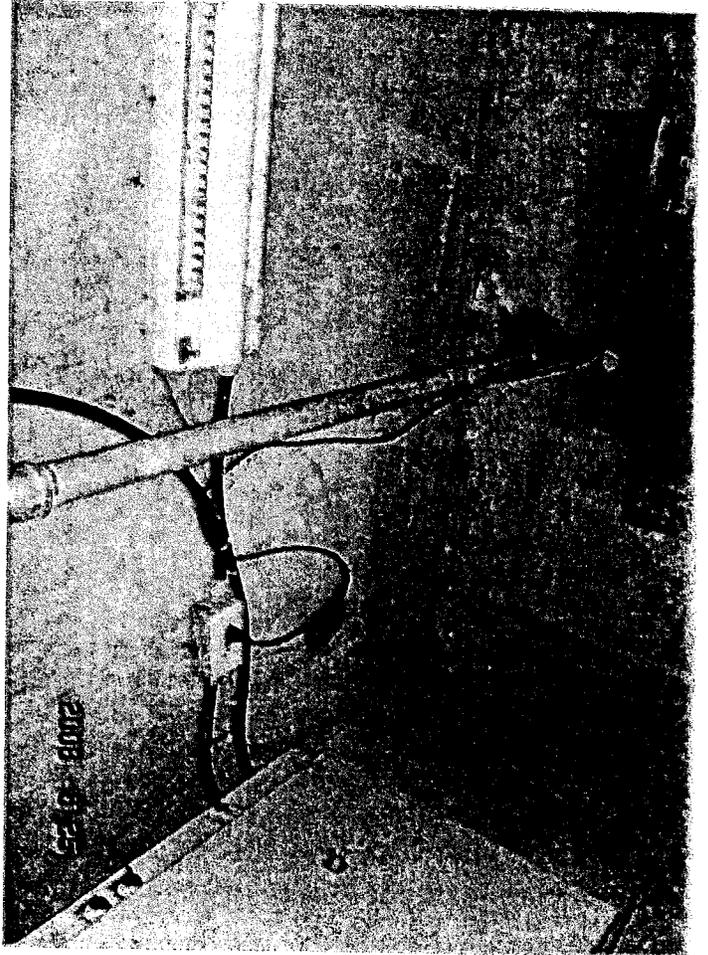
Top left: Well 2 (WL004) is located on the corner of Mission Street and South Avenue. The wellhead is in the locked vault shown in this picture.

Lower left: The control panel, heater and wall outlet are some of electrical components located in the vault. High water levels inside the vault is reduced through use of a sump pump that draws from a depression in the floor. The sump pump is plugged into a wall outlet located in the vault a few feet above the floor level. So if water rose faster than the sump pump capacity, the vault would flood and shut the breakers off to all electrical components (including the sump pump).

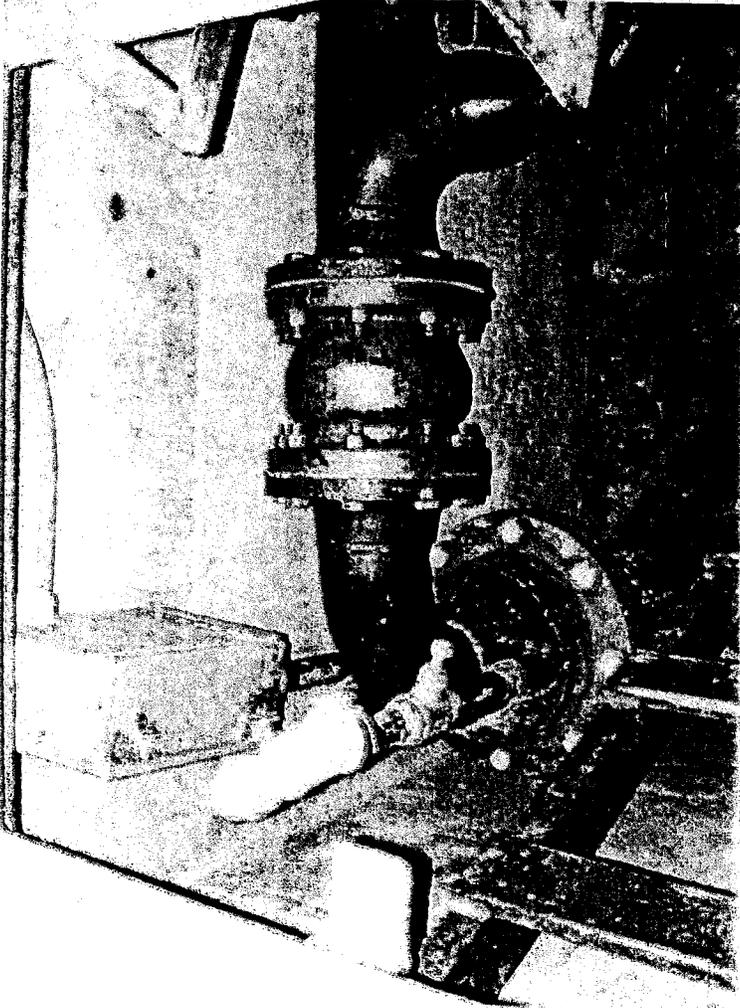
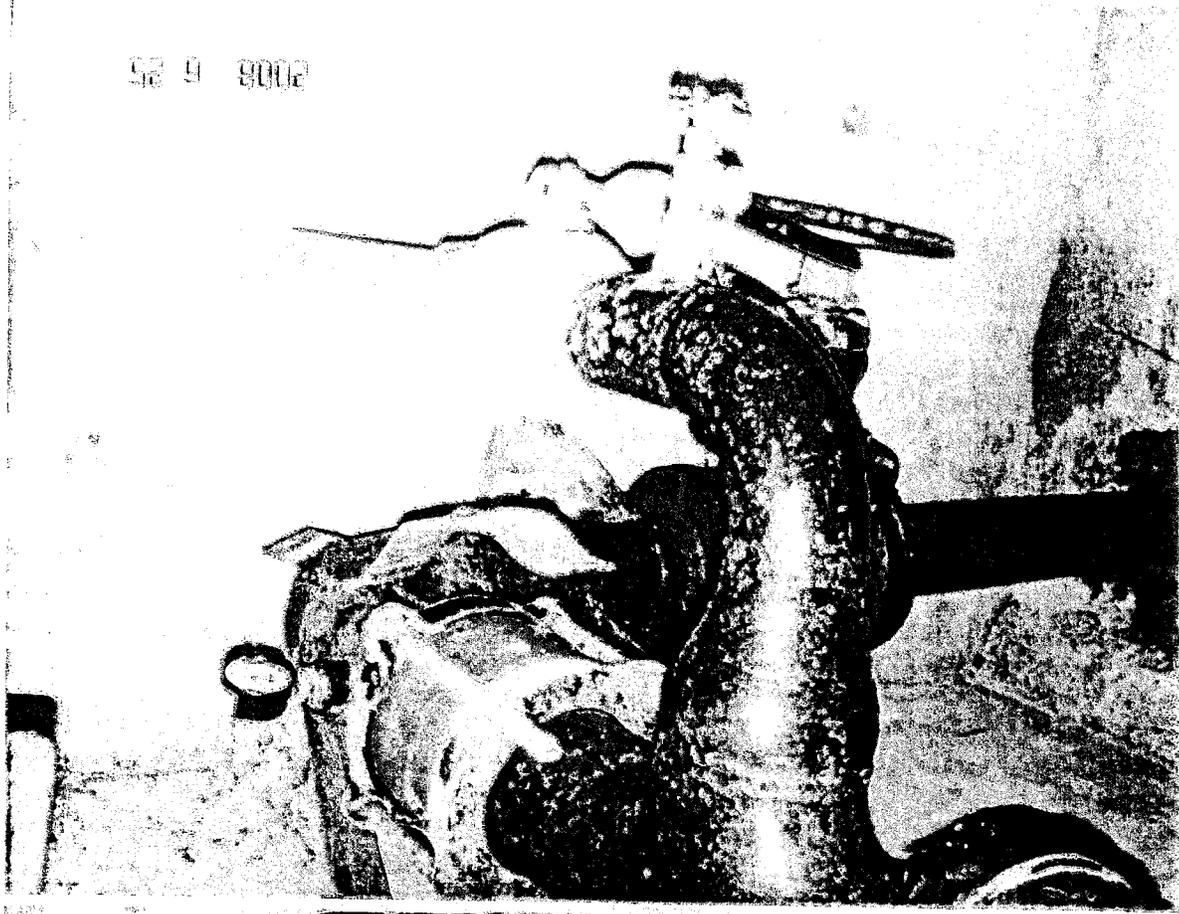
The pictures on this page show the remaining components in the well 2 (WL004) vault.

Top left: The wellhead is vented, but it terminates below the vaults flood rim along with an additional electrical box. The ladder is not permanently fixed to the side wall. The access hatch is not properly gasketed.

Top right: Well 2 (WL004) entry point to distribution can be seen running into the vault floor. A 2" blow-off pipe extends through the wall and terminates in a nearby ditch. This blow-off outlet is currently capped.

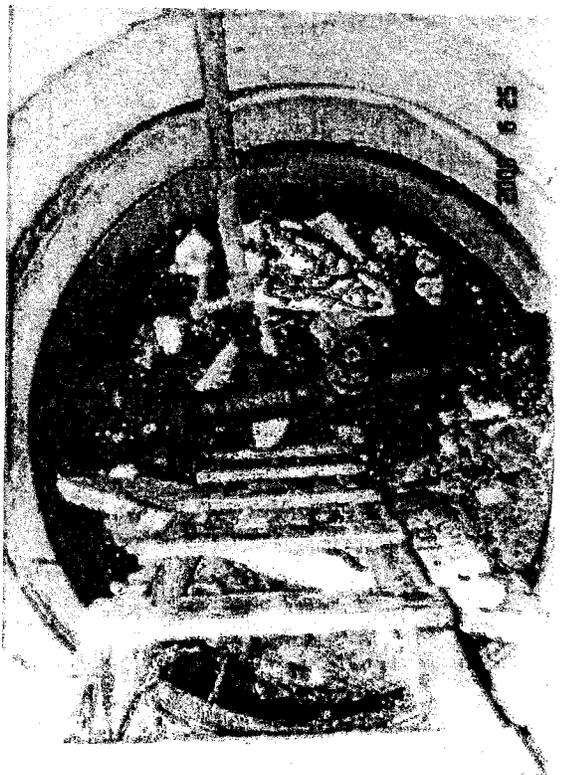
Upper left: Well 3 (WL005) wellhead. Split cap for outside use not recommended. Vent is screened. Well 3 is surrounded by homes.

Lower left: Inside well 3 vault. Garbage in vault with some sign of high water. Not a permanent affixed ladder.

Lower right: Well 3 control panel +/- 10' from control vault.

- Well 3 does not have a meter to help determine production.
- The split style well cap is not recommended for outdoor use because it's prone to leaking over a period of time. I recommend Stevensville purchase a quality well cap that more adequately protects the source from contaminants. Example enclosed.

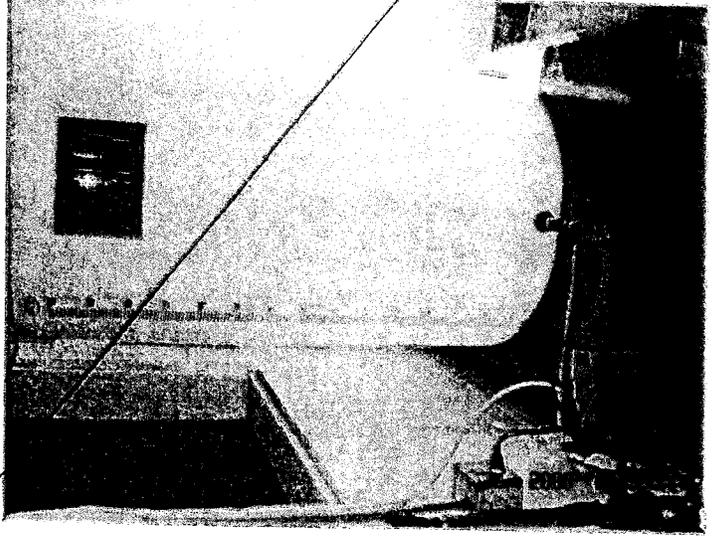
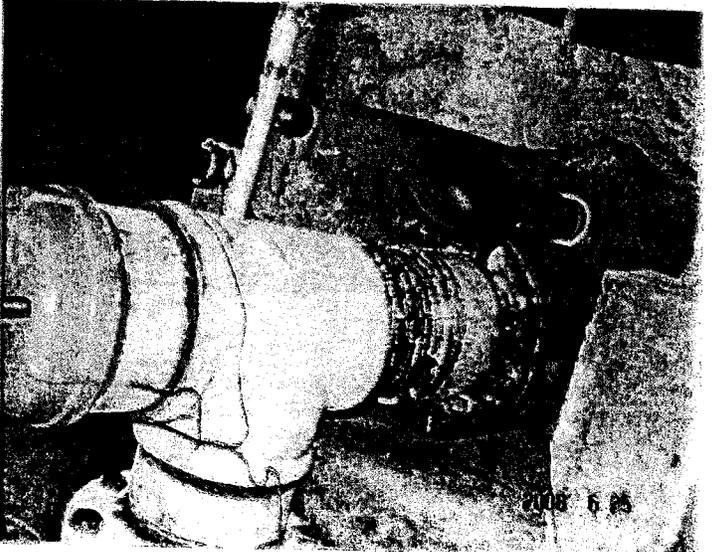
Well 1 (WL003) pictures are shown this page with orthophosphate treatment. (No disinfection in place @ WL003). Injection point for TP002. This well has VFD controls but is set to operate like a standard motor. I can only assume it was installed to minimize hammer at start and stop because VFD used in conjunction with storage tank float controls doesn't seem to be overly beneficial. PVC line goes to spigot. I recommended the operator write the length of the sounding tube on the face of the pressure gauge for easy reference when using the depth gauge set up. The fire hose is used for blow-off purposes.

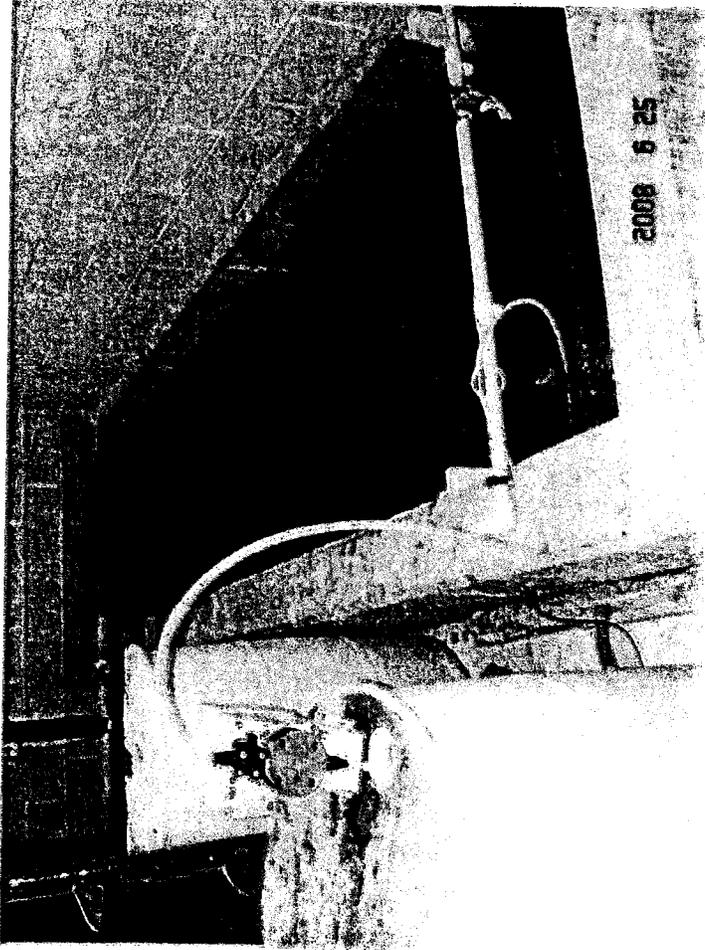
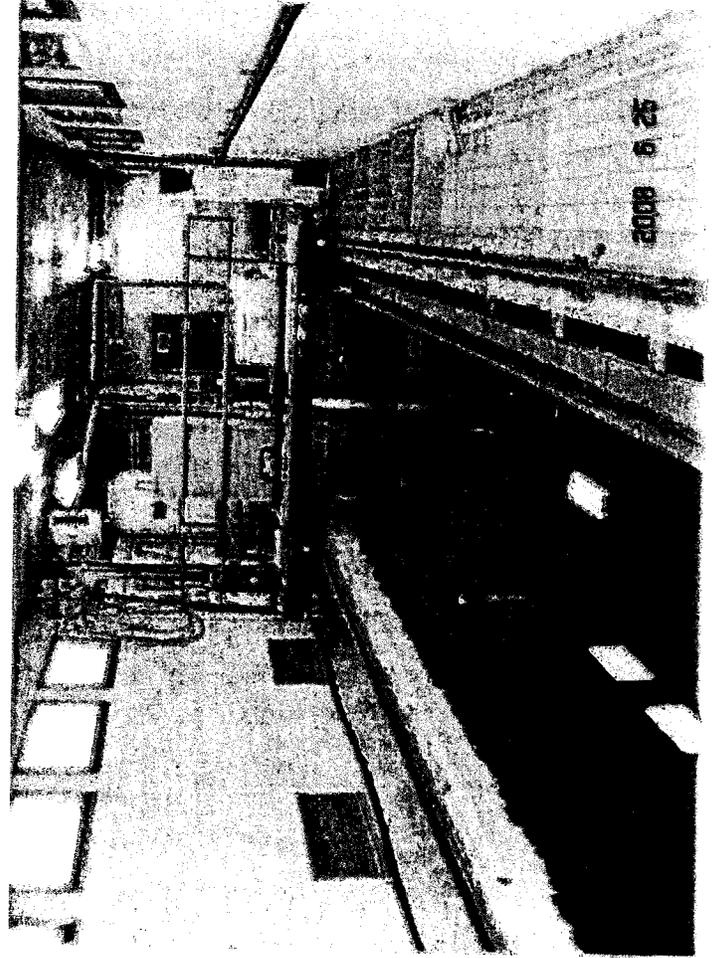
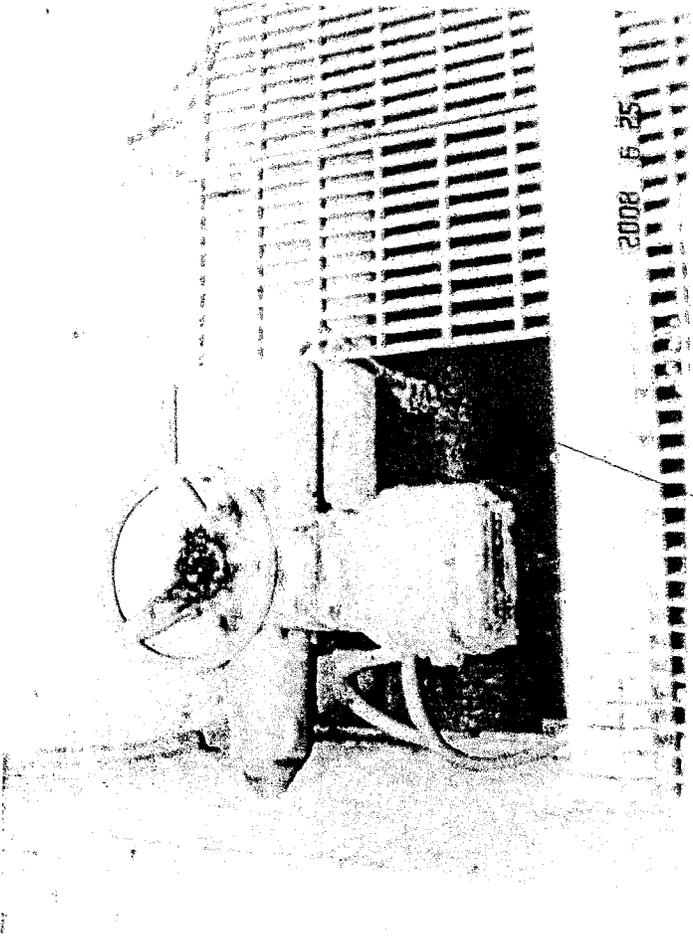
Top left: Surface water inlet from Swamp Creek and Mill Creek sources (TP001). Excess water flows over a wall at the far end of the entry basin and goes to storm drain. Coagulant (alum) is added and flows through settling basin. Chlorine injection is available at this point, but is not used.

Lower left: The sand filter bed can be seen. Chlorine injection point is at the far left side of the picture as the filtered water goes to the 500,000 gallon storage tank (ST001).

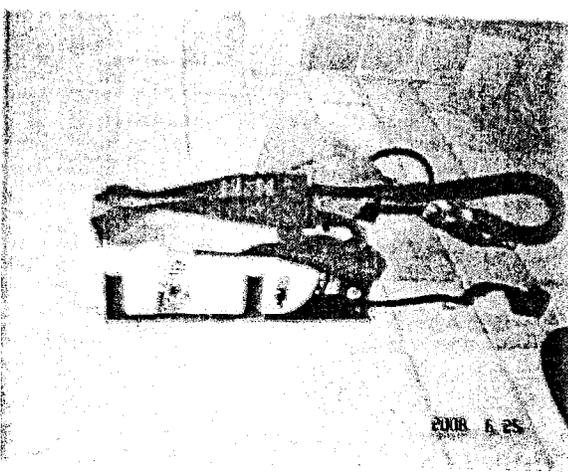
Comment: Outlet vent was near the floor but did not open properly and is currently inadequate. Chlorine gas has eaten the bottom of the metal door. No panic bar on the door. Not scale under the chlorine tanks currently in use. Chlorine room inlet vent is low and in the door. The surface water source is required to treat water and meet CT for disinfection while existing wells do not currently disinfect. DEQ rules also require disinfection after treatment and Well 1 treats with orthophosphate without disinfection.

Stevensville uses gas chlorination at T001 (surface water plant). Deficiencies include no panic bar on door, no scale under tanks in use and vent outlet doesn't open with exhaust fan operation. Accumulation of chlorine gas at floor level has eaten the bottom of the door up.

- I strongly recommend key Stevensville staff carefully read LT1, LT2 and the GWR to make sure you're in compliance now and in the future.
- The gas chlorine room is an extreme safety concern and correction should be prioritized to get the exhaust fan fixed and the panic bar installed on the door.

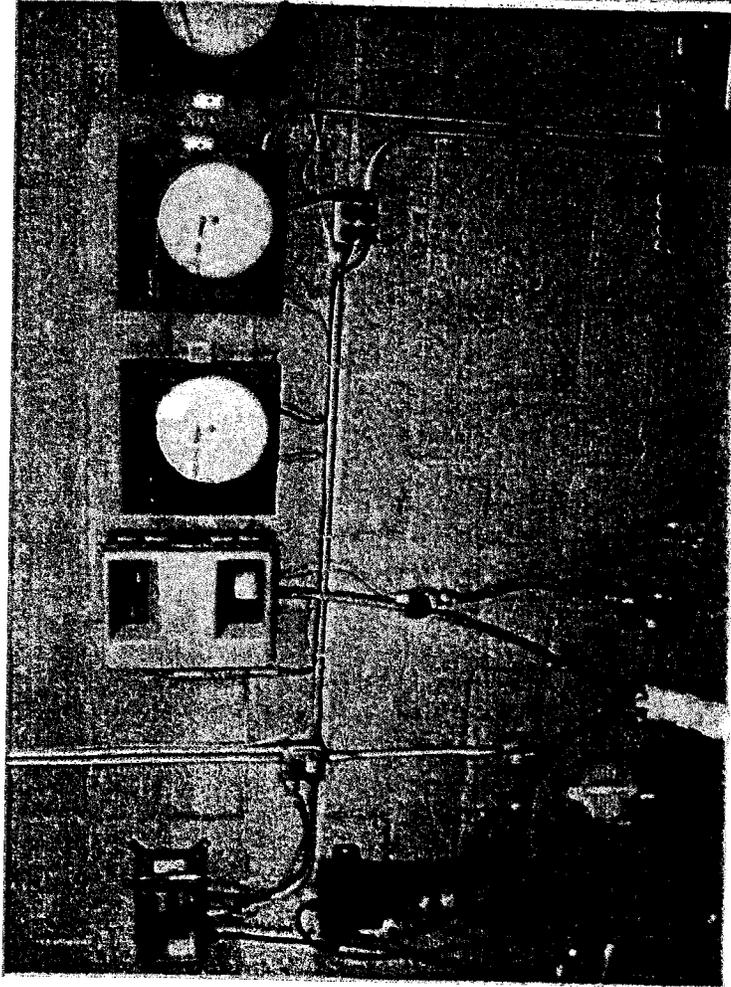
Turbidimeter, colorimeter, and chart graphs are located in the treatment plant control room. Orthophosphate is added for corrosion control.

System has an automatic bypass if the surface water treatment plant exceeds acceptable turbidity measurements prior to entering the storage tank. No turbidity recorder on raw water.

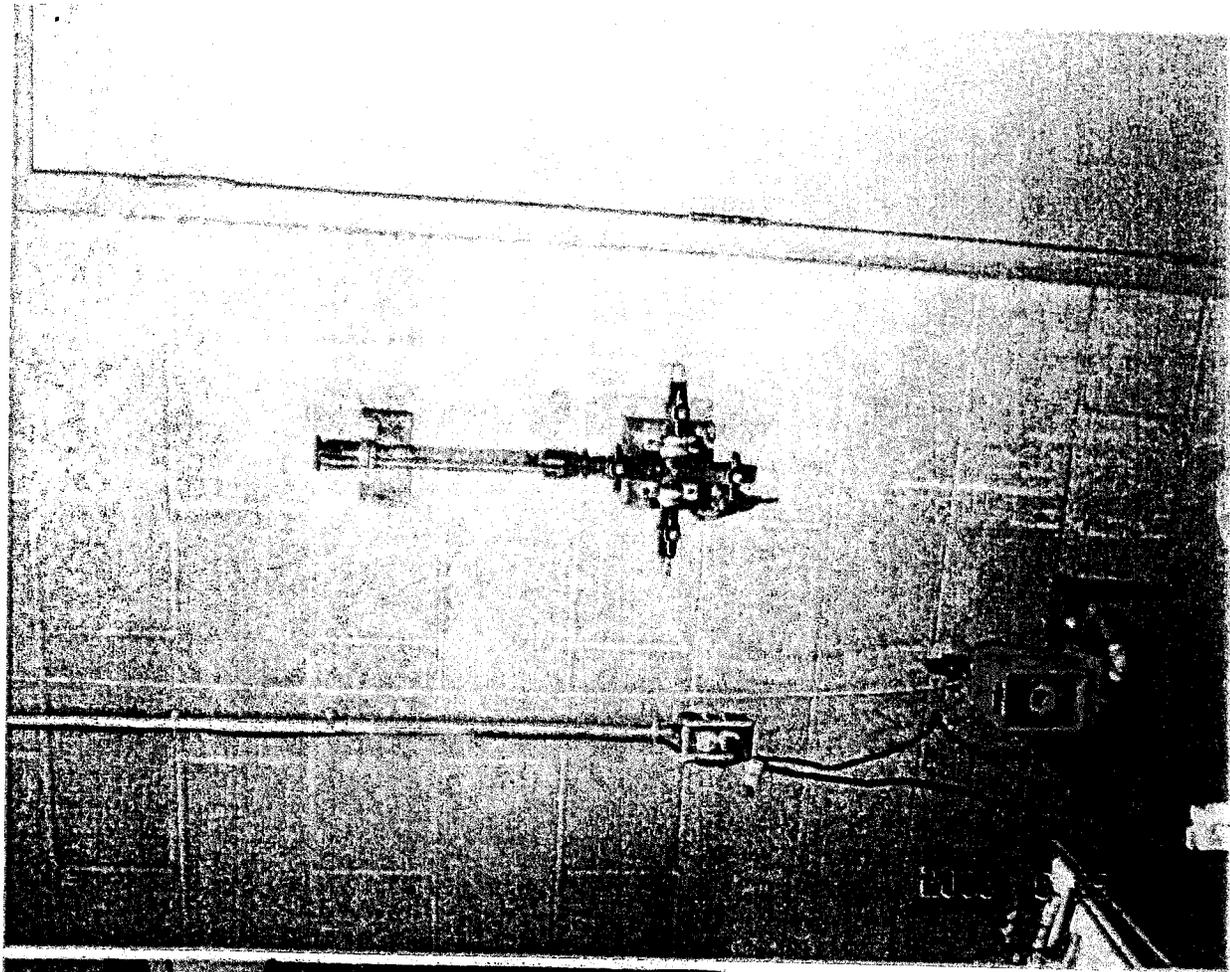
Top left: Top of 500,000 gallon storage tank (ST001) looking toward the surface water treatment building (TP001). The small shed located between TP001 and ST001 houses the automatic bypass valve if turbidity levels exceed acceptable levels leaving the plant.

Top right: Top of the storage tank with the facility roof vent shown in the front of picture. Vent was screened.

Bottom left: TP001, bypass structure, ST001 and a meter vault where a chlorine booster pump injects water leaving ST001 as it enters distribution.

NOTE: System doesn't know for sure where the bypass or ST001 overflow outlets are located, or if they're screened.

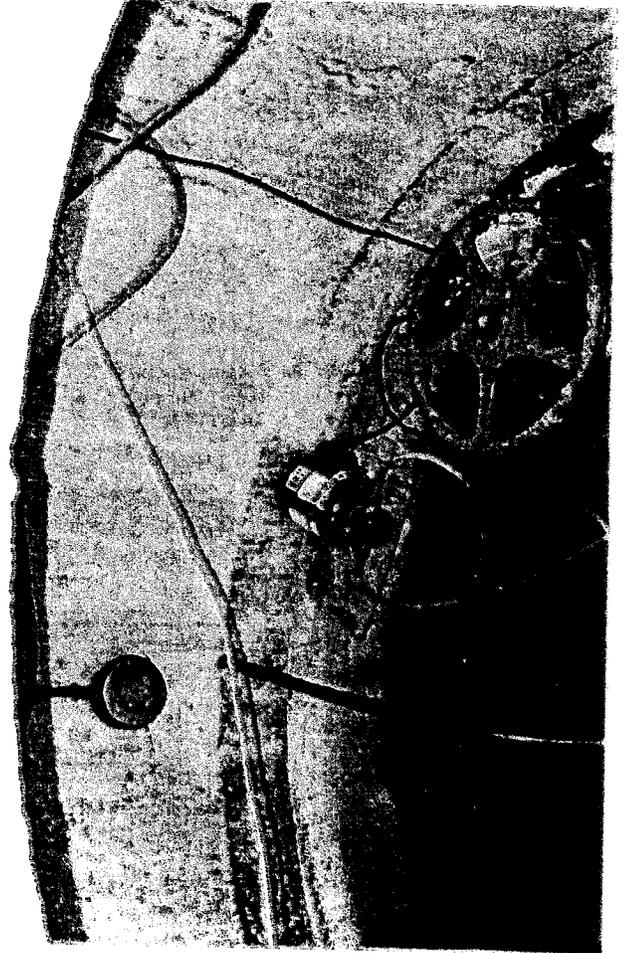
Top left: Existing 500,000 gallon storage tank (ST001) to the left – old storage tank structure that is now used for wastewater disposal near far fence – framed metal siding is used for lid to meter vault that also has a post storage chlorine injector and sump pump to keep ground water below components.

Top right: Picture in meter vault shows meter, sump pump and high ground water. Sump pump goes to old storage tank. Note: Current DEQ standards would not allow a vault in high ground water. DEQ-1 section 8.6

Bottom left: Booster chlorine injection pump can be seen in the same vault. This booster has had to be replaced a few times because of loss of head and it burned out. There is no redundant pump and it's in a vault subject to high ground water levels.

- Chlorine residual levels that are monitored immediately after the storage facility are dependent on the operation of the a small booster pump that has had issues with air lock and failure. This booster is also located in one of the vaults with high ground water that is discharged by a sump pump. Perhaps a different setup may prove more reliable to monitor entry point chlorine residual.
