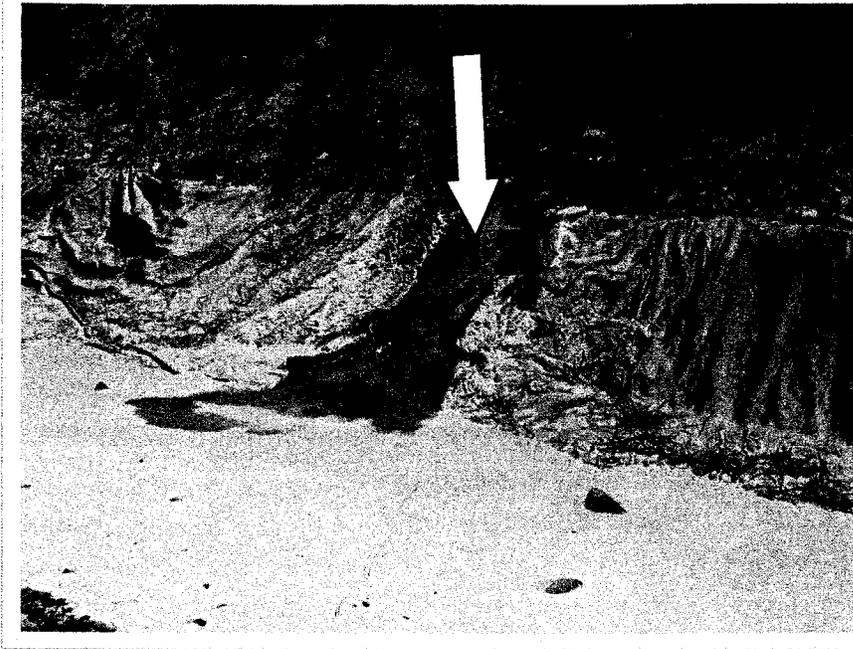
Photo 1 – Spring flowing into Canal

A spring located above the canal is flowing over and under the canal resulting in infiltration of external water sources and movement of structural foundation of the canal.

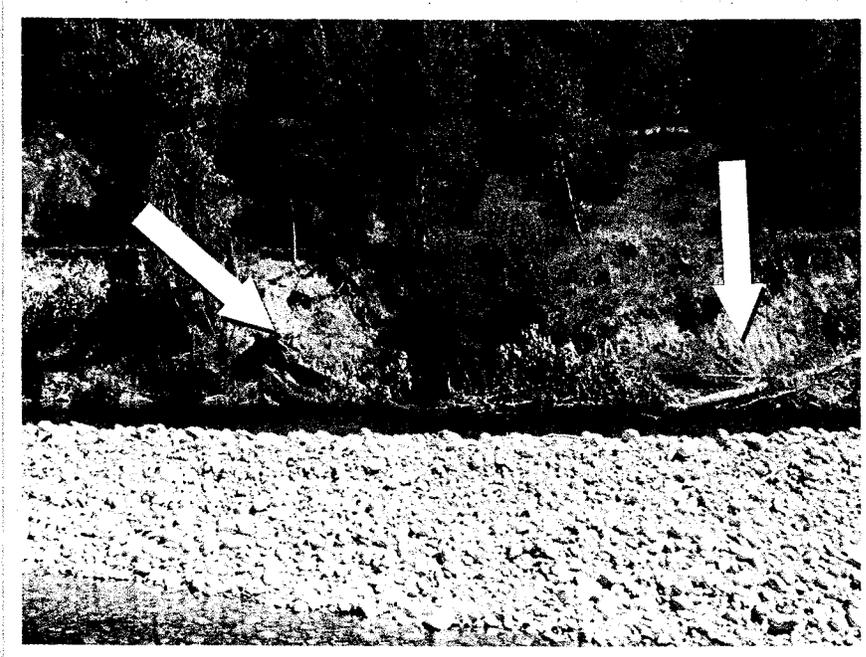
Photo 2 – Sloughing of Canal Bank

This picture illustrates the sloughing of the canal bank into the Bitterroot River. The Hedge Canal is located immediately behind the top of bank.

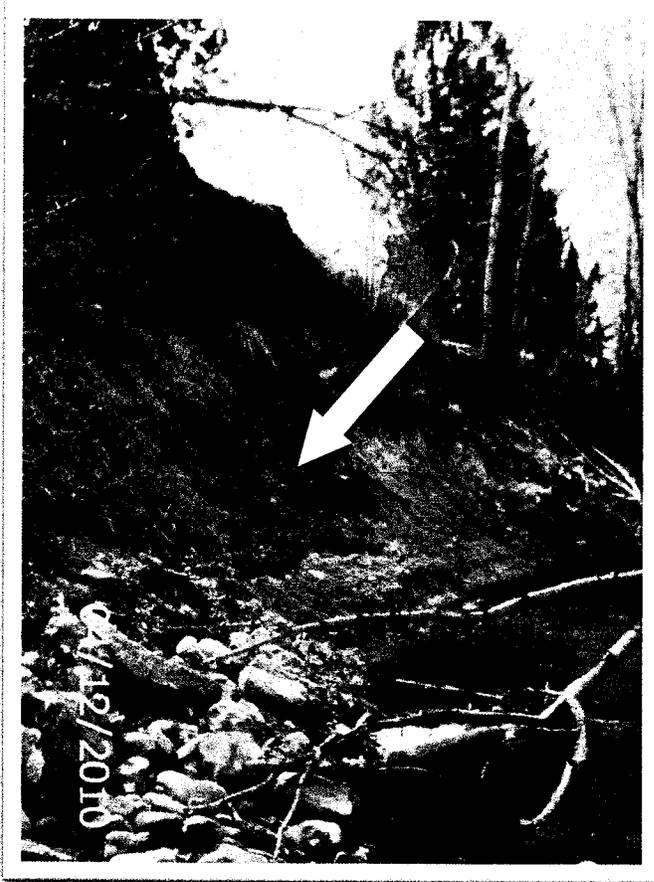
Photo 3 – Spring Seepage through Canal/Riverbank

This picture illustrates the seepage of the spring through the canal bank into the Bitterroot River. The Hedge Canal is located immediately behind the top of bank.

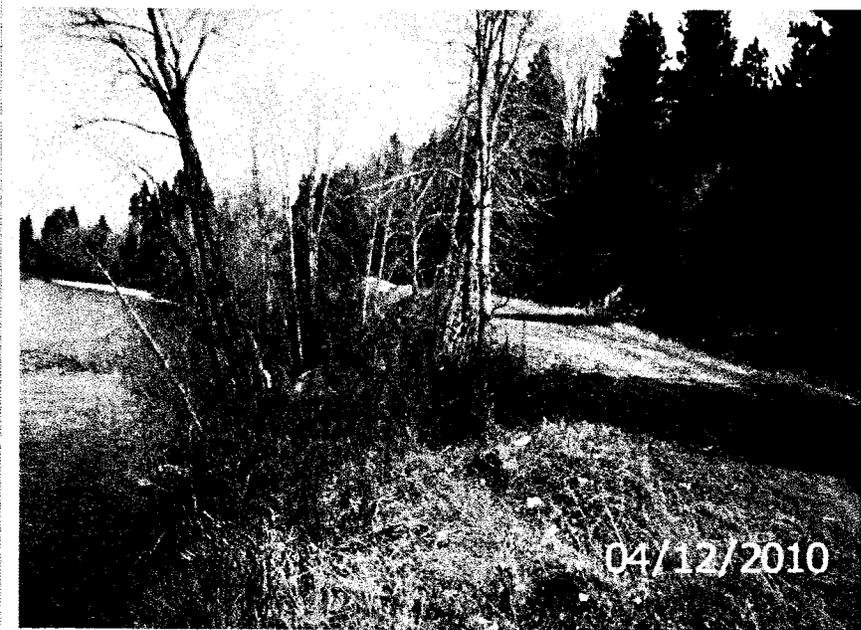
Photo 4 – Sectional View

This picture, taken looking downstream (North), illustrates the sectional view of the Hedge Canal, bank and Bitterroot River.

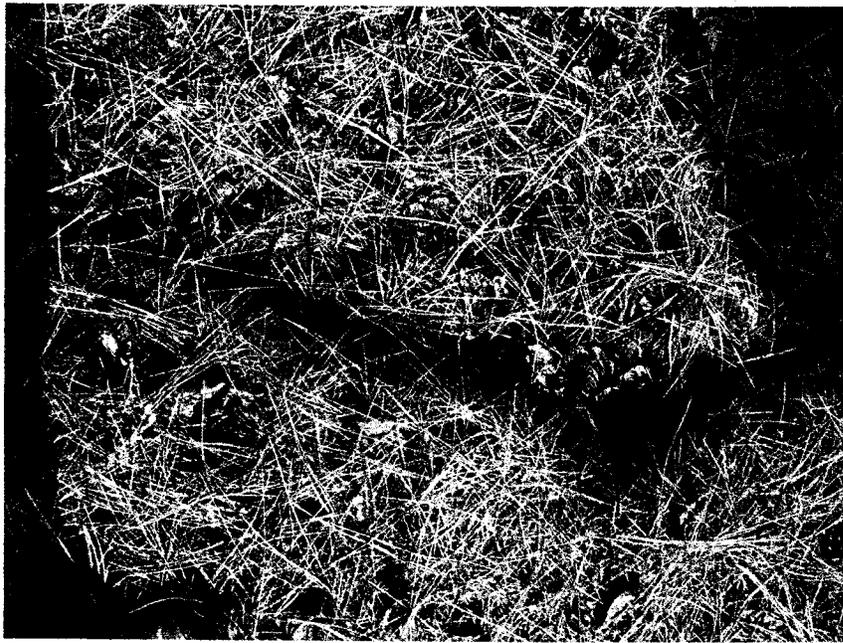
Photo 6 – Cracks in the canal bank attributing to sloughing

The underlying causes of the current condition of the Hedge Canal are seepage and channel erosion. The canal bank is weakened from above by the spring seepage through the canal bank and from below by the erosion occurring along the streambank.
