PRELIMINARY ALIGNMENT REVIEW

Makoshika State Park
Radio Hill Road Reconstruction

Glendive, Montana

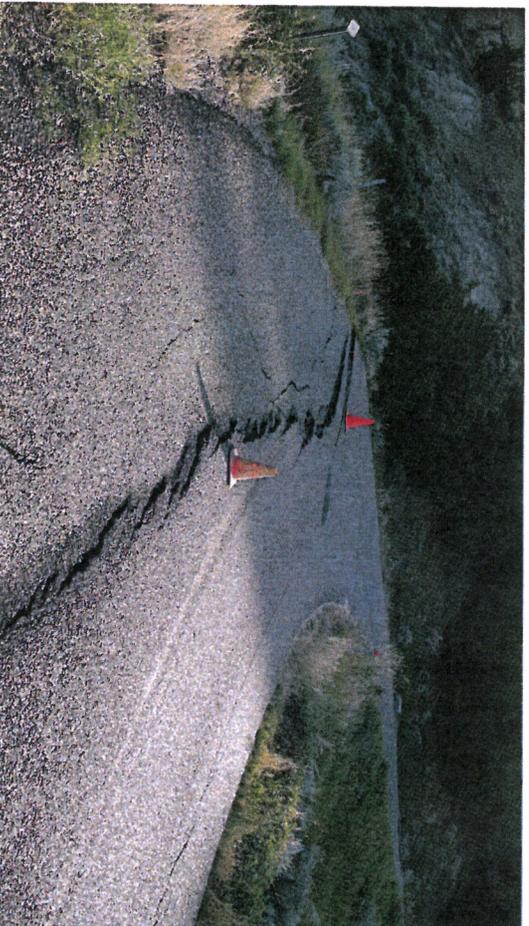
Surficial cracks within the asphalt road began appearing along the curve that is adjacent to the detention basin during May 2011. It is important to note that this area experienced precipitation amounts that were much greater than average over the months of March through June of that year. By mid-summer, the cracking worsened and the road began to show signs of settlement, which is evidence of sub-base failure, as shown in Photo 1.

Photo 1 – Surficial cracking and evidence of sub-base failure. (Photo courtesy of MT FWP).

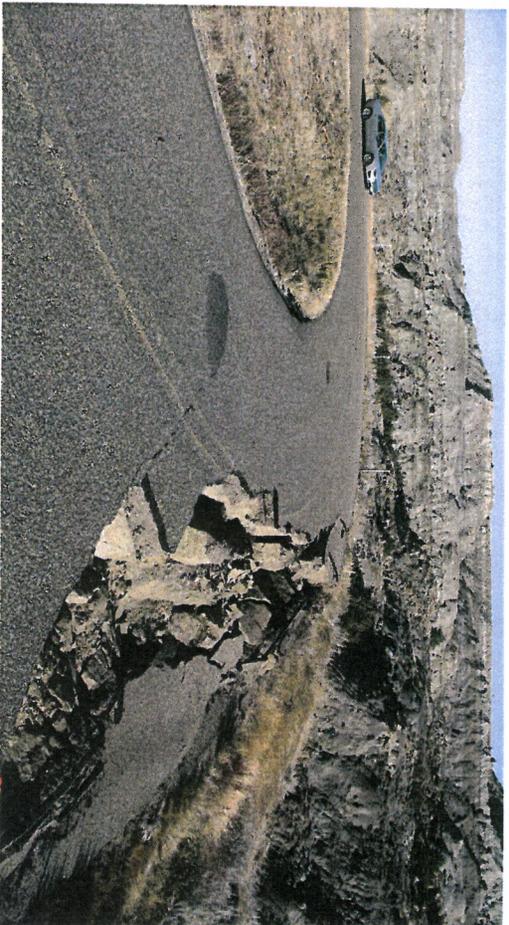
By September 2011 the cracks had expanded further and the road and adjacent slope had failed. In October 2011, a large portion of the adjacent slope failed and took a portion of the road with it, as shown in Photo 2. The road was then closed and a contractor was selected to construct a temporary, alternate route. The alternate route filled in the existing detention facility and moved the curve inward approximately 50 feet. To maintain storm drainage, a continuous length of 18-inch HDPE intercepted the flow from the existing roadside inlet and conveyed the runoff downslope of the failed section. This work was completed in November 2011.

Photo 2 – Failure of roadway and adjacent slope. (Photo courtesy of MT FWP).

The detention pond, constructed in 2001, was designed to be seeded, but had no additional lining that would prevent the infiltration of runoff into the underlying soils. It is suspected that this detention pond, combined with the extraordinary amount of precipitation in the spring of 2011, contributed to the saturation of the surrounding soils and ultimately the failure of the adjacent slope and roadway.

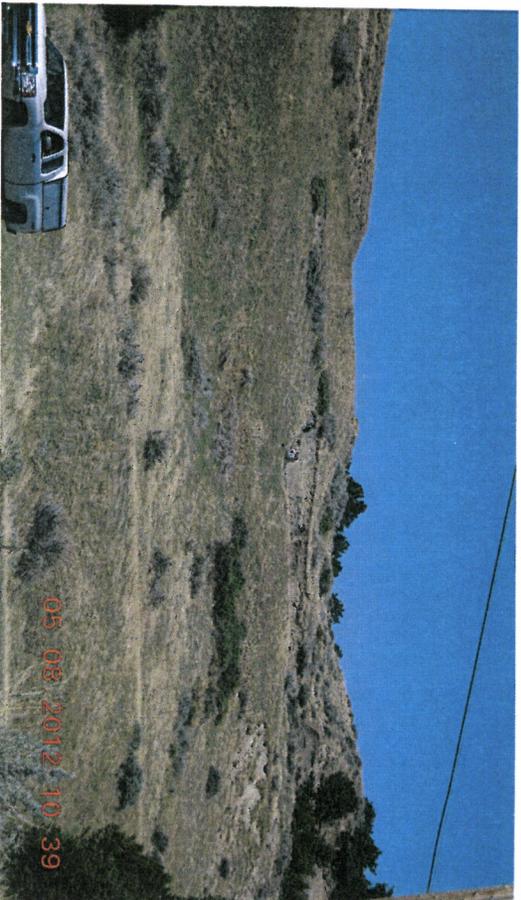
The first alternative improves the current temporary alignment and stabilizes the adjacent potential problem areas, as shown in Figure 2. During the topographical survey of the area, two to three additional slope areas along the escarpment and adjacent hillside were noted that had significant potential to calve off, much like the failure that occurred on the curve. One such area is shown in Photo 3.

Photo 3 – Potential, future failure area shown in upper middle of picture.

In order to achieve a long-term solution, the adjacent areas that are currently exhibiting signs of failure will need to be stabilized. This stabilization will likely involve a combination of stone or concrete columns, soil nailing/pinning, and surficial anchoring with netting. Figures 1 and 2, shown below, illustrate the mechanics of soil nailing and micropiles. According to the Geotechnical Engineering Report, these stabilization methods include:

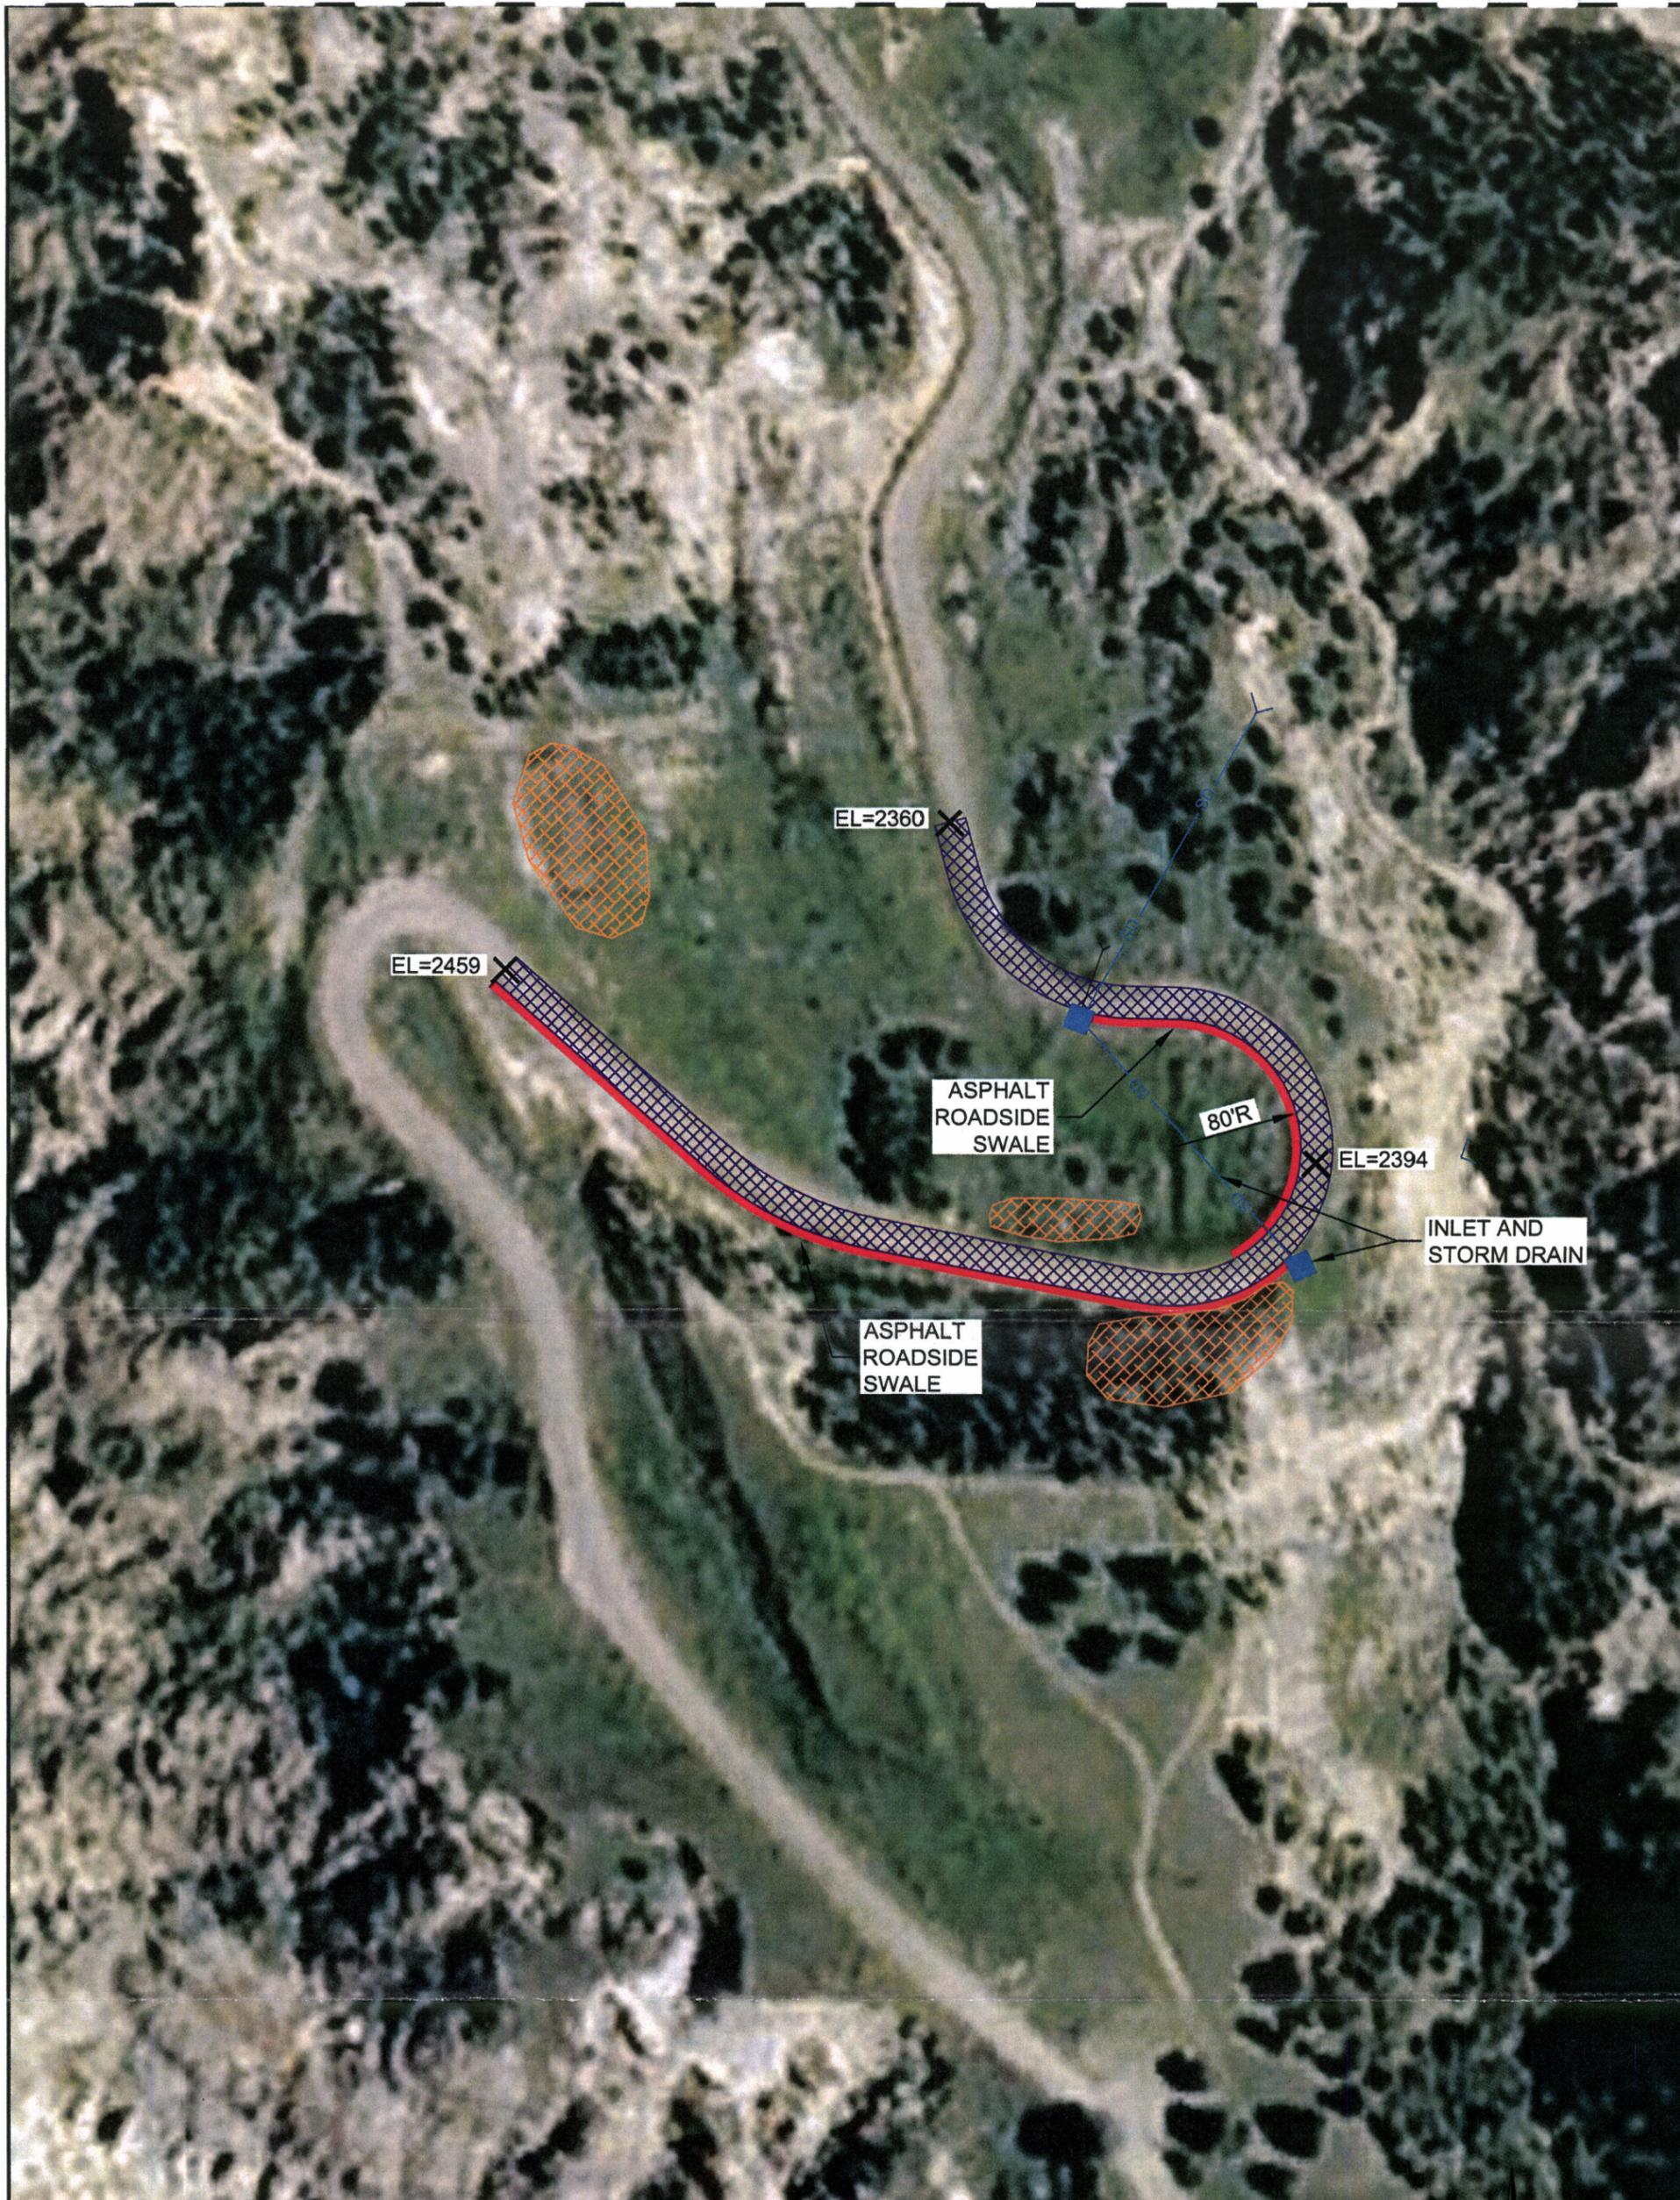
Alternative No. 2 involves re-establishing the original alignment and addressing the adjacent potential problem areas, as illustrated in Figure 3. This potential route is very similar to Alternative No. 1; however, returning to the original road location improves the drivability of this section of road by slightly decreasing the roadway slope and also marginally increasing the curve radius of the curve from 72 feet to 80 feet.

The length of road constructed under this alternative is approximately 940 feet with 830 feet of new asphalt roadside swale. Again, the asphalt road would be 24 feet wide providing two 12 foot driving lanes. A new inlet would also be installed to convey stormwater away from the site. Rather than direct water to a detention facility, the runoff would be piped to the west and discharged into the existing drainage.
