Strategic Master Planning Report

MONTANA STATE
DEPARTMENT OF CORRECTIONS

PHASE 2 AMENDMENT REPORT | DECEMBER 27, 2022

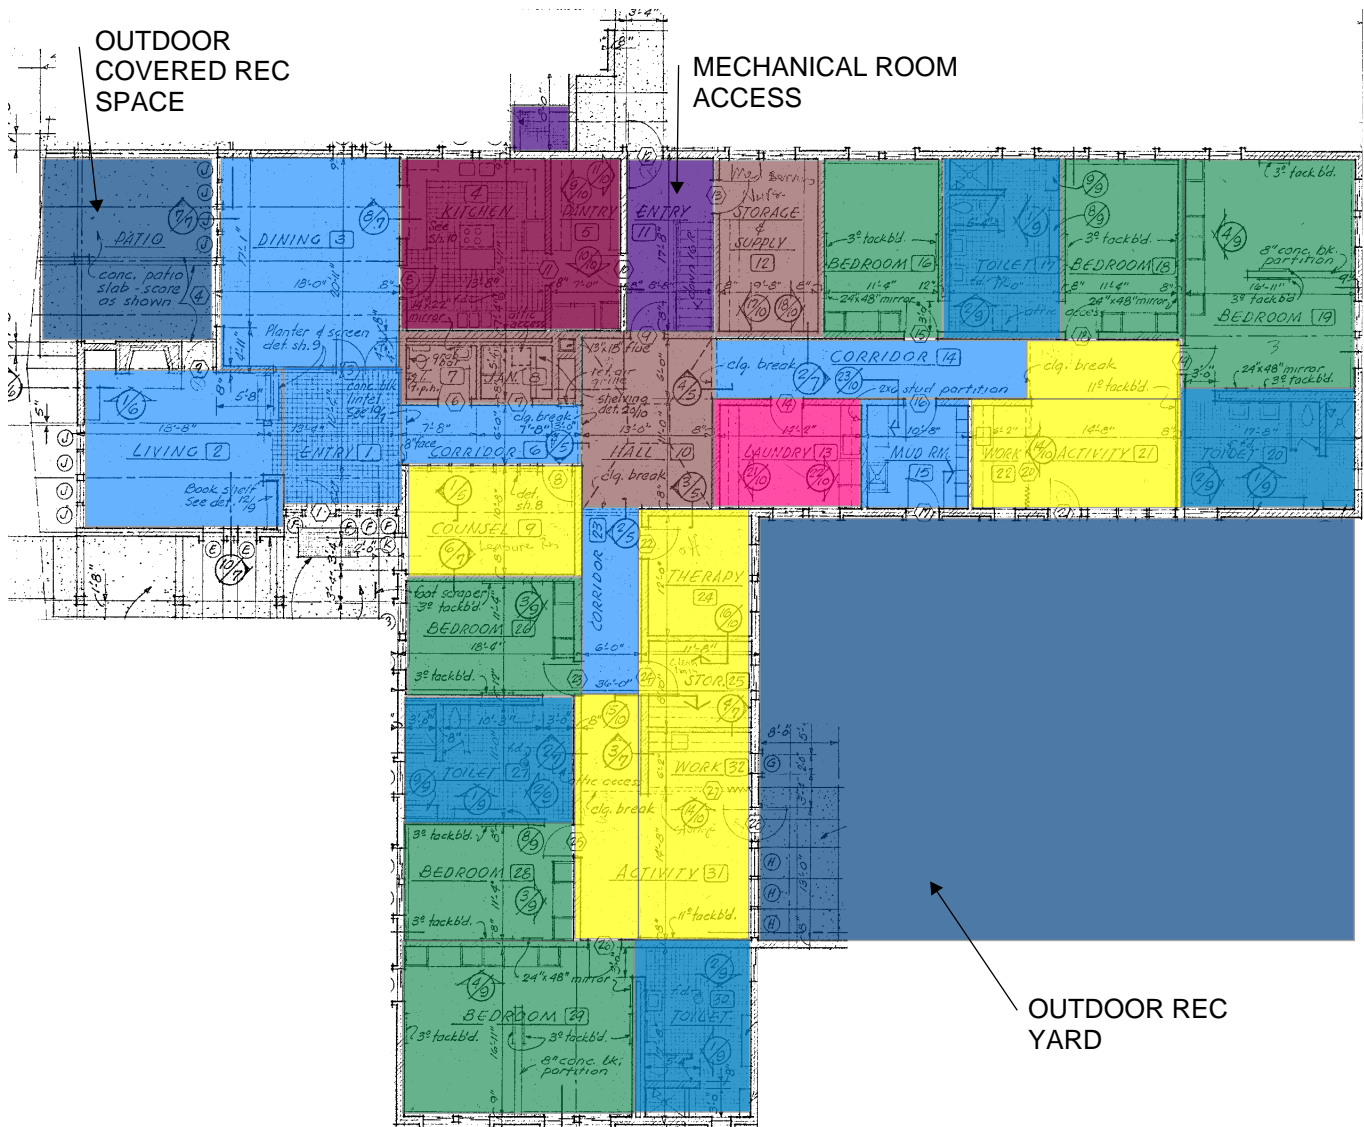
Watch East B1/B2
Abandon Cottage

Building is abandoned and currently being used for surplus storage. Facility has been used for other uses (Boys/Girls Club) and Community Activities in the past. Facility has some systems operational. Review is to be determine if building can be revived for other use. From initial review of building, considering age, load bearing wall construction, foundation issues, ACM possibilities, retrofitting the facility for functions of a different use (occupancy group) may be cost prohibitive.

From initial review of building, considering age, load bearing masonry wall construction, foundation issues, ACM possibilities, retrofitting the facility for functions of a different use (occupancy group) may be cost prohibitive. This facility may be best slated for demolition vs rehabilitation for other use.

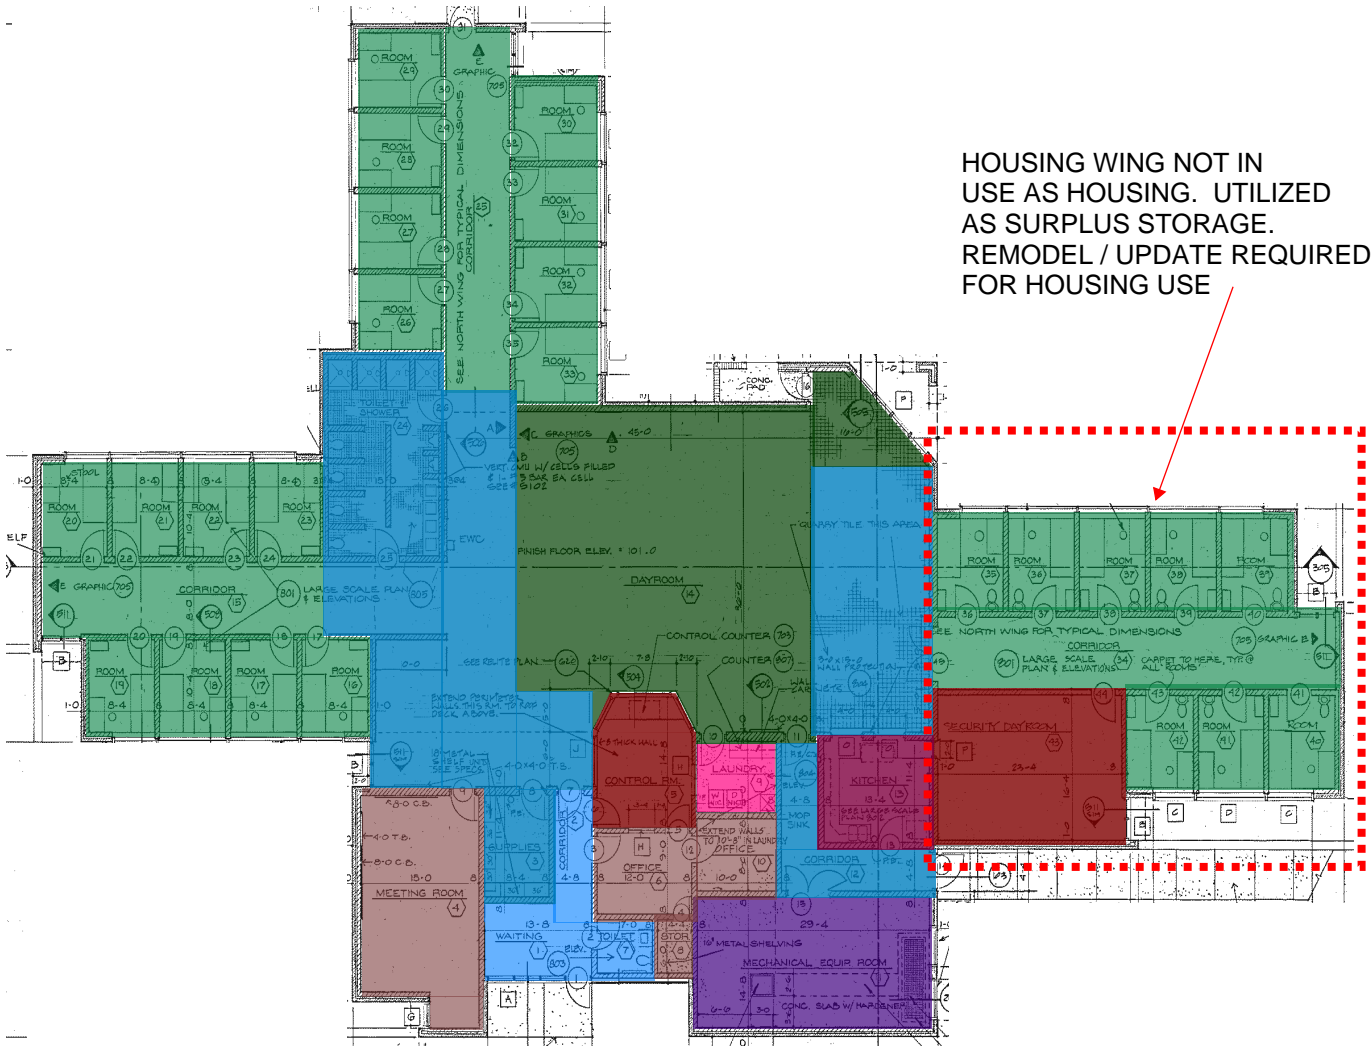
B2 FLOOR PLAN
 9,285 GSF
 SINGLE STORY

Note: From the total area of the building, 20% (1800 SF) of the building was not remodeled from 2000 renovation. Area left un-remodeled is currently used as surplus storage. Recommend to remodel / upgrade section for detention use.

HOUSING WING NOT IN USE AS HOUSING. UTILIZED AS SURPLUS STORAGE. REMODEL / UPDATE REQUIRED FOR HOUSING USE

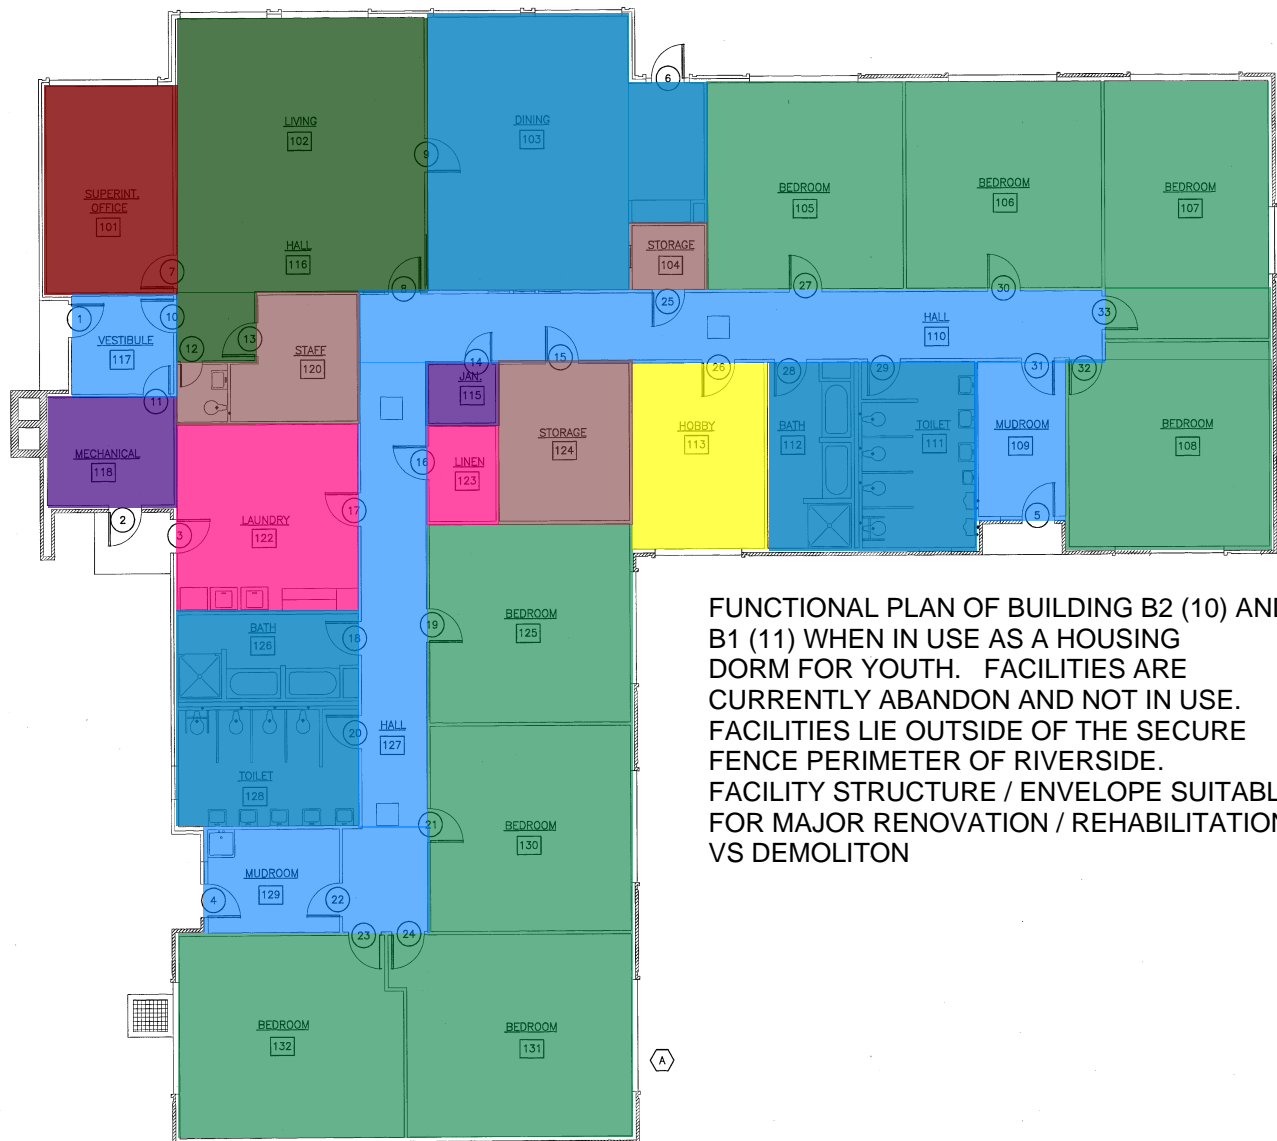
7480 GSF

FUNCTIONAL PLAN OF BUILDING B2 (10) AND B1 (11) WHEN IN USE AS A HOUSING DORM FOR YOUTH. FACILITIES ARE CURRENTLY ABANDON AND NOT IN USE. FACILITIES LIE OUTSIDE OF THE SECURE FENCE PERIMETER OF RIVERSIDE. FACILITY STRUCTURE / ENVELOPE SUITABLE FOR MAJOR RENOVATION / REHABILITATION VS DEMOLITON

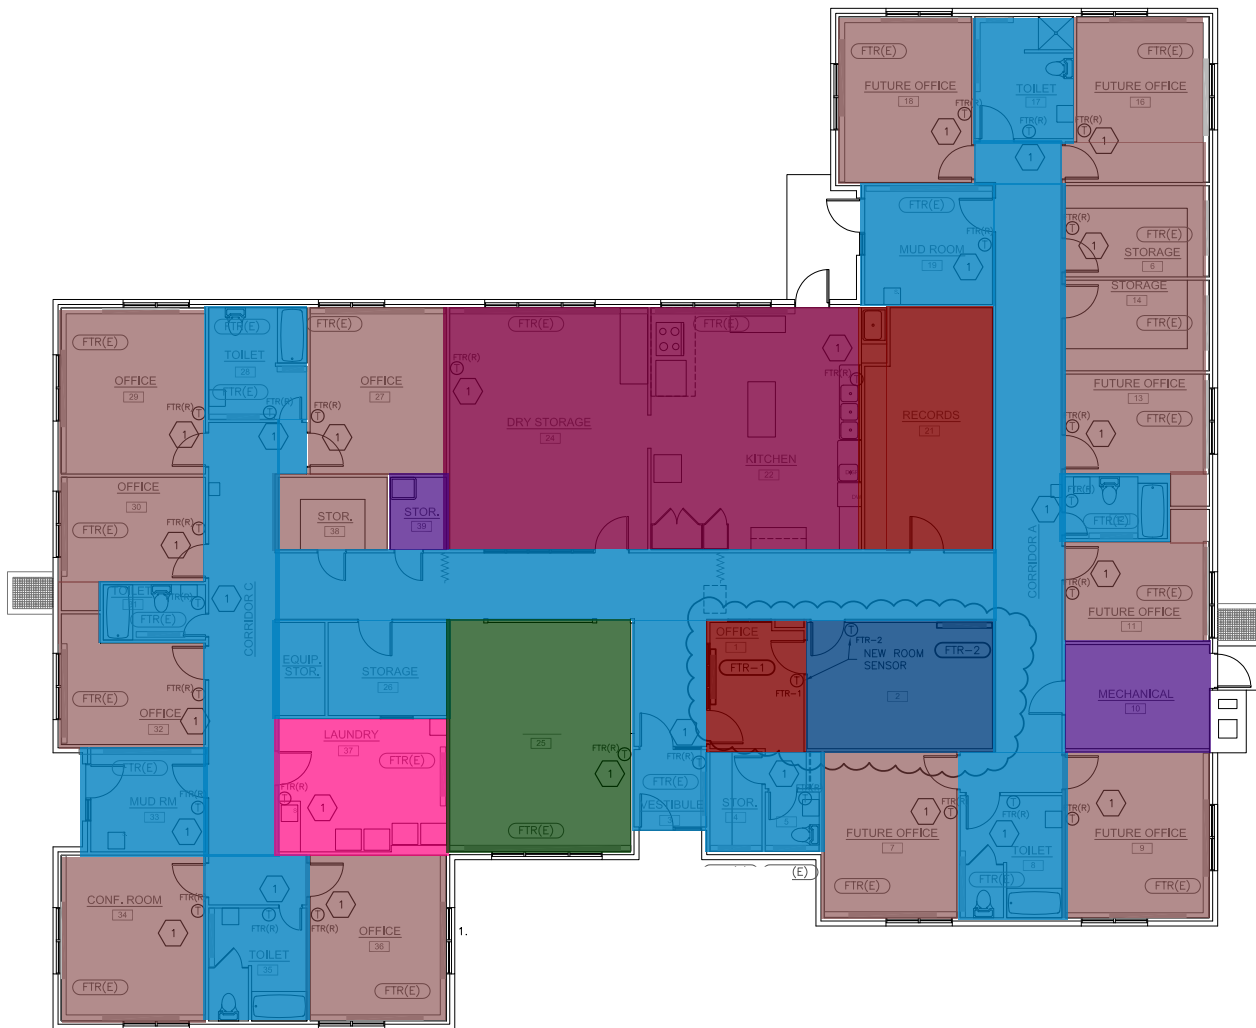
BLDG B7 (15) FLOOR PLAN
7035 GSF

BUILDING ORIGINALLY CONSTRUCTED AS A LOW SECURITY DORM FACILITY. MT DOC UTILIZES BLDG FOR SOME ADMIN FUNCTIONS, INFIRMARY, LIMITED KITCHEN FUNCTIONS AND GENERAL STORAGE BUILDING SUITABLE FOR INTERIOR DEMOLITION AND REMODEL
