Montana State Legislature

SALINITY CONTROL

in Montana

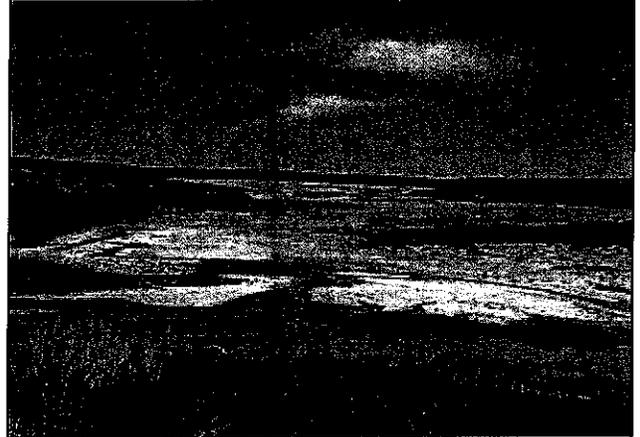
Before Photo. A large flowing saline seep in a crop-fallow field in 1996 prior to any reclamation measures. Photo corresponds to Well 8 in Figure 6.

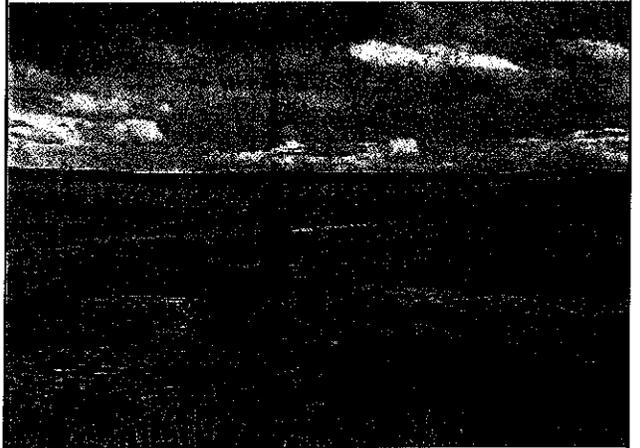
After Photo. Same saline-affected area in 2000 after the recharge area had been identified through a ground water investigation. The recharge area was rotated to a alfalfa-grass mixture and later the seep perimeter seeded to salt-tolerant grass species.
