HB 345 Testimony Graphics: Feb 6, 2007
Karin Boyd Applied Geomorphology, Inc.

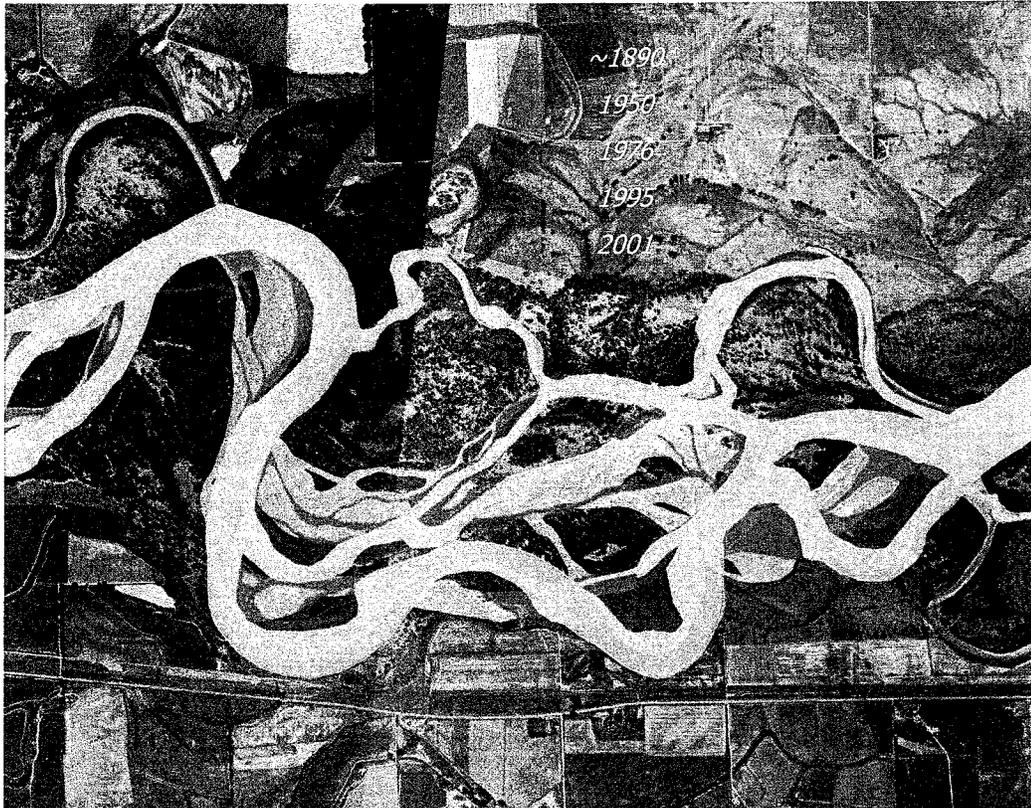
FIGURE 1 Yellowstone River, Rosebud County: 100 years of channel locations (2001 in light green). Channel shifting is associated with regeneration of riparian forests and healthy habitat. High hazard areas extends beyond existing channel banks, where the river is prone to dramatic shifts during high water.

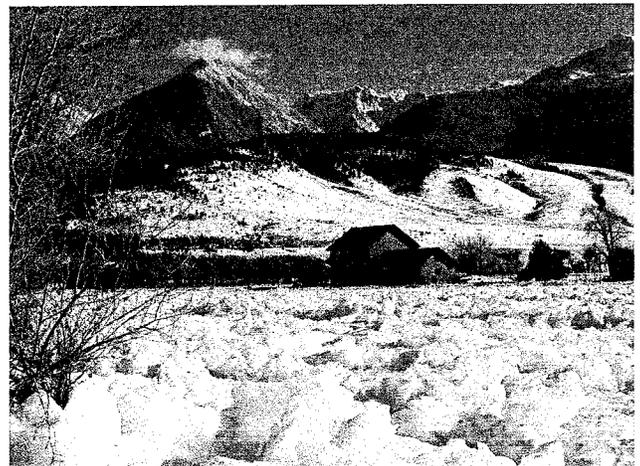
FIGURE 3. Yellowstone River, Park County: Jan 2007 Ice Jam that extended out beyond the river banks onto the floodplain.

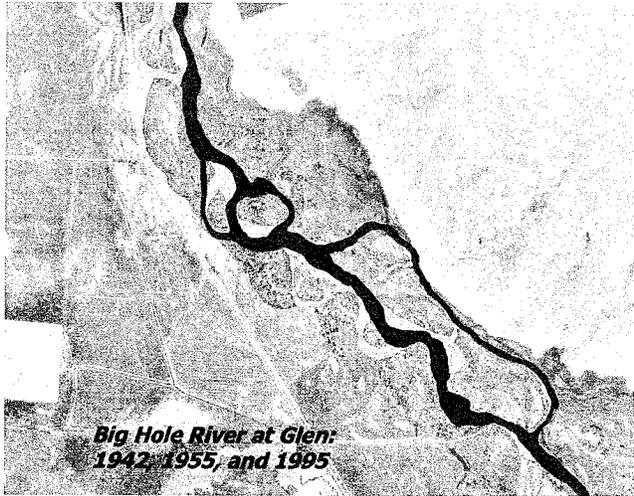
FIGURE 4a. Big Hole River near Glen: 50 years of channel location

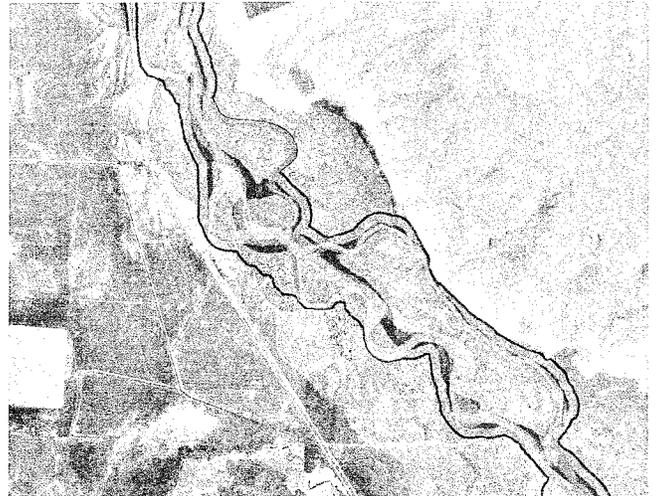
FIGURE 4b. Big Hole River near Glen: Hazard Corridor that includes historic channel locations, and extends well beyond the current channel banks.

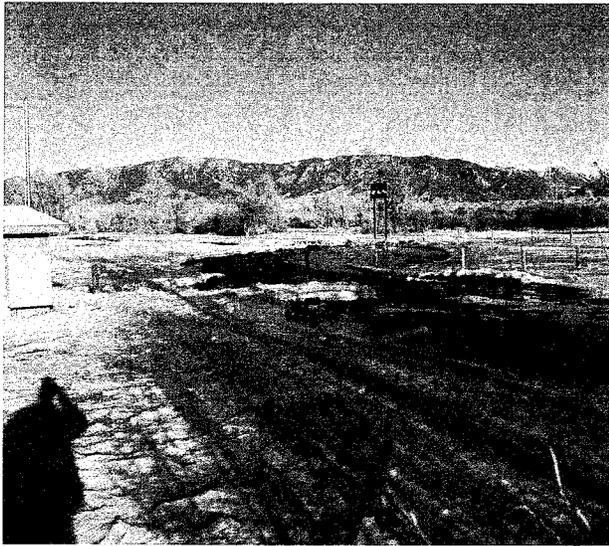
FIGURE 5. Madison River Jan 2007: New channel in ballfields due to ice formation on river.

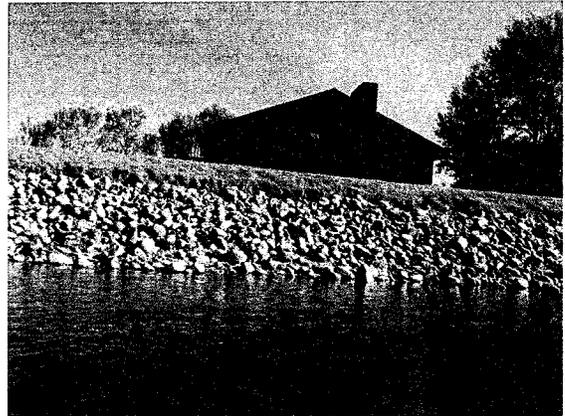
FIGURE 6. Bitterroot River bank armor: Protecting personal investment.

- Costly construction of bank armoring to protect investments
 - ⇒ "Locking" the location of a river
 - ⇒ Loss of river adjustability to future conditions
 - ⇒ Loss of habitat formation/sustainability
