EXHIBIT 9

Town of Belt
P O Box 453
Belt, Mt. 59412

Re: Town of Belt DNRC RRGL and TSEP Grants

SANITARY SURVEY FORM - INVENTORY

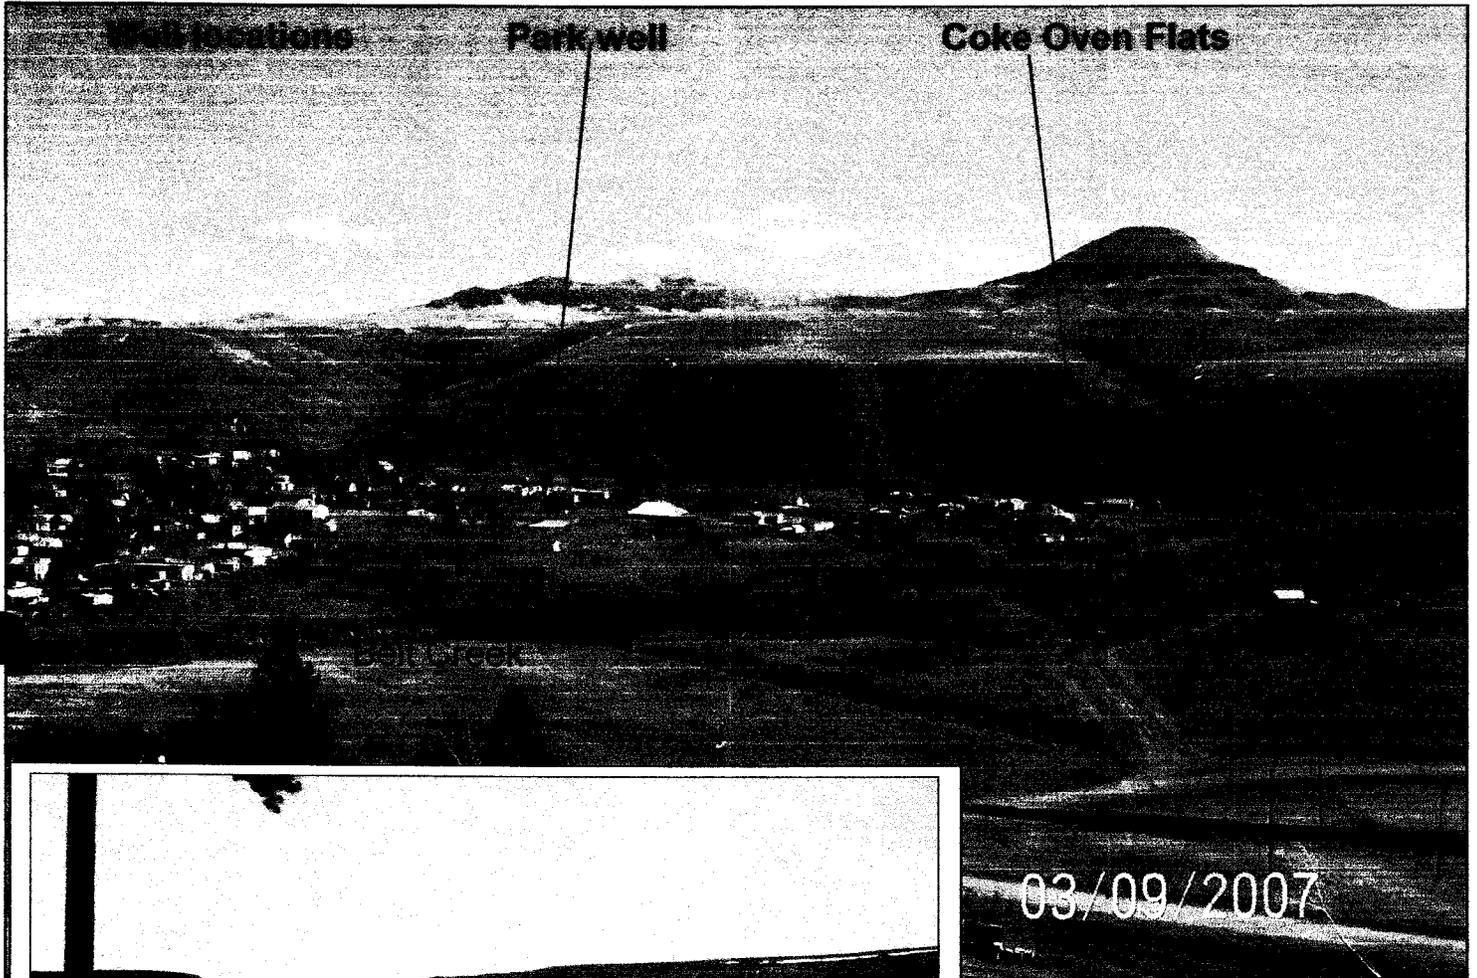
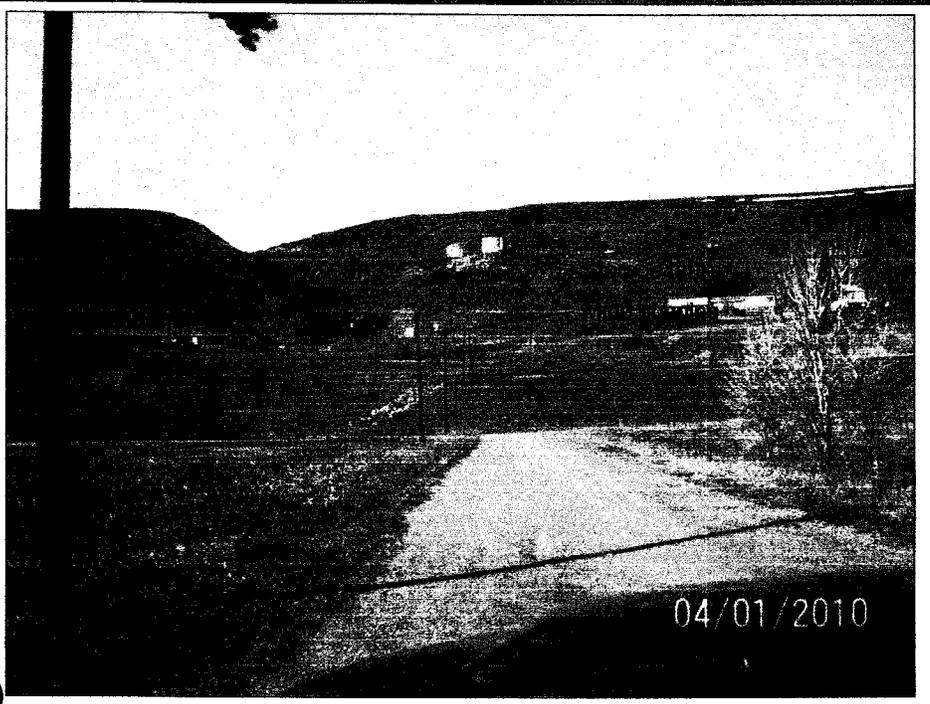
Draw brief site plan showing location of well(s), springs(s), water storage, distribution system, pumphouse(s), entry point(s), treatment, etc. and label with appropriate facility designation. Include interconnections with other PWS's. Add additional pages as needed.

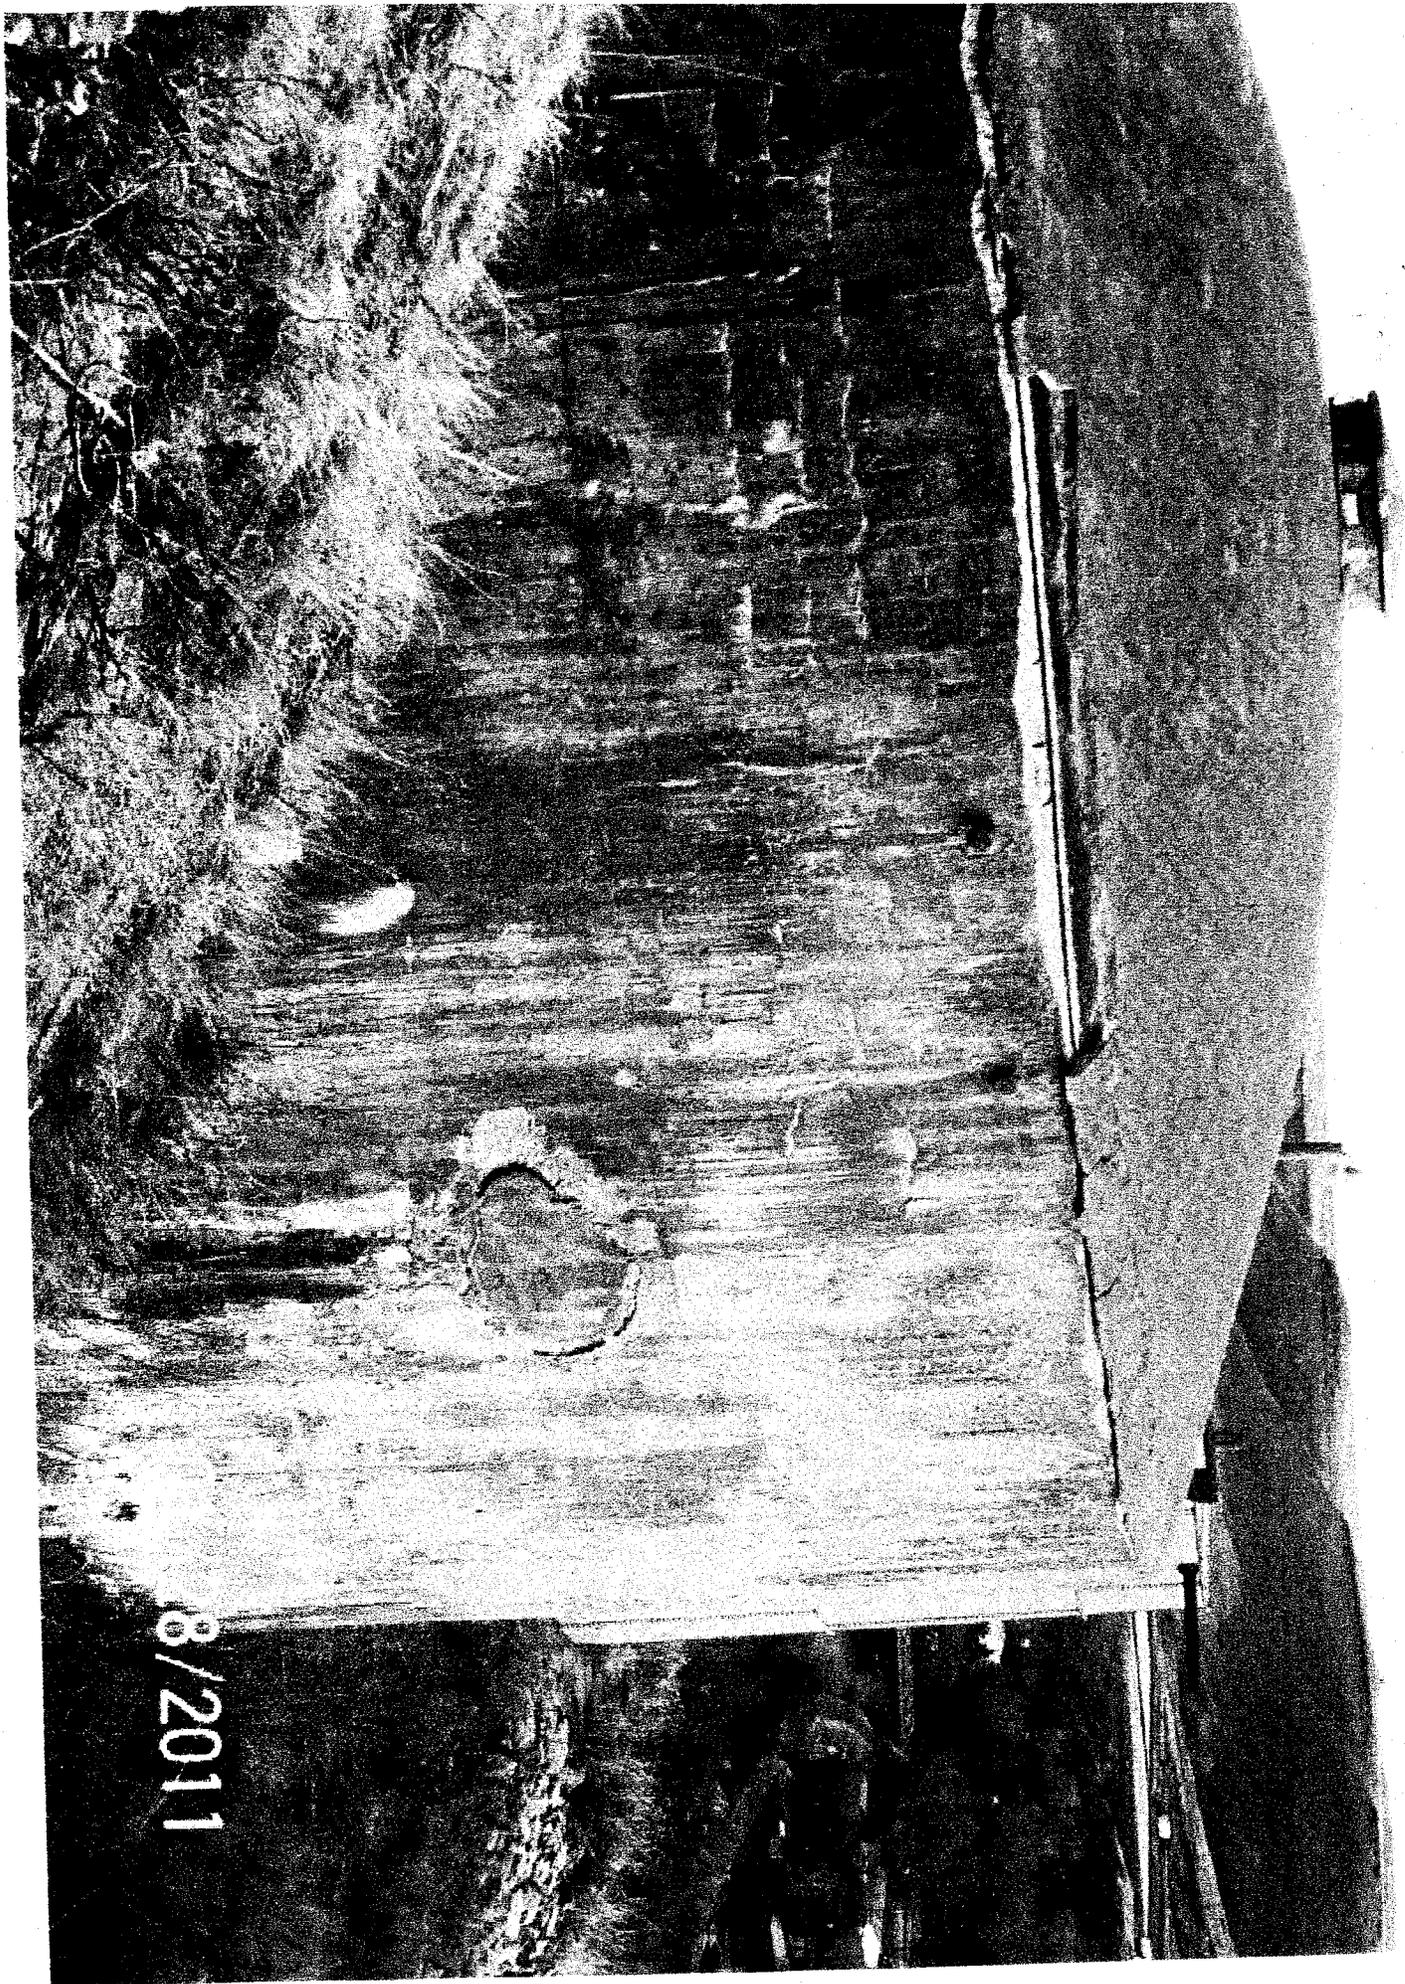
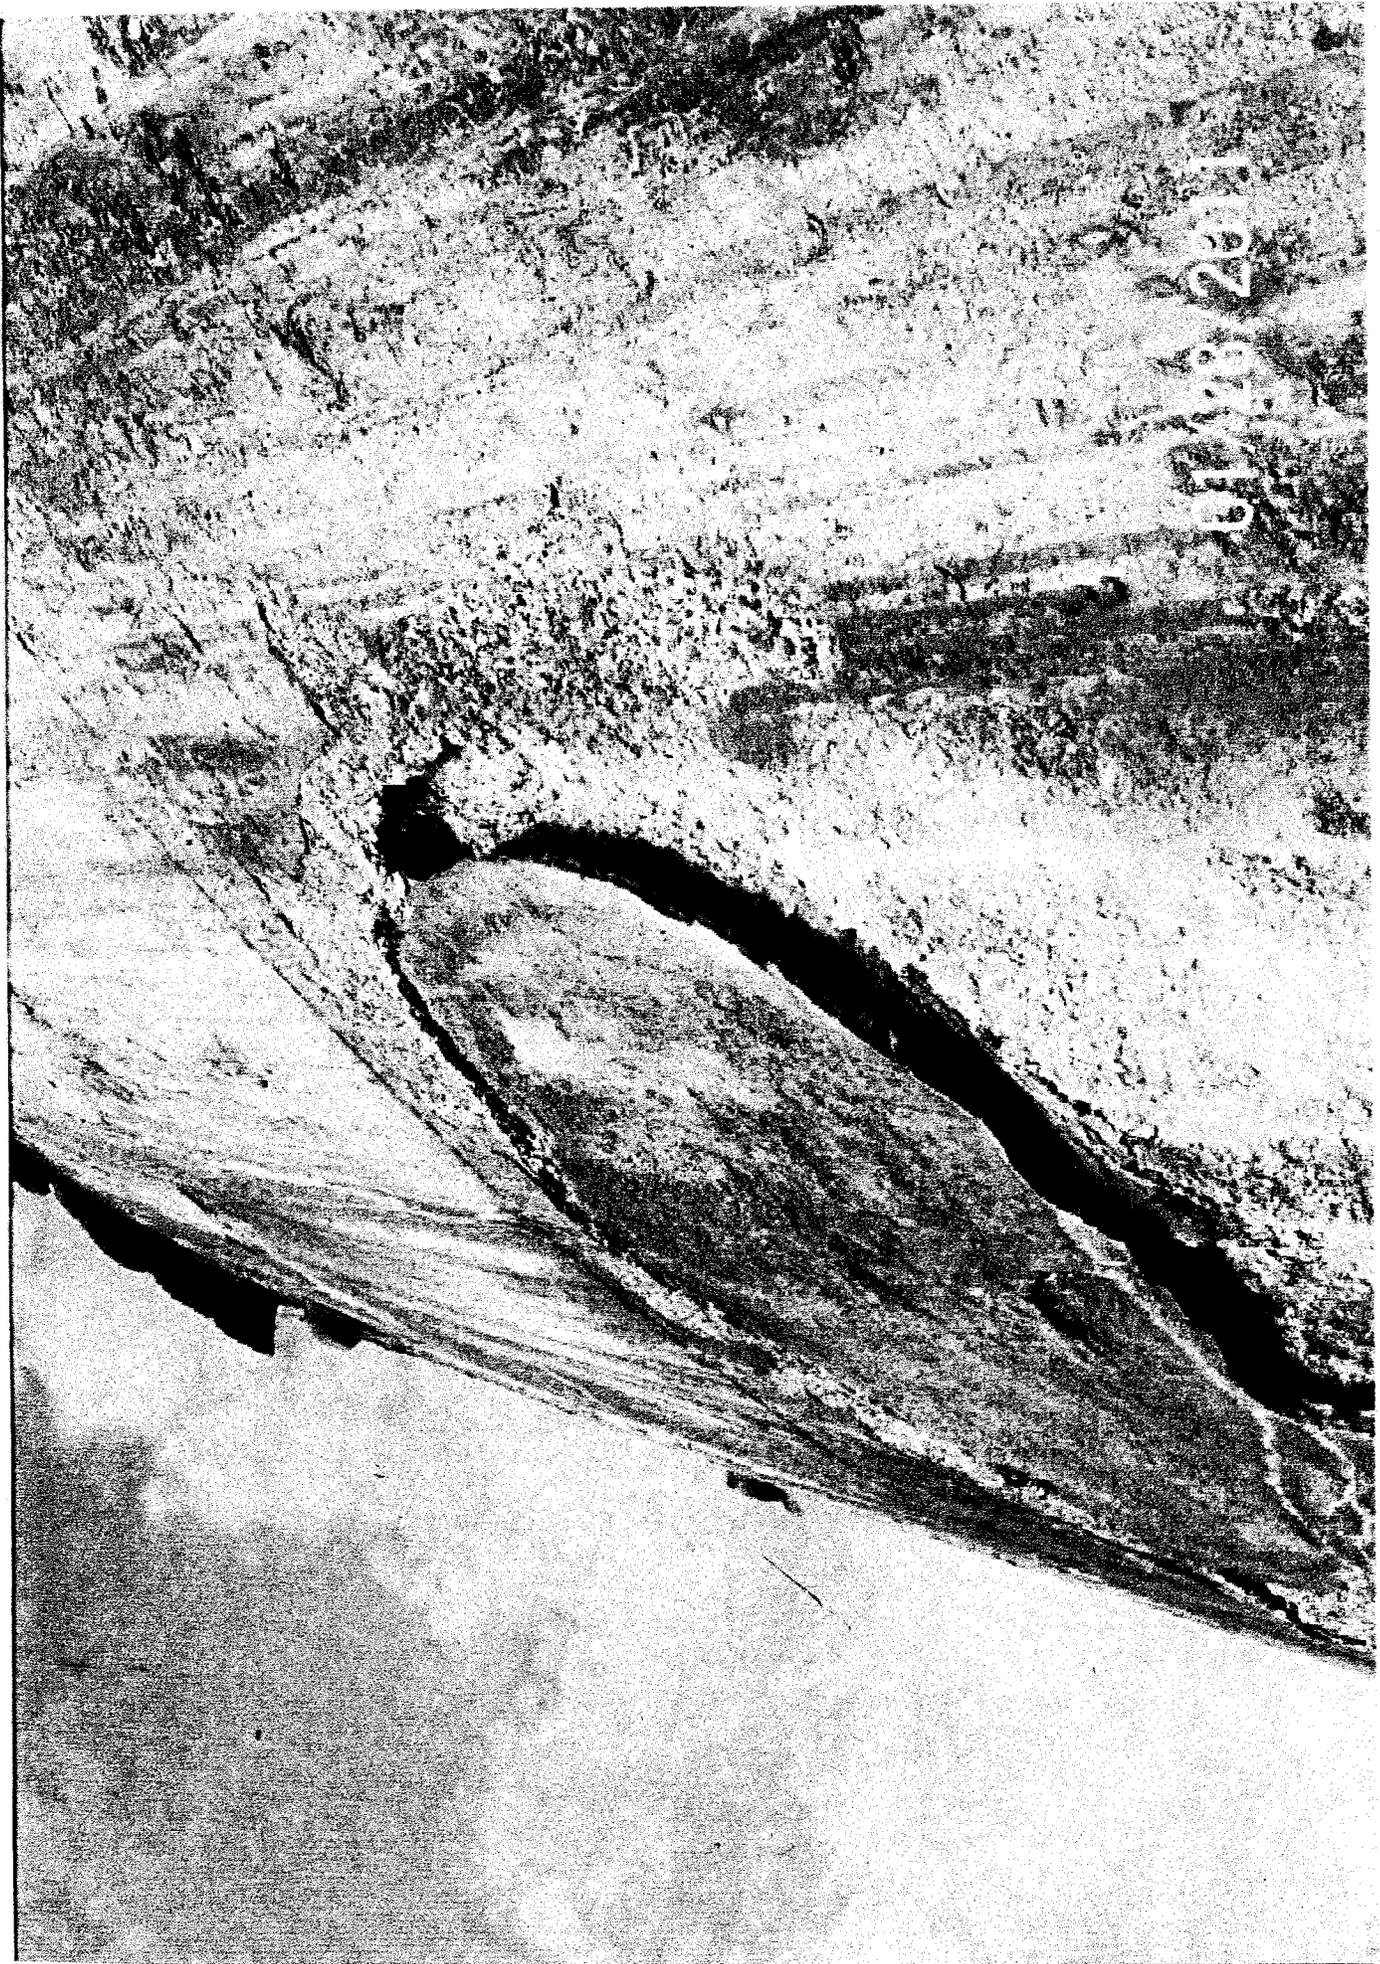
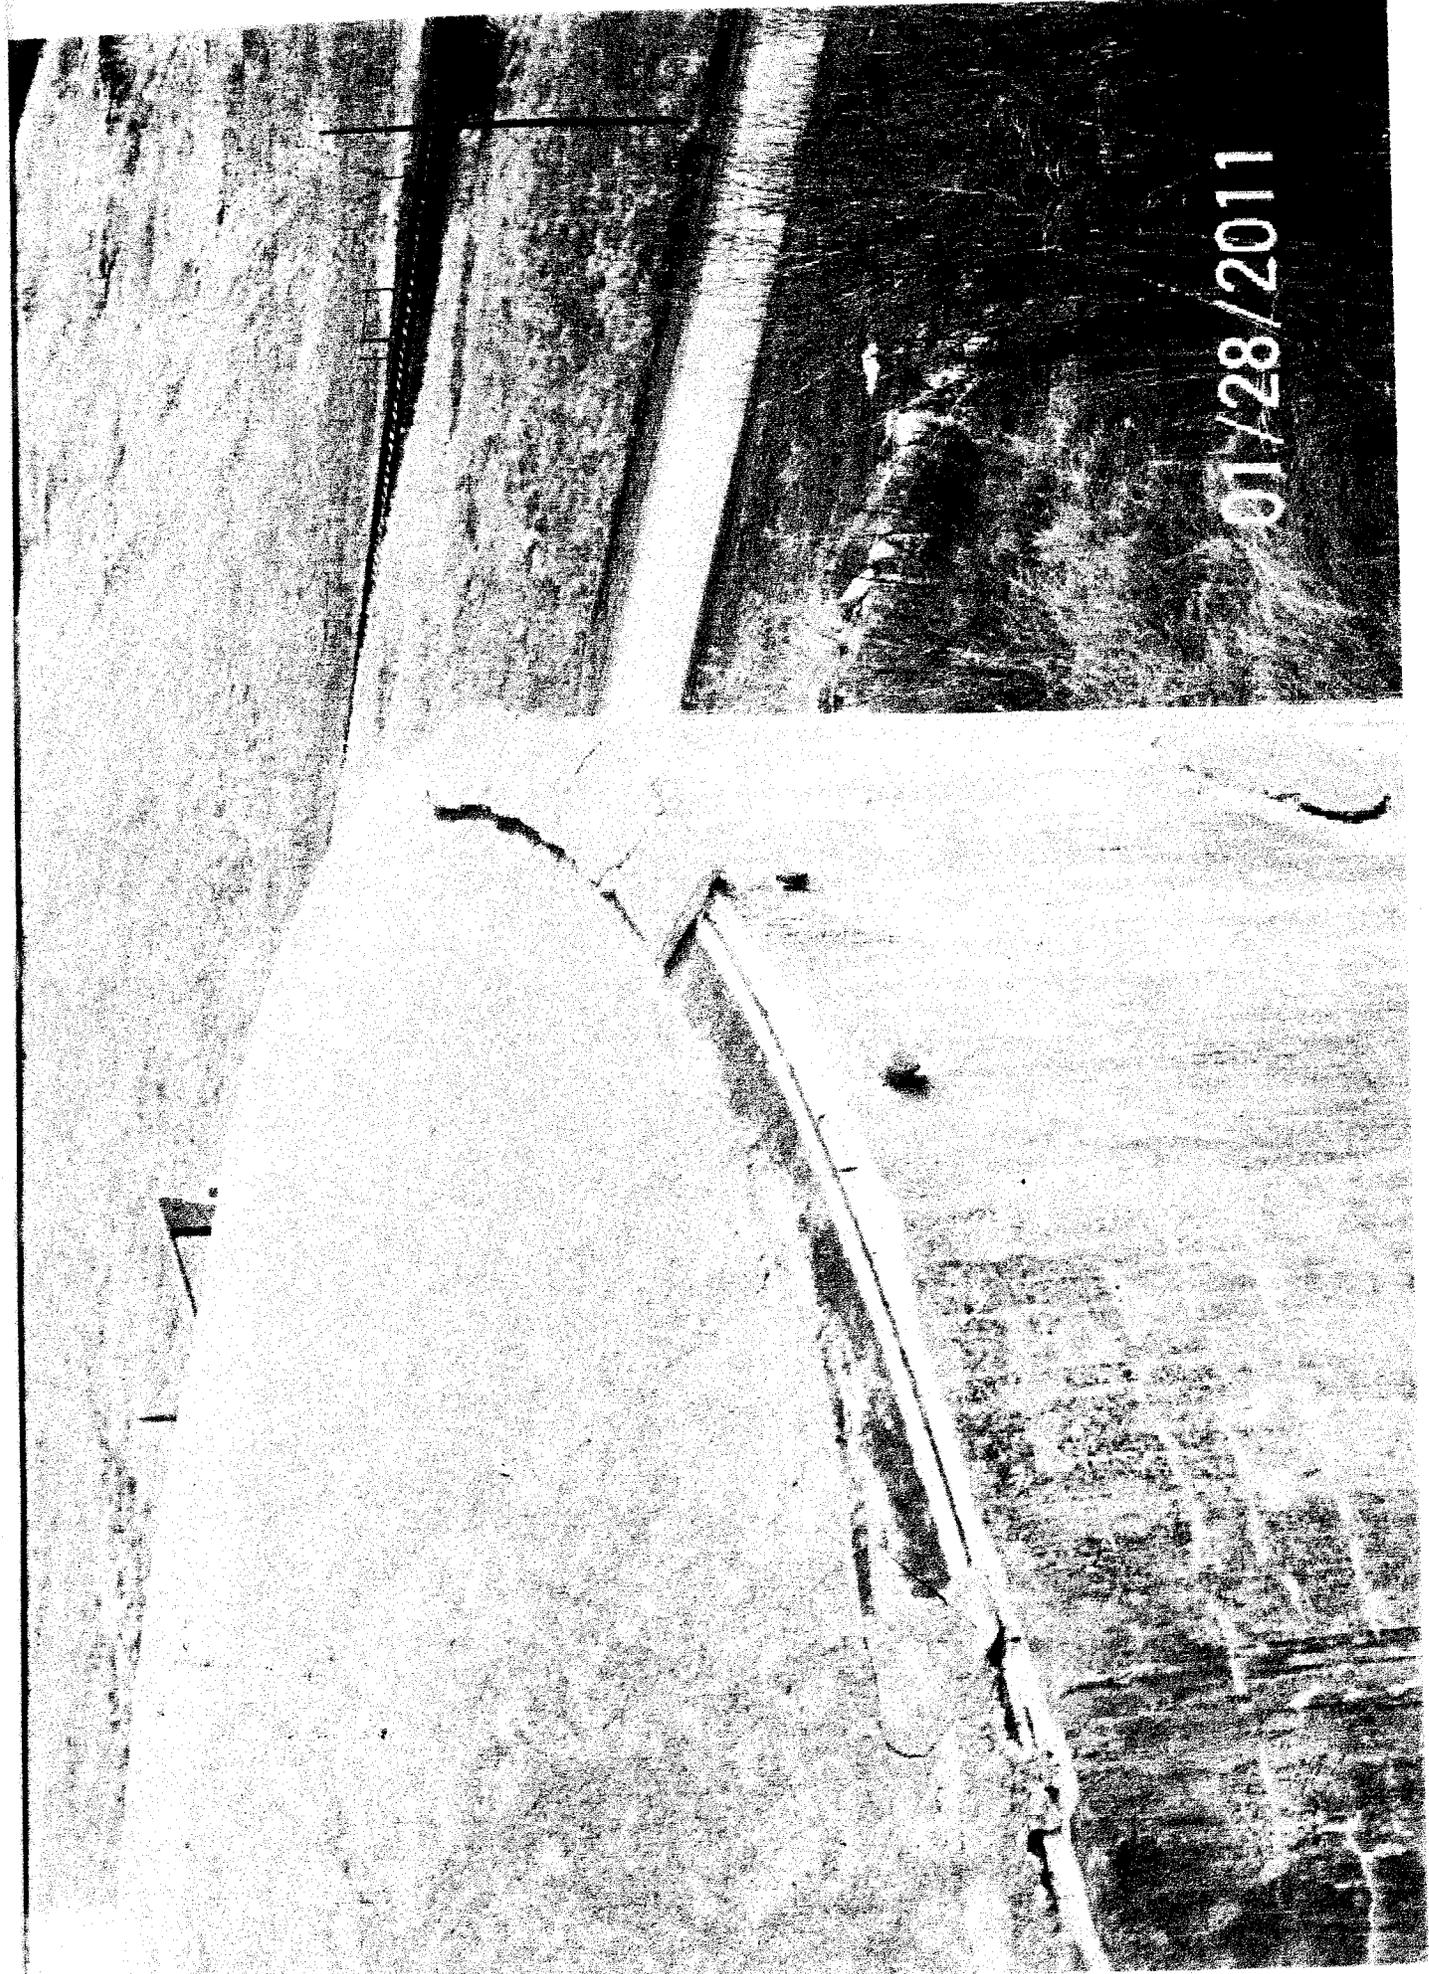
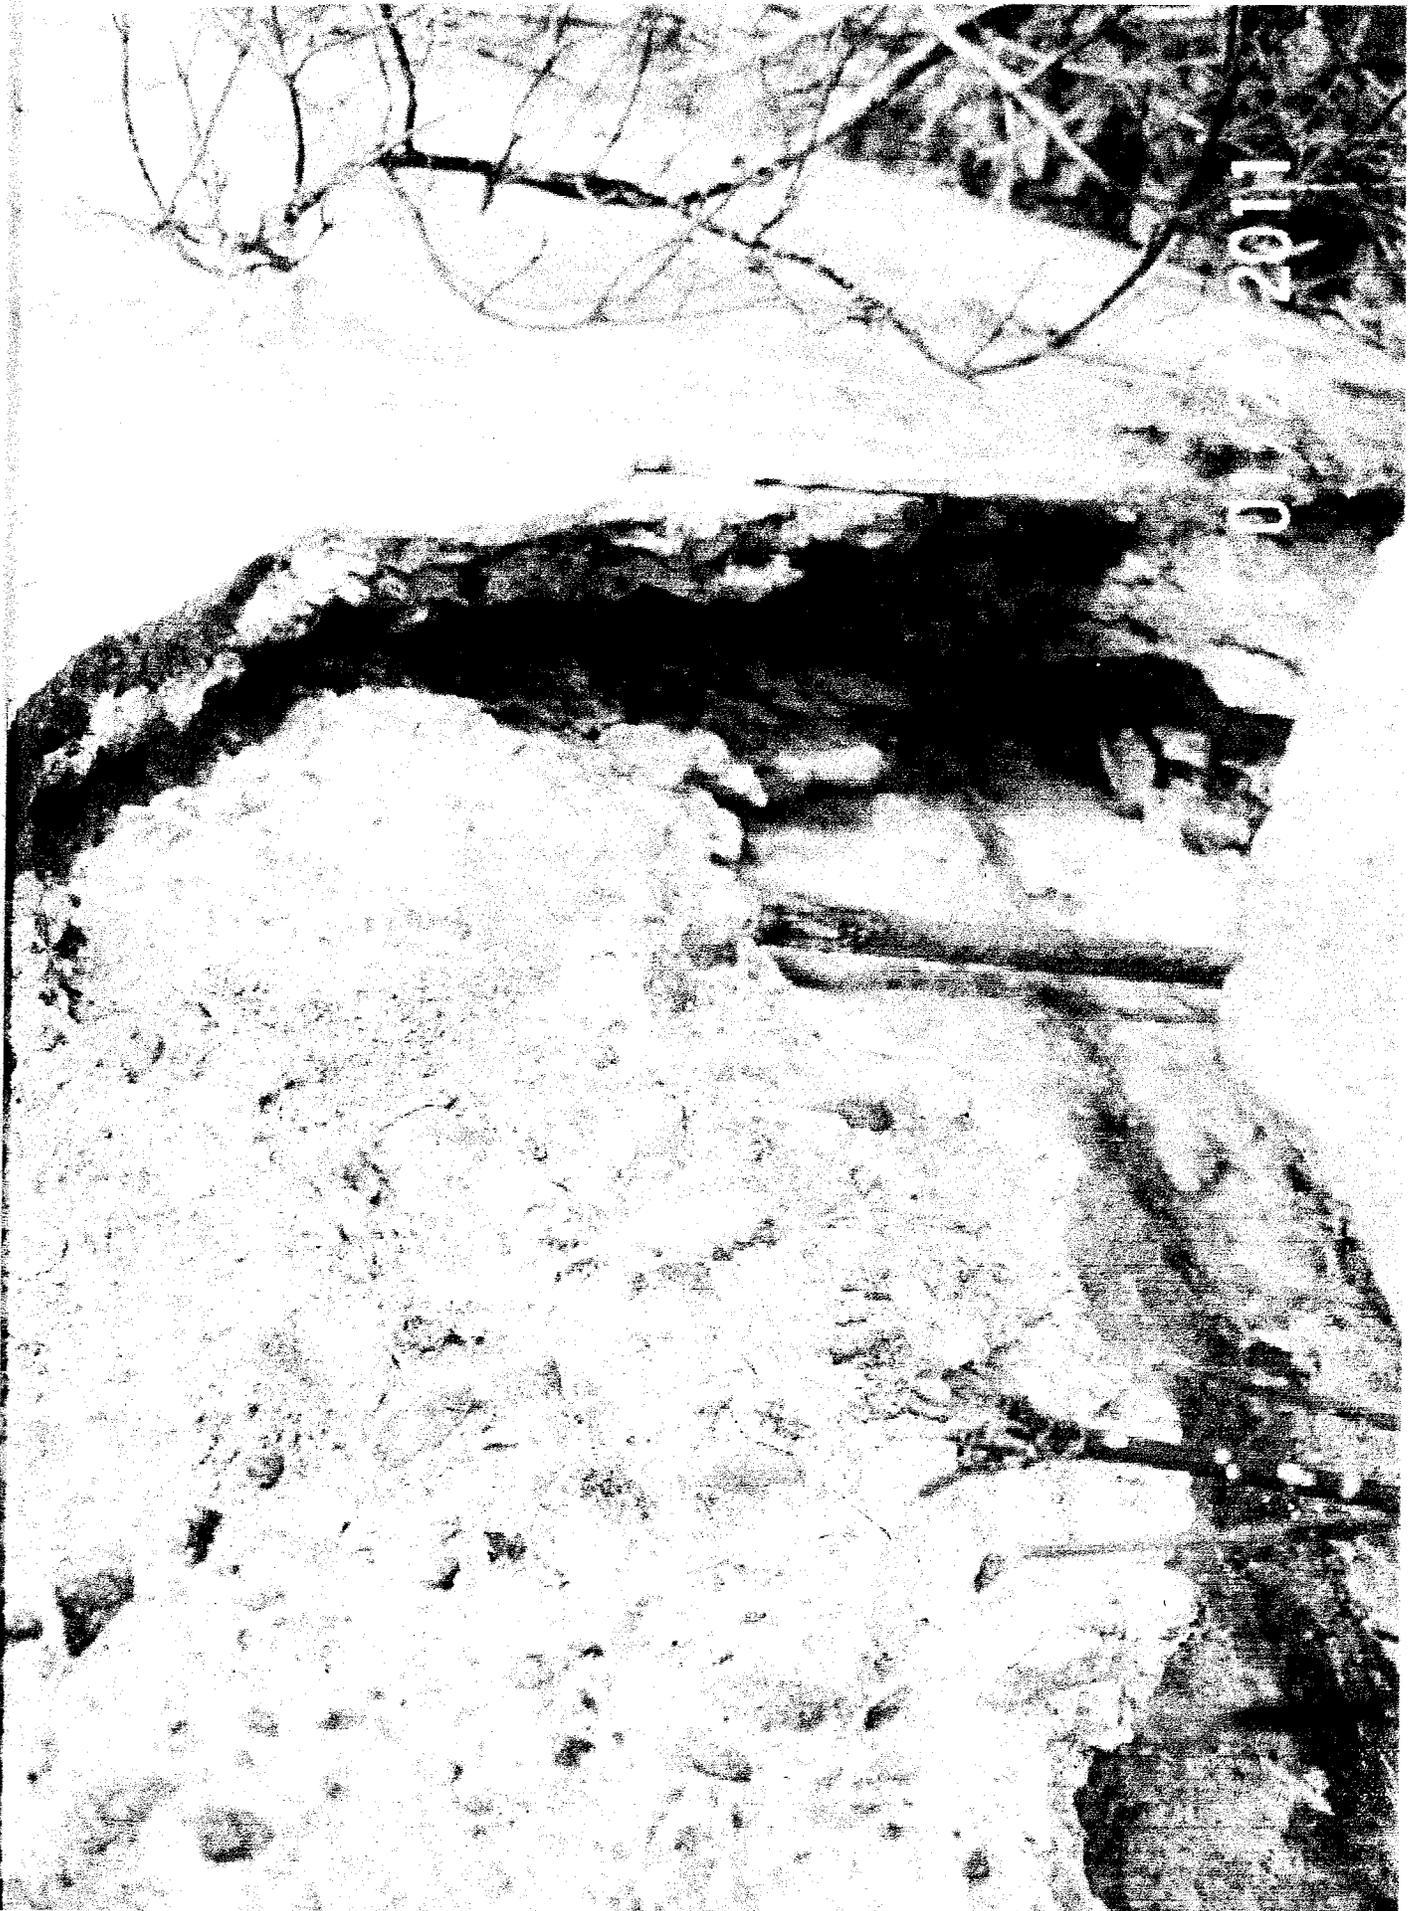
As shown on the attached photographs, our concrete water tank is very near catastrophic failure and is unlikely to last another two years, leaving us critically short of fire protection and summer demand storage. MDOC staff ranked our application down because we did not included a "structural analyses" of the tank. We considered such a waste of money, money we felt was better spent on the replacement of the tank, as one look at the leaks, cracks, and exposed reinforcing bar tells everyone this tank has lived its economic life. *Please review the attached photographs taken last Friday of tank conditions.*

This tank has serious structural issues. The concrete is spalling and rebar showing through. It has numerous leaks and the top is really in bad shape.
