Yellowstone Club Wastewater Spill - March 2016

Pond Failure Report and Enforcement Action

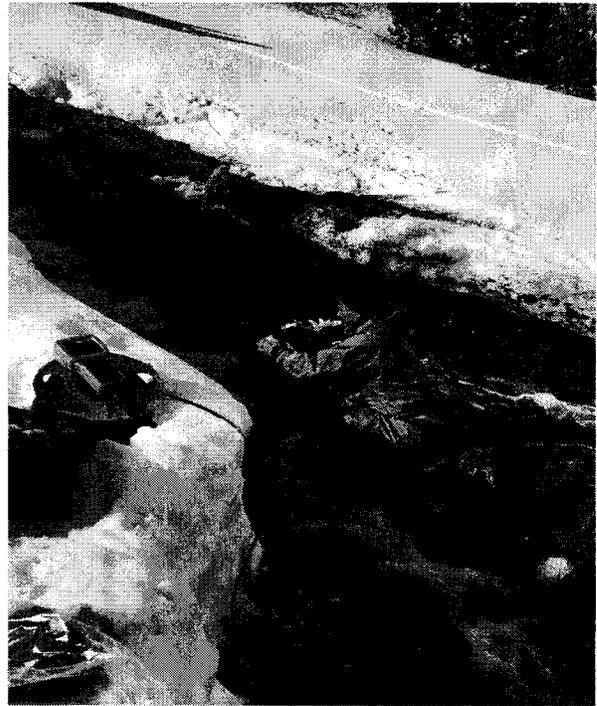
DEQ's Mike Suplee taking water quality samples right below the pond.

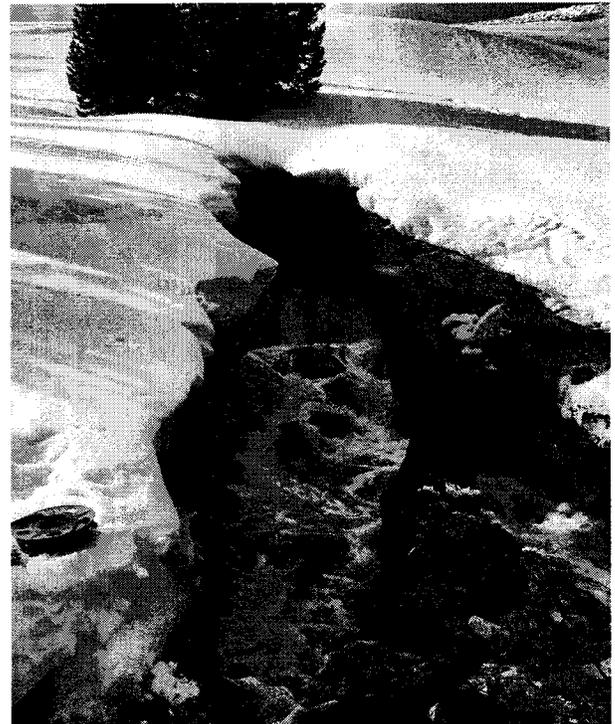
Spill site

The source of the break was an outlet pipe that flows to the Yellowstone Club golf course for irrigation of the turf grass in summer months. In the winter this is an effluent storage pond. Most of the effluent comes from the Big Sky Sewer District, with a small portion coming from the waste water treatment facility used at Yellowstone Club. There was an estimated discharge of 35 million gallons.

DEQ and Yellowstone Mountain Club believe ice forming around the standpipe screen, and then the water level rising and pulling the standpipe out of place, caused the failure in the pond. DEQ reviewed and approved formal plans for a remedy of this issue and the pond is now operational.

Fixing the failure problem focused on pressure injecting grout to seal the annular space around the casement pipe, filling the entire volume of the casement pipe with concrete, and concrete reinforcement at both ends of the casement pipe.
