The enclosed Draft Environmental Assessment (EA) has been prepared for the Clearwater Fish Barrier Modification/Removal Project. FWP proposes to reconstruct or remove a fish barrier and earthen dike constructed along the Clearwater River (north of Seeley Lake, Missoula County) in 1964. The integrity of the fish barrier has diminished over time.

ENVIRONMENTAL ASSESSMENT
 CLEARWATER FISH BARRIER
 MODIFICATION/REMOVAL
 MISSOULA COUNTY, MT

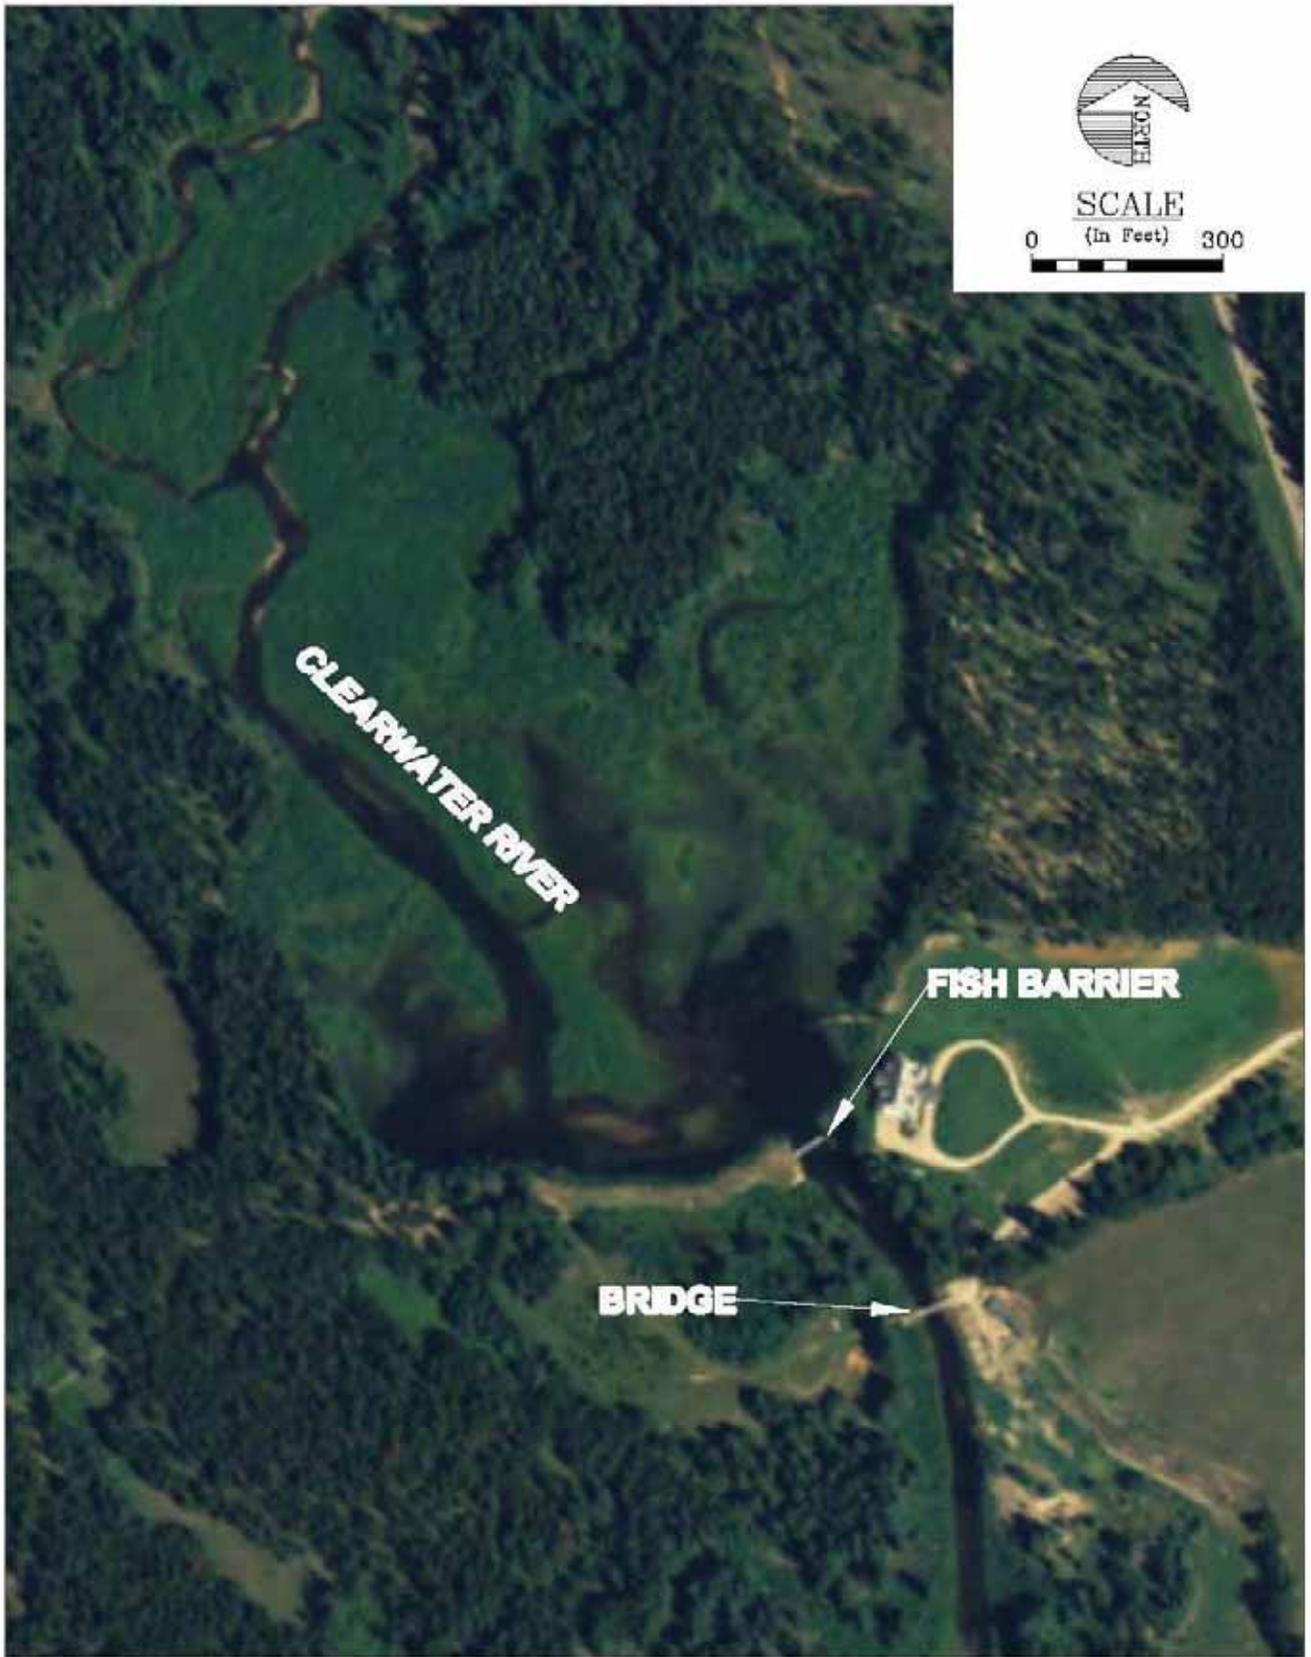
SITE OVERVIEW

CLEARWATER FISH BARRIER
ENVIRONMENTAL ANALYSIS

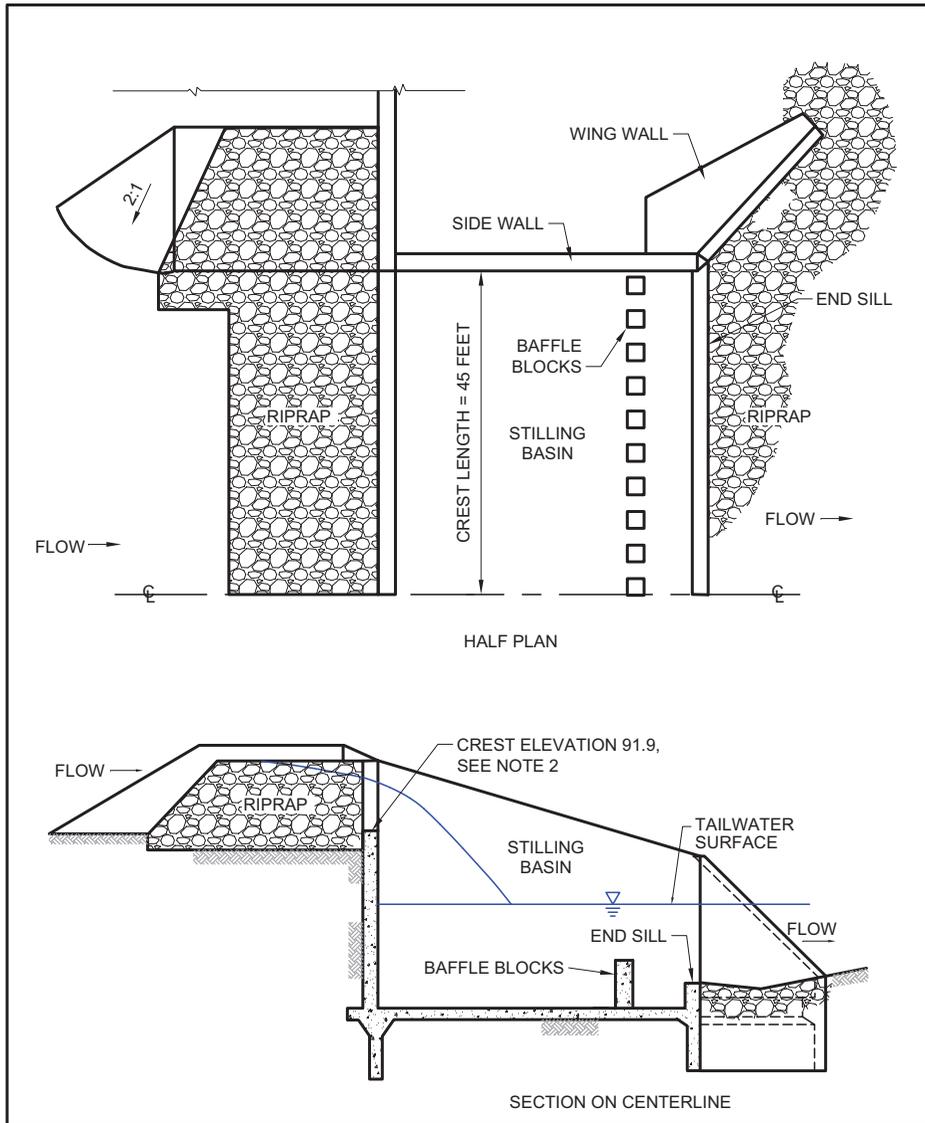
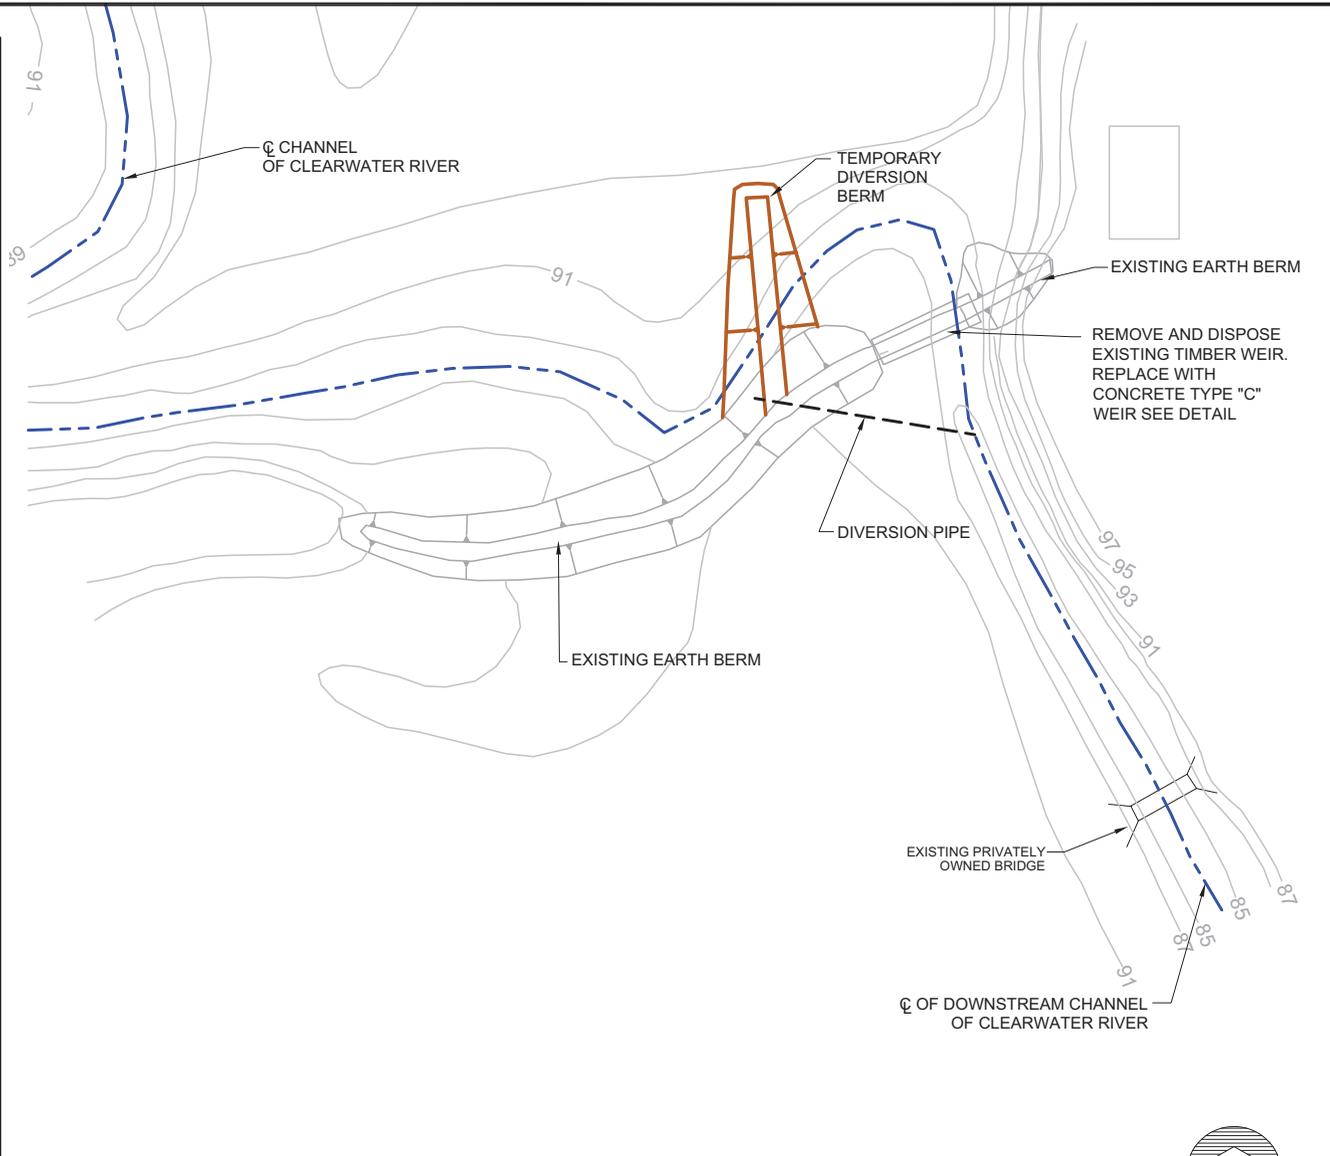
ENVIRONMENTAL ASSESSMENT CLEARWATER FISH BARRIER MODIFICATION/REMOVAL MISSOULA COUNTY, MT	ALTERNATIVE 2 CONCRETE REPLACEMENT	FIGURE 2-1
--	---	----------------------

The replacement weir structure would be an SCS type C concrete drop structure. This type of structure is well suited to this application due to its structural stability and ease of construction and similarity to the existing timber barrier in that it consists of a straight drop, a concrete lined stilling basin, baffle blocks, an end sill, sidewalls and wingwalls. This same type of structure was contemplated in previous investigations into fish barrier replacement alternatives (Hydrometrics, 1996).

Alternative 2 construction would require first creating a temporary berm upstream of the existing structure that would divert water into a CMP pipe (Figure 2-1). This would serve to temporarily dewater the area of the existing weir during its replacement. On completion of the construction, a fish passage bypass channel would be constructed to meet fish passage objectives and specifications.

Replacement of the existing structure would entail removal of the existing logs and cables. This alternative would be accomplished by first creating a temporary berm upstream of the existing fish barrier that would divert water around the construction (**Figure 2-1**). Some additional pumping to dewater the stilling basin and the local area immediately around the weir structure would also be necessary.

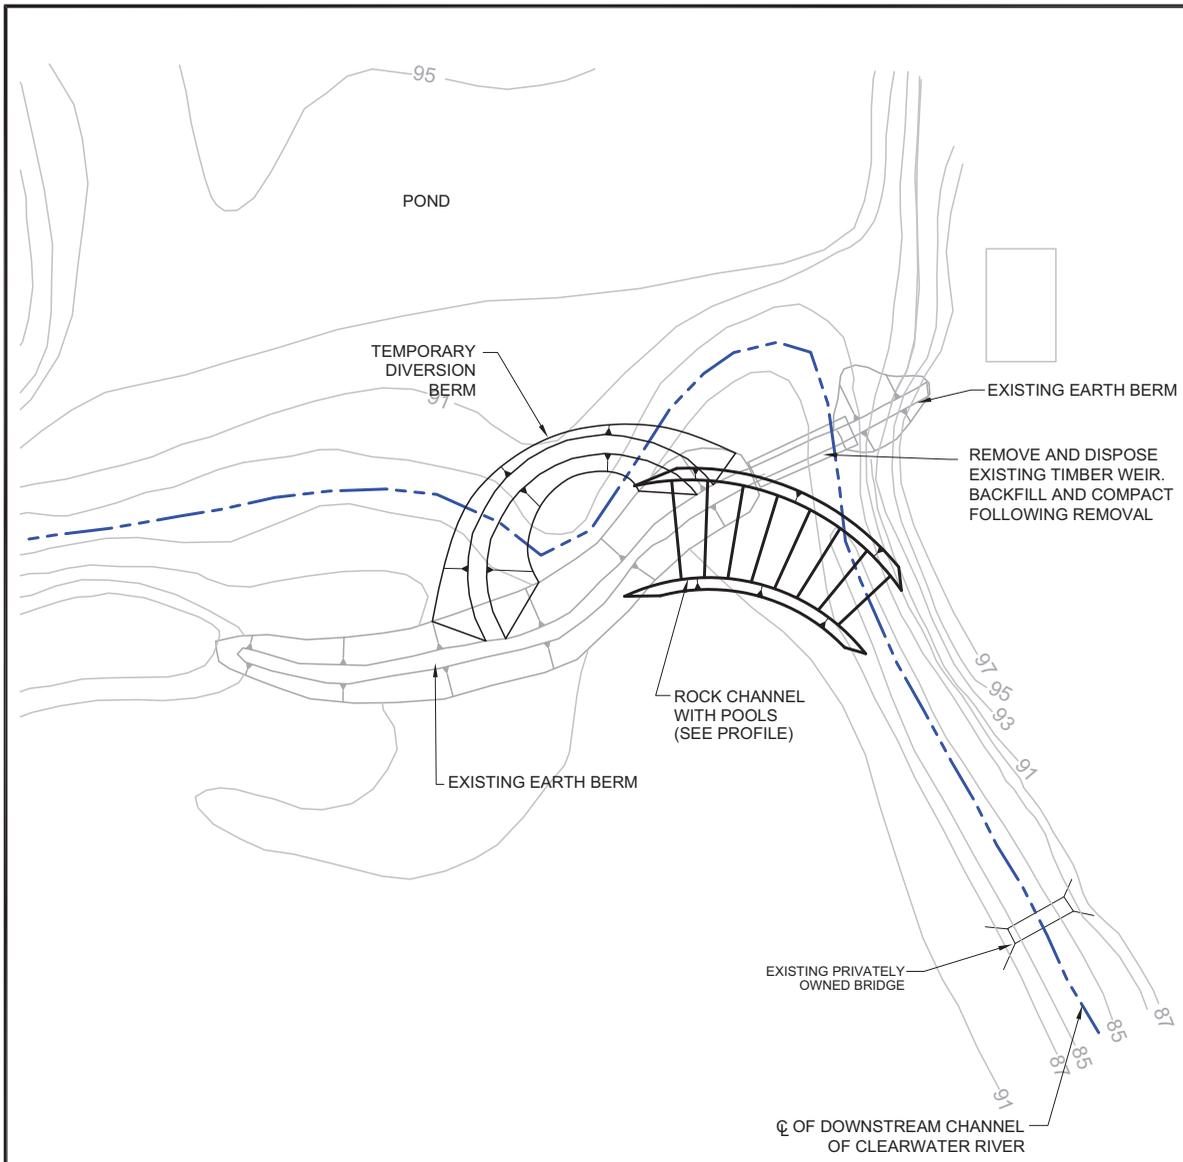
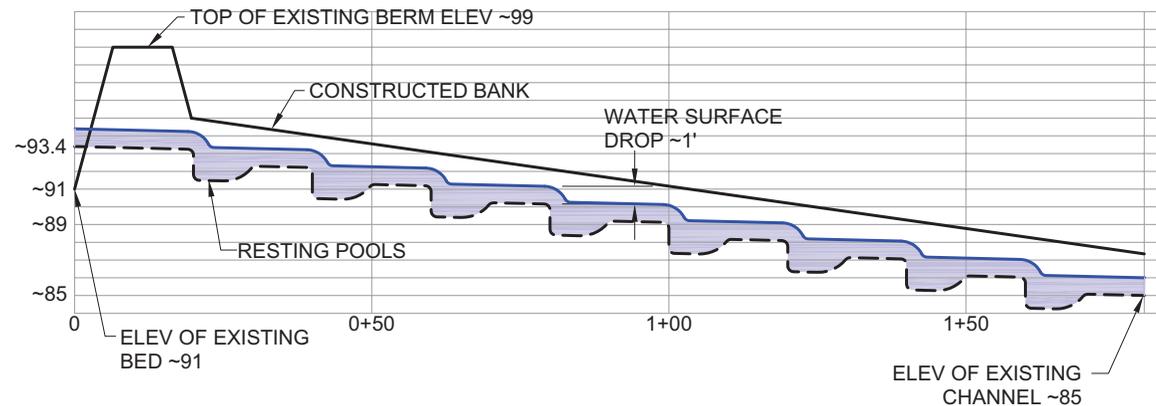
ROCK CHANNEL PROFILE
NO SCALE

The rock channel would be constructed so as to be able to pass the predicted 100-year flow (1,530 cfs) safely. The channel would be constructed with a prominent thalweg in it. This would concentrate low flows in the thalweg area providing depth for migrating fish.

Following completion of the rock lined channel, the temporary upstream diversion berm would be removed and the berm replaced. The existing timber weir structure would also be demolished and removed to minimize any liability associated with leaving it in place. The gap in the left abutment caused by removal of the existing timber weir structure would also be backfilled and compacted to prevent possible channel migration to that area.

This alternative would be accomplished by installing a temporary berm on the upstream face of the berm to isolate a portion of the berm. Next a channel would be excavated through a 'notch' in the isolated portion the existing earth berm to blend smoothly into the downstream channel. This elevation difference from the upstream pool to the downstream channel would be accommodated by a relatively steep rock lined channel with several short rock drops. The notch would also serve to make certain that natural channel processes did not cause river to migrate away from the rock-defined or reinforced channel onto unreinforced portions of the floodplain where it could cause extensive erosion. The notch in the middle of the earth berm would be designed so as to provide a seasonal constriction to high flows thereby seasonally inundating wetlands upstream of the berm.

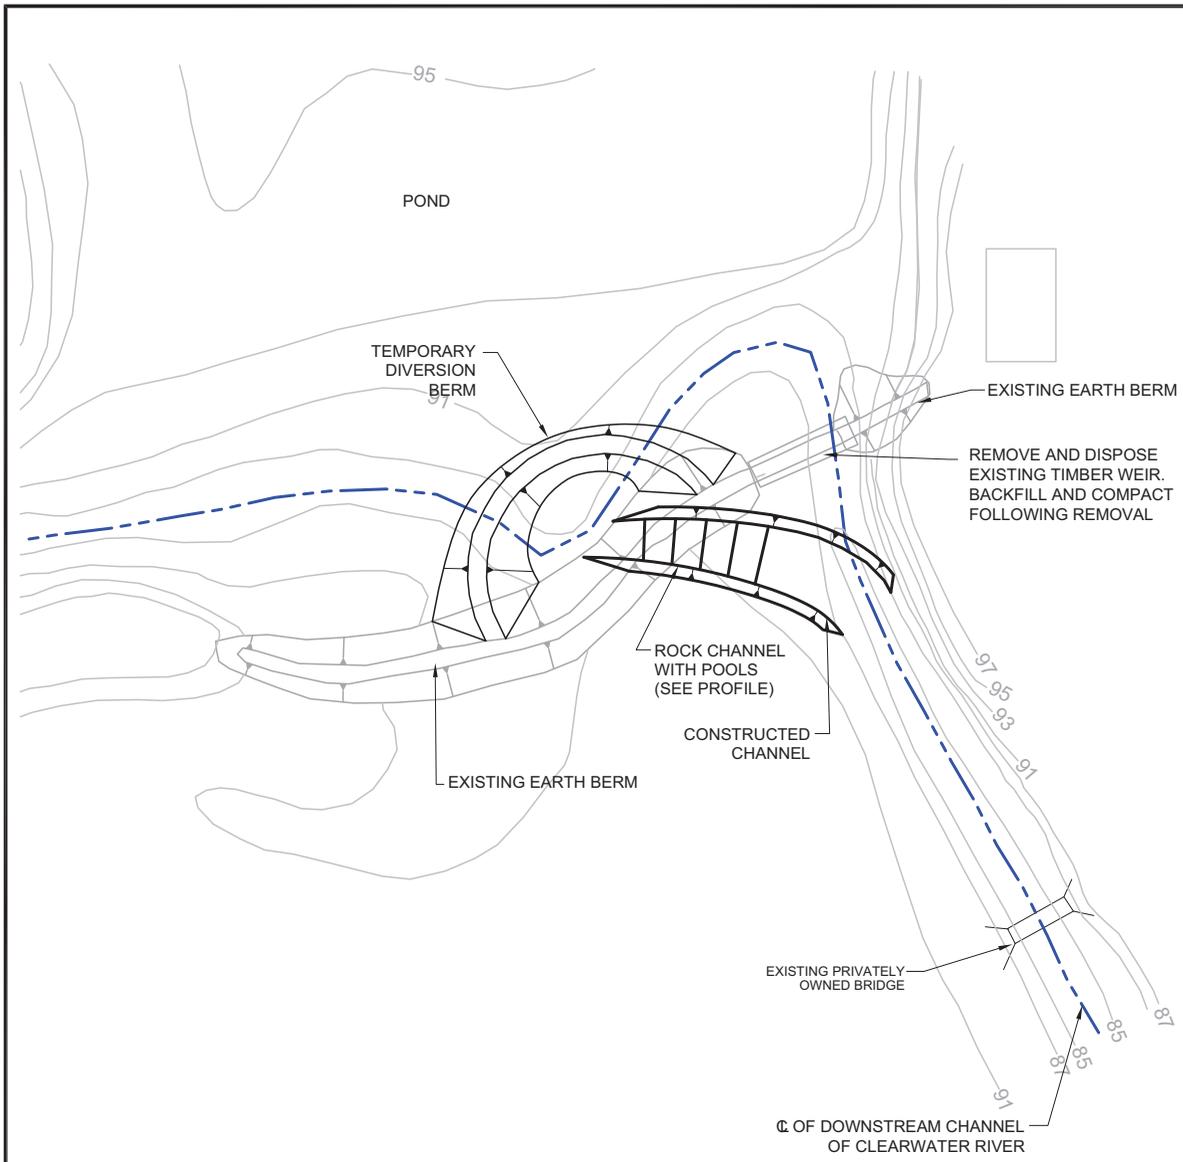
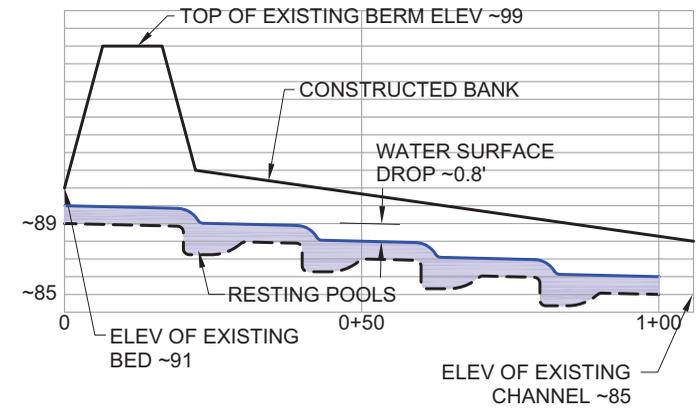
ROCK CHANNEL PROFILE
NO SCALE

The rock channel would be constructed so as to be able to pass the predicted 100-year flow (1,530 cfs) safely. The channel would be constructed with a prominent thalweg in it to provide adequate depth for migrating fish.

Following completion of the rock lined channel, the temporary upstream diversion berm would be removed and the berm replaced. The existing timber weir structure would also be demolished and removed to minimize any liability associated with leaving it in place. The gap in the left abutment caused by removal of the existing timber weir structure would also be backfilled and compacted to prevent possible channel migration to that area.

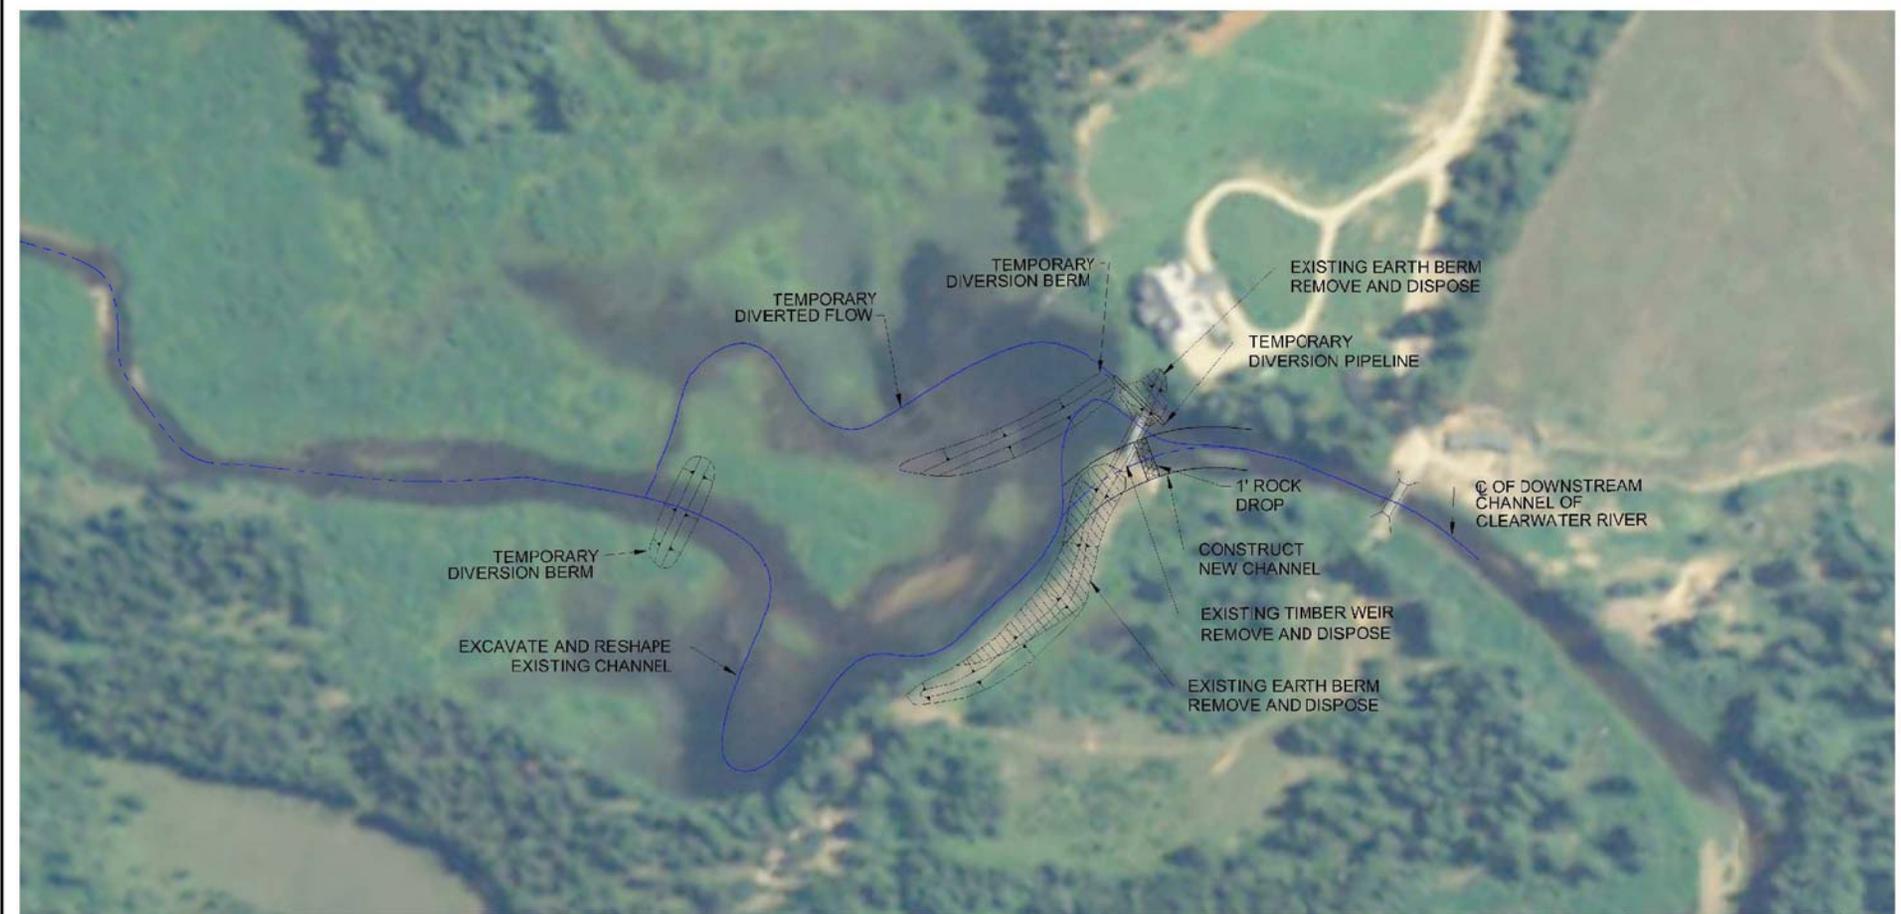
Alternative 4 construction would require a temporary CMP outlet and lowering the pool elevation. Then a diversion berm would be built at a location 700 to 1,000 feet upstream from the fish barrier to route inflows to the left abutment. This would dewater the right (west) portion of the impoundment area allowing a natural channel to be rebuilt in the vestiges of the old channel that survives there (see **Figure 2-4**). The new channel would have a grade of approximately 0.4% to 0.6%, similar to the natural channel grade upstream and downstream from the project site. The replacement channel plan would generally occupy what appears to be the location where the channel was located prior to the fish barrier being constructed. The channel would be lined with stream-size gravel and cobbles and that other habitat features such as root wads and large woody debris would also be incorporated. It is also possible to include one to three rock drop structures in the replacement channel to serve as impediments to upstream migration of some fish species (primarily northern pike). It is envisioned that the new channel would be somewhat narrow and incised particularly as it approaches the face of the existing berm; however, this is not inconsistent with the topography of the area. The alternative to this is to excavate a broad floodplain onto which overbank flows from large flood events would spill. This would entail excavation of a large volume of sediments from the reservoir basin and removal of wetlands. The costs and

This alternative would result in a general lowering of the water surface in the impoundment area by approximately seven to nine feet. Construction disturbance and landscape changes would be significantly greater with channel replacement in comparison with the other alternatives. The upstream wetlands would be altered and replaced with a streamside riparian zone. Removal of the existing weir structure and berm would potentially eliminate the State of Montana's long-term liability for the site. Risk of increased sediment production during construction or in the following several years would be greater than for the other alternatives.
