The enclosed *Revised* Draft Environmental Assessment (EA) has been prepared for the Clearwater Fish Barrier Modification/Removal Project. Montana Fish, Wildlife & Parks (FWP) proposes to reconstruct or remove a fish barrier and earthen dike constructed in 1964 along the Clearwater River (north of Seeley Lake, Missoula County), because the integrity of the fish barrier has diminished over time. The original Draft EA for this project was issued for public review in January 2009. This current revision primarily involves minor changes and clarifications to the original preferred alternative (3A) to construct a full height rock-step channel at the site. The revised preferred alternative includes a channel crest elevation that is 1.5-feet higher than previously proposed, in order to maintain the current reservoir pool elevation.

CLEARWATER FISH BARRIER  
ENVIRONMENTAL ANALYSIS

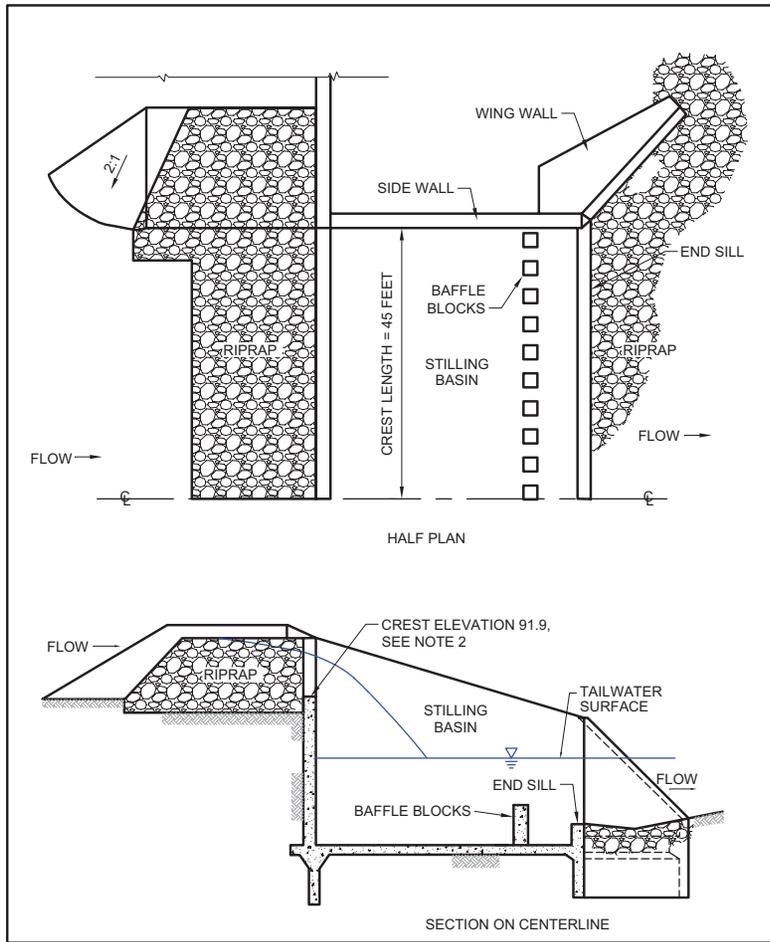
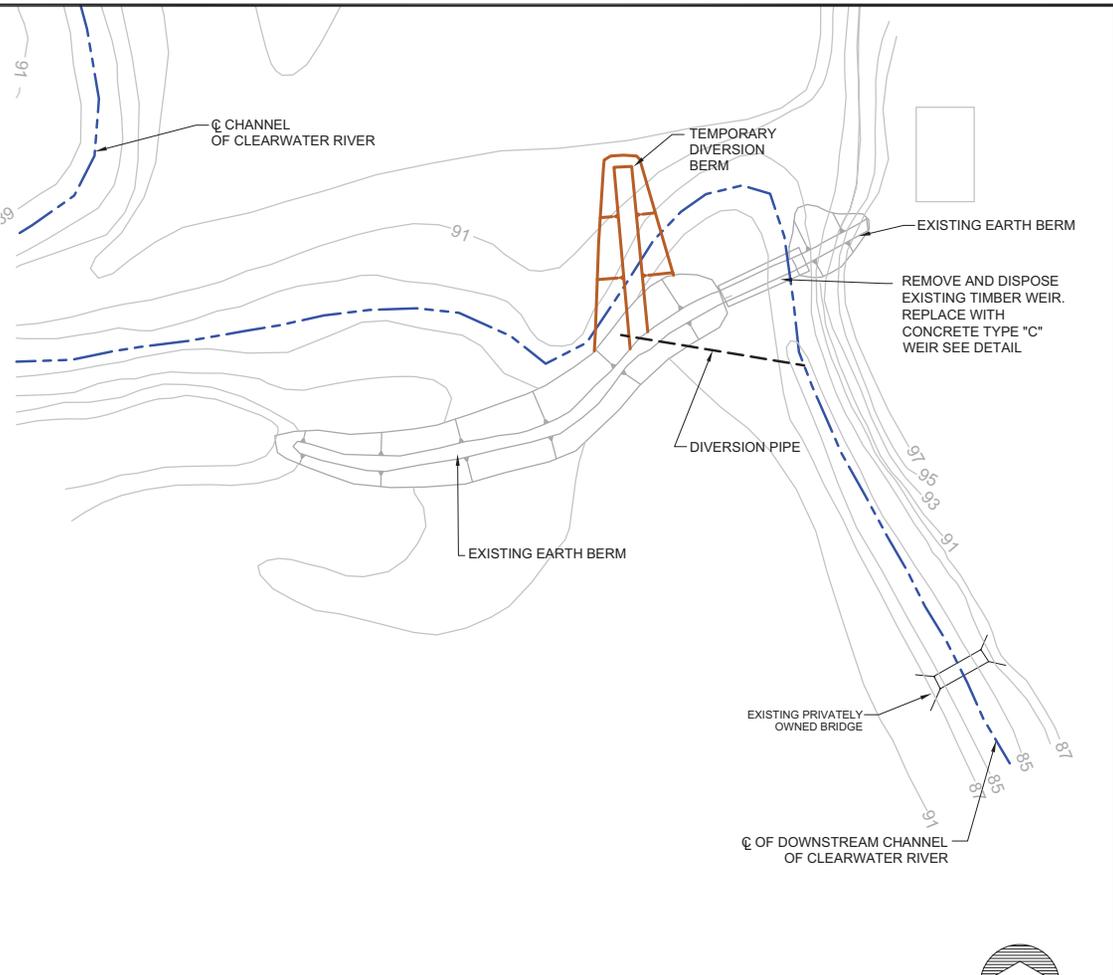
ENVIRONMENTAL ASSESSMENT CLEARWATER FISH BARRIER MODIFICATION/REMOVAL MISSOULA COUNTY, MT	<b>ALTERNATIVE 2 CONCRETE REPLACEMENT</b>	FIGURE <b>2-1</b>
--	---	----------------------

Alternative 2 construction would require first creating a temporary berm upstream of the existing structure that would divert water into a CMP pipe (Figure 2-1). This would serve to temporarily dewater the area of the existing weir during its replacement. On completion of the construction, a fish passage bypass channel would be constructed to meet fish passage objectives and specifications.

The replacement weir structure would be an SCS type C concrete drop structure. This type of structure is well suited to this application due to its structural stability and ease of construction and similarity to the existing timber barrier in that it consists of a straight drop, a concrete lined stilling basin, baffle blocks, an end sill, sidewalls and wingwalls. This same type of structure was contemplated in previous investigations into fish barrier replacement alternatives (Hydrometrics, 1996).

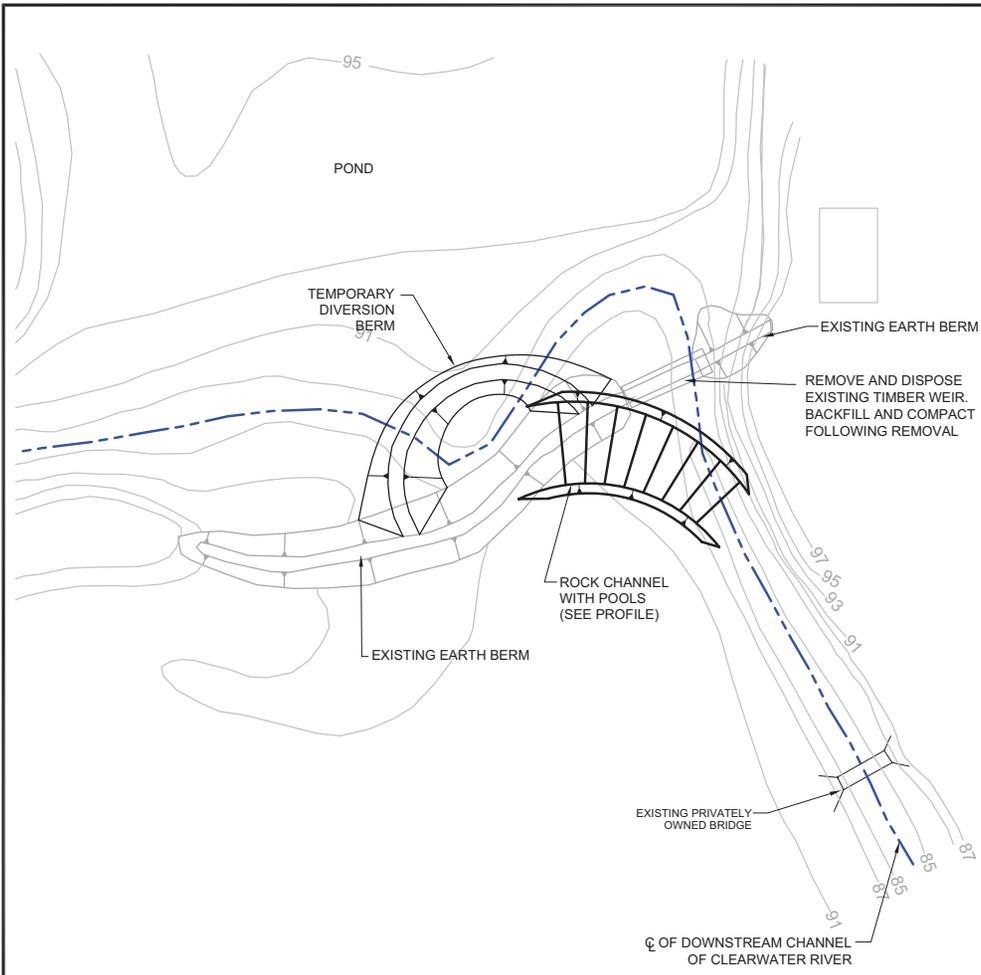
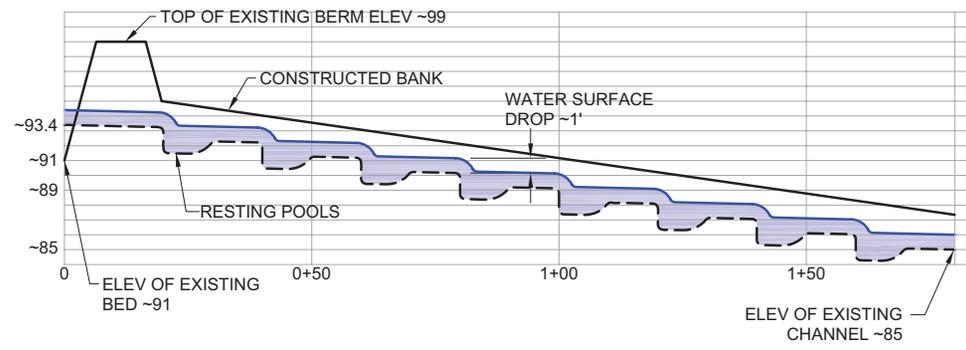
**ROCK CHANNEL PROFILE**  
NO SCALE

The rock channel would be constructed so as to be able to pass the predicted 100-year flow (1,530 cfs) safely. The channel would be constructed with a prominent thalweg in it. This would concentrate low flows in the thalweg area providing depth for migrating fish.

Following completion of the rock lined channel, the temporary upstream diversion berm would be removed and the berm replaced. The existing timber weir structure would also be demolished and removed to minimize any liability associated with leaving it in place. The gap in the left abutment caused by removal of the existing timber weir structure would also be backfilled and compacted to prevent possible channel migration to that area.

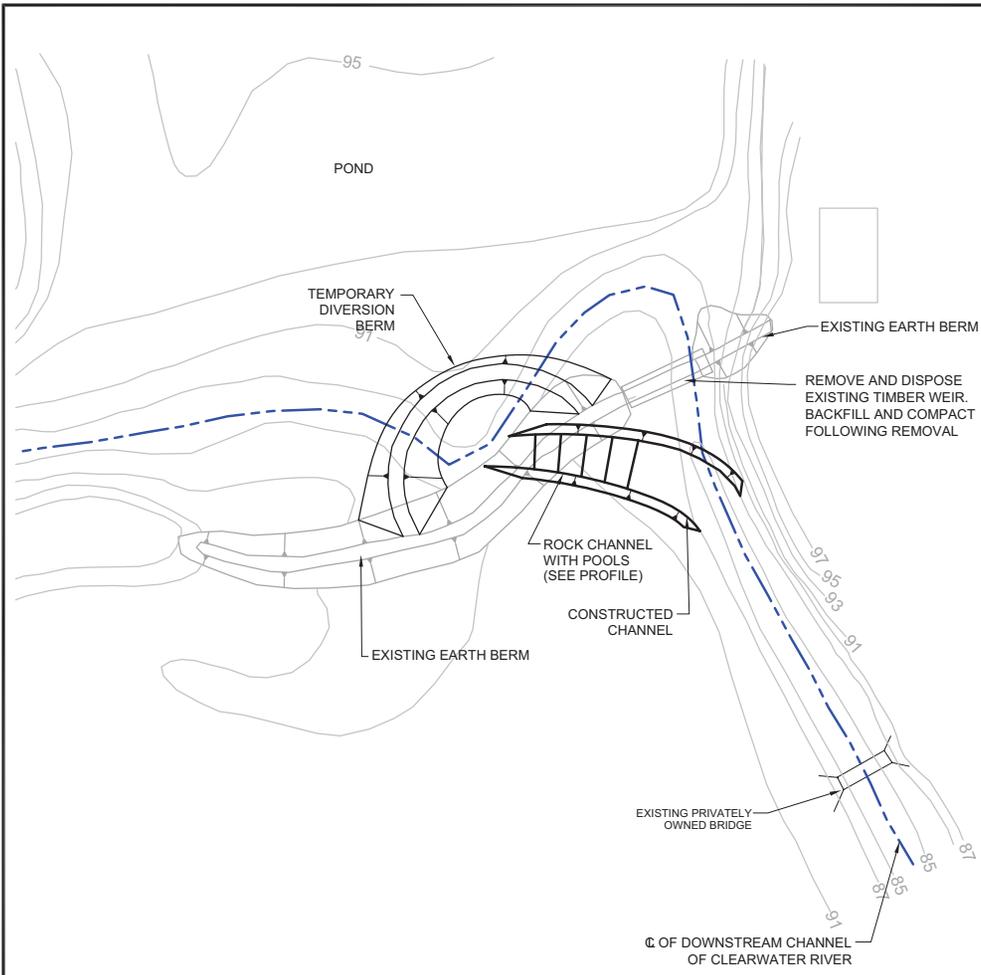
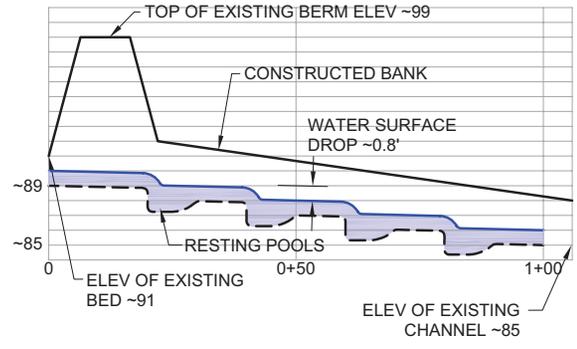
**ROCK CHANNEL PROFILE**  
NO SCALE

The rock channel would be constructed so as to be able to pass the predicted 100-year flow (1,530 cfs) safely. The channel would be constructed with a prominent thalweg in it to provide adequate depth for migrating fish.

Following completion of the rock lined channel, the temporary upstream diversion berm would be removed and the berm replaced. The existing timber weir structure would also be demolished and removed to minimize any liability associated with leaving it in place. The gap in the left abutment caused by removal of the existing timber weir structure would also be backfilled and compacted to prevent possible channel migration to that area.

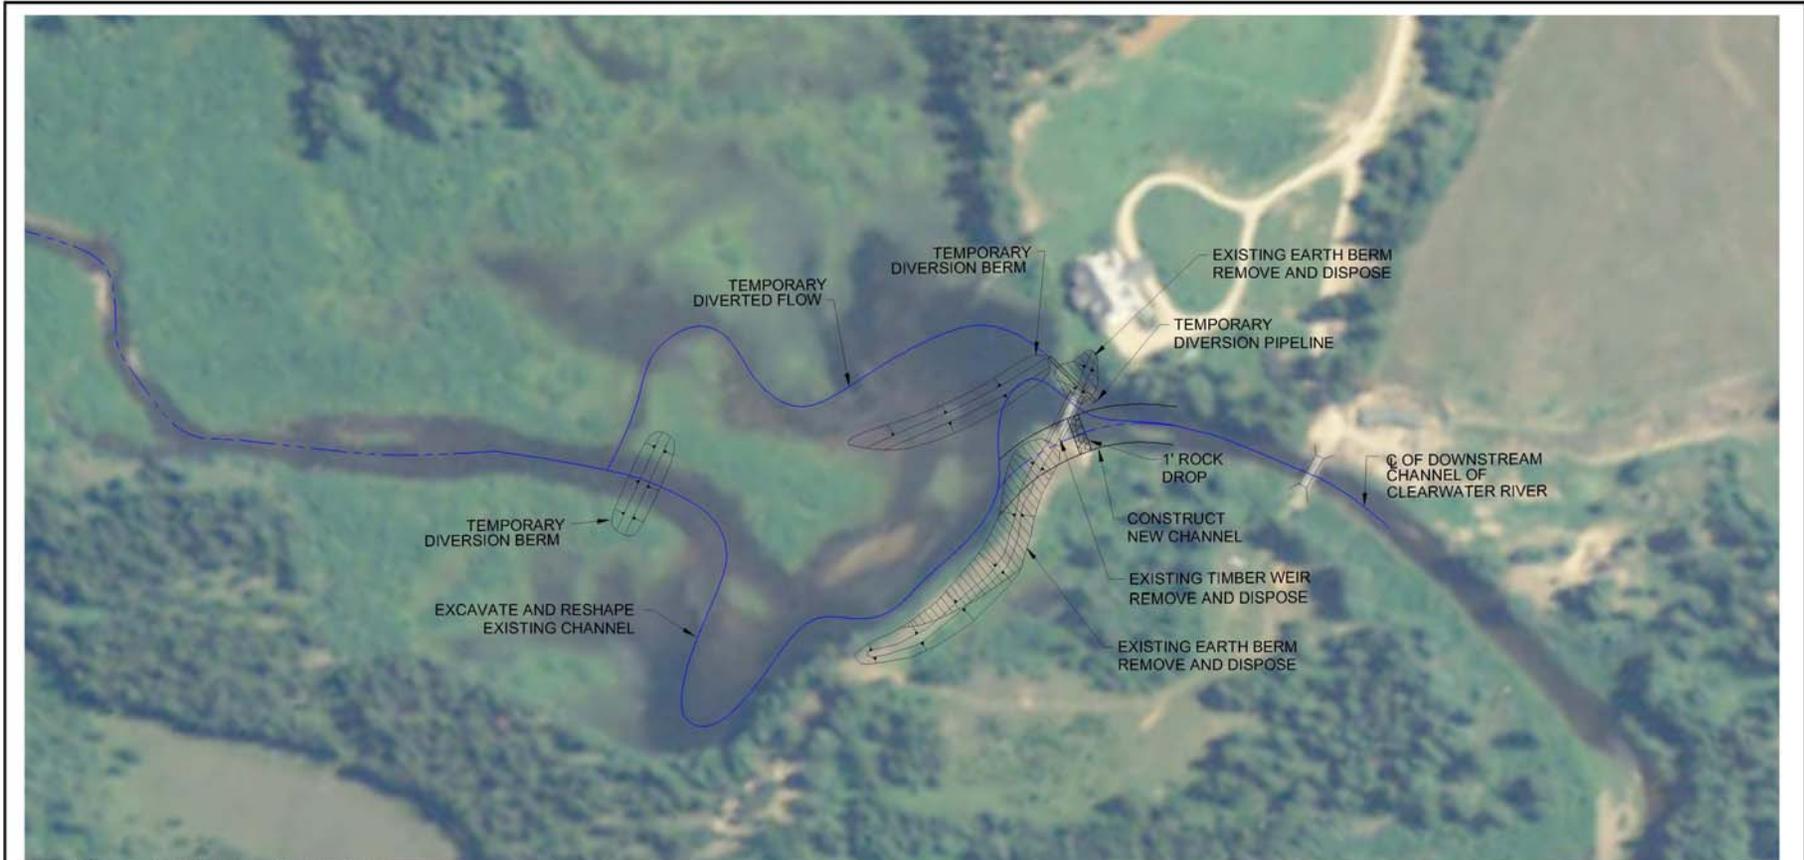
Alternative 4 construction would require a temporary CMP outlet and lowering the pool elevation. Then a diversion berm would be built at a location 700 to 1,000 feet upstream from the fish barrier to route inflows to the left abutment. This would dewater the right (west) portion of the impoundment area allowing a natural channel to be rebuilt in the vestiges of the old channel that survives there (see **Figure 2-4**). The new channel would have a grade of approximately 0.4% to 0.6%, similar to the natural channel grade upstream and downstream from the project site. The replacement channel plan would generally occupy what appears to be the location where the channel was located prior to the fish barrier being constructed. The channel would be lined with stream-size gravel and cobbles and that other habitat features such as root wads and large woody debris would also be incorporated. It is also possible to include one to three rock drop structures in the replacement channel to serve as impediments to upstream migration of some fish species (primarily northern pike). It is envisioned that the new channel would be somewhat narrow and incised particularly as it approaches the face of the existing berm; however, this is not inconsistent with the topography of the area. The alternative to this is to excavate a broad floodplain onto which overbank flows from large flood events would spill. This would entail excavation of a large volume of sediments from the reservoir basin and removal of wetlands. The costs and

This alternative would result in a general lowering of the water surface in the impoundment area by approximately seven to nine feet. Construction disturbance and landscape changes would be significantly greater with channel replacement in comparison with the other alternatives. The upstream wetlands would be altered and replaced with a streamside riparian zone. Removal of the existing weir structure and berm would likely eliminate the State of Montana's long-term liability for the site. Risk of increased sediment production during construction or in the following several years would be greater than for the other alternatives.
