**MEMORANDUM****To: Ryan Weiss, Deputy Trust Lands Administrator, Forestry and Trust Lands Division, MT-DNRC****From: Teresa Kinley, Geologist/Hydrologist, Minerals Management Bureau, FTLD, MT-DNRC, and  
Andrea Stanley, Hydrologist/Soil Scientist, SWLO, MT-DNRC****RE: Updates on Outfall Pipes in/near Clark Fork at Former Smurfit-Stone/Frenchtown Mill Superfund Site, Location: Sections 14, 23, (24, and 11) of T14N, R21W, Missoula County, Montana****Summary**

**November 13, 2019 Site Visit**

**Smurfit-Stone Site Visit on November 2, 2023**

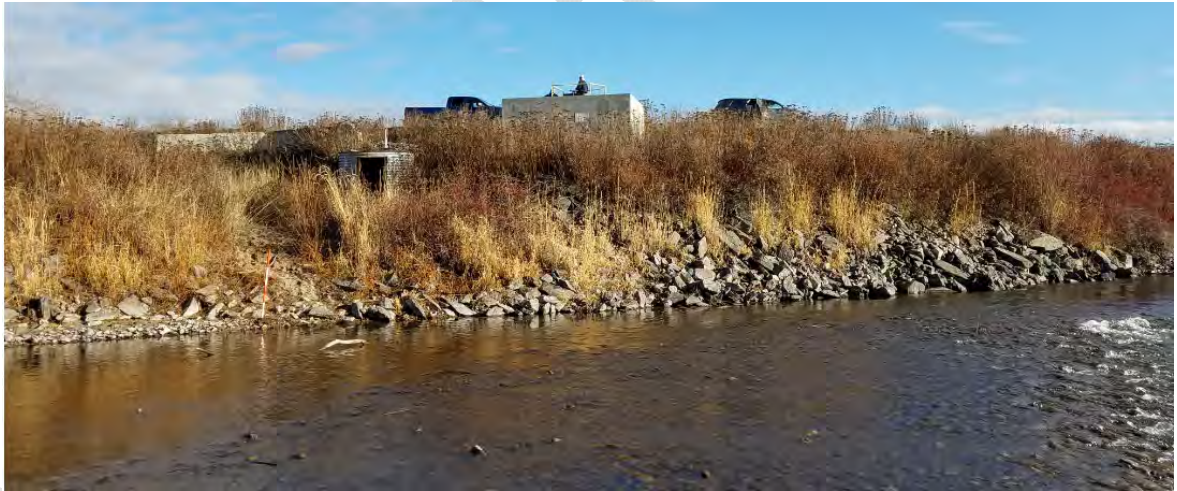
1. No outfall infrastructure located below the low-water mark was visually observed [as defined in ARM 36.25.1101(12)] at or near the structures located at "Outfall 1" (46.9582, -114.2193; Section 23, T14N R21W). Other structures are located beyond (and upslope) of the low-water mark, including riprap armoring of a constructed berm. The photo below shows the condition of the river bank at the Outfall 1 location.

At Outfall 1, no surface pipe was visible. Confirmation of presence or absence of outfall pipe is needed and determination of what constituted the outfall. Part of a berm with consistent slope goes into the water at this site. Features looked similar to those seen in the Outfall 1 photo on page 2.

Relic outfall structure could be buried below the shoreline and streambed at Outfall 1. Confirmation of presence or absence of outfall structure at Outfall 1 is needed.

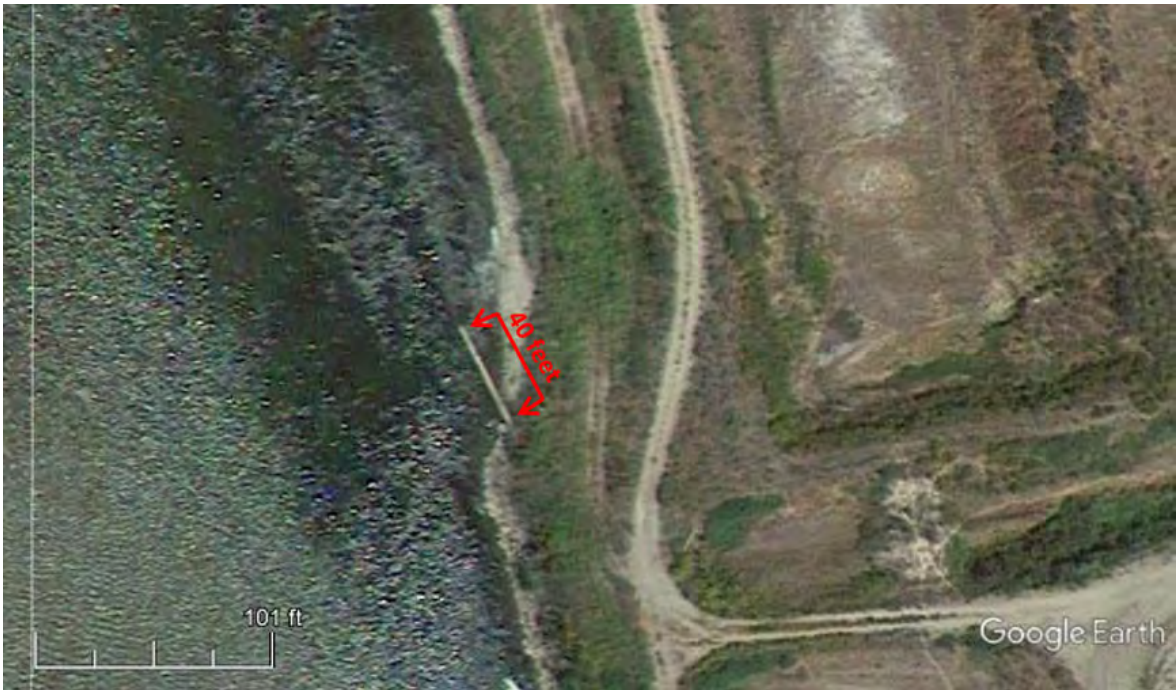
2. At "Outfall 2" (46.9602, -114.2199; Section 23, T14N, R21W) a single three-foot diameter steel pipe extends beyond a berm located on the right bank of the Clark Fork and below the low-water mark. On November 13, we observed the pipe to extend at least 30 feet onto the river bed below the water surface elevation.

Aerial imagery of the site from July 22, 2013 (see below), indicates the pipe extending approximately 40 feet beyond the wetted perimeter of the river. The river discharge at the upstream USGS on that day of the aerial image varied between 1,980 and 2,050 cfs, well below the  $Q_{LOW}$ . Therefore, based on this imagery and the correlated river discharge for July 22, 2013,

we assume the pipe extends at least 40 feet onto the river bed beyond the low-water mark.

Removal of the outfalls encroaching on State ownership is necessary. The November 2, 2023 field visit confirmed that Outfalls 2 and 3 occur in part or whole on the bed of the Clark Fork of Columbia River at/below the low-water discharge.

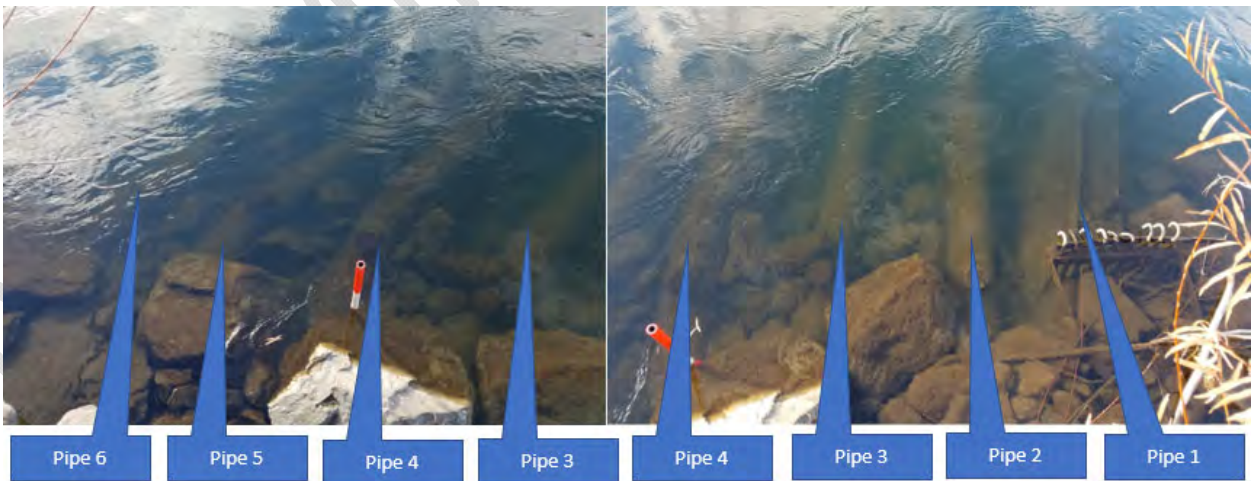
- At “Outfall 3” (46.9771, -114.2271, Section 14, T14N, R21W), see below, six pipes extend beyond a berm located on the right bank of the Clark Fork and extend onto the riverbed beyond the low-water mark. Five of the pipes are approximately 1-foot diameter and the sixth pipe has a three-foot approximate diameter; all six extend at least five feet (likely farther) beyond the low-water mark. Two photos taken November 13, 2019, below, show the view of the pipes from the right bank of the Clark Fork.

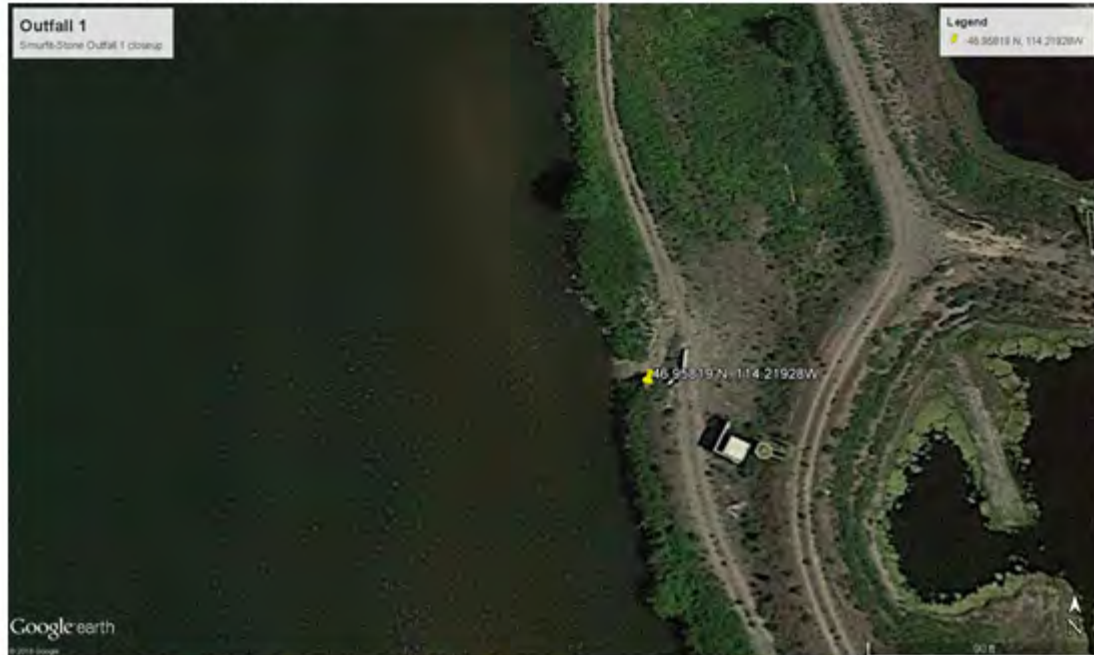
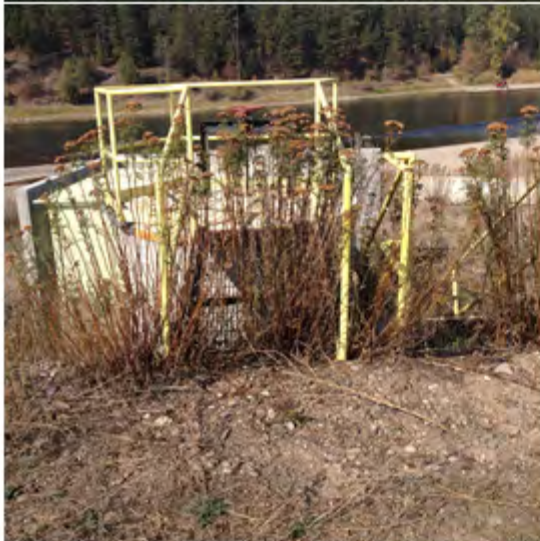
Outfall 001 -

Location: At the end of the pipe, discharging into the Clark Fork River, located at 46.95819 N latitude and 114.21928 W longitude.

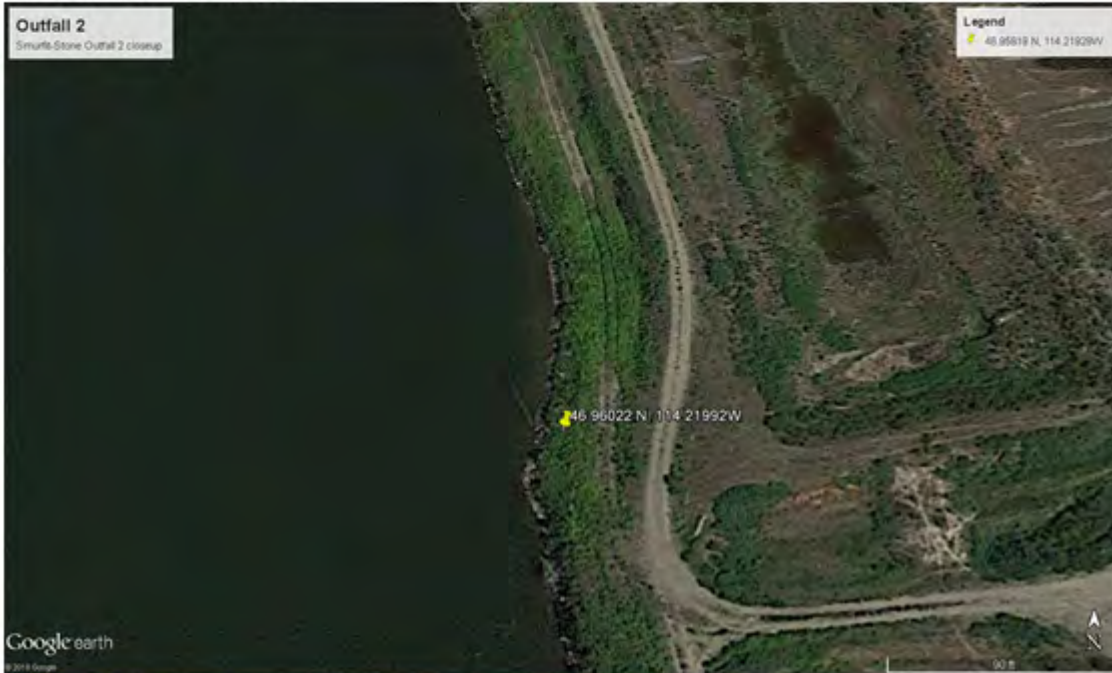
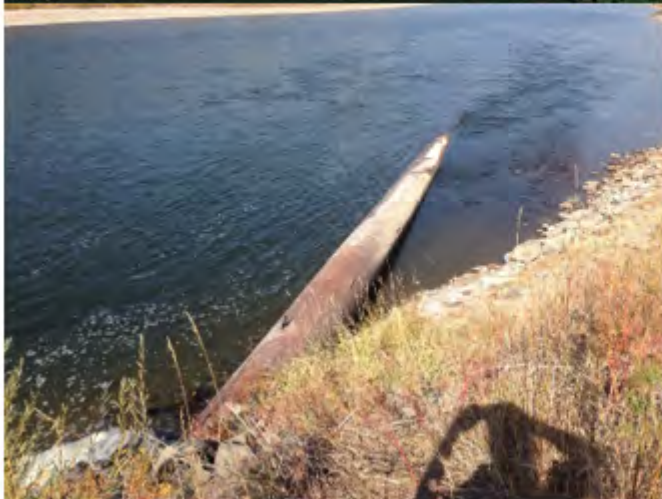
Outfall 002 -

Location: At the end of the pipe, discharging into the Clark Fork River, located at 46.96022 N latitude and 114.21992 W longitude.

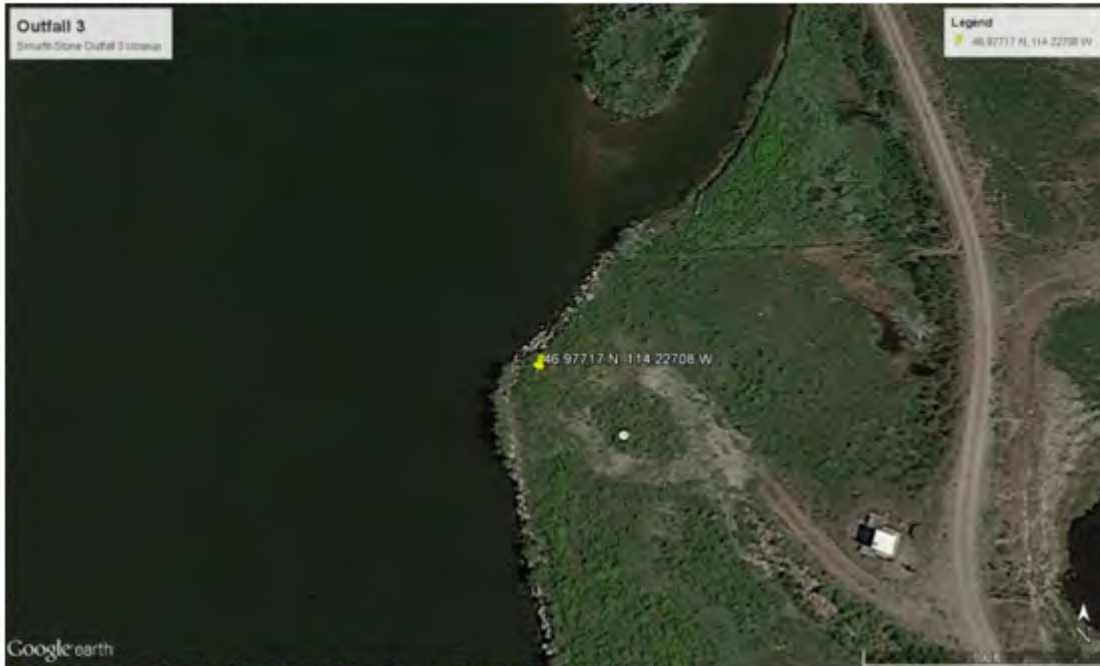
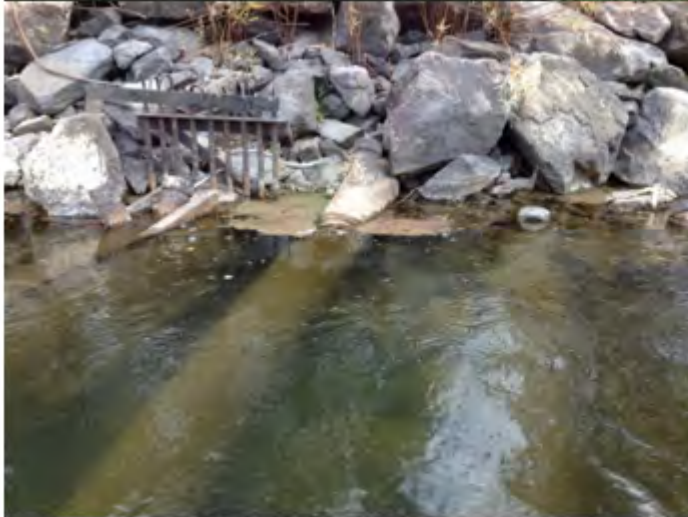
Outfall 003 -

Location: At the end of the pipe, discharging into the Clark Fork River, located at 46.97717 N latitude and 114.22708 W longitude.

Note: This pipe is a diffuser. From the 1995 Permit:

“Point 003 is a diffuser to assure effluent mixing at lower river flows.”

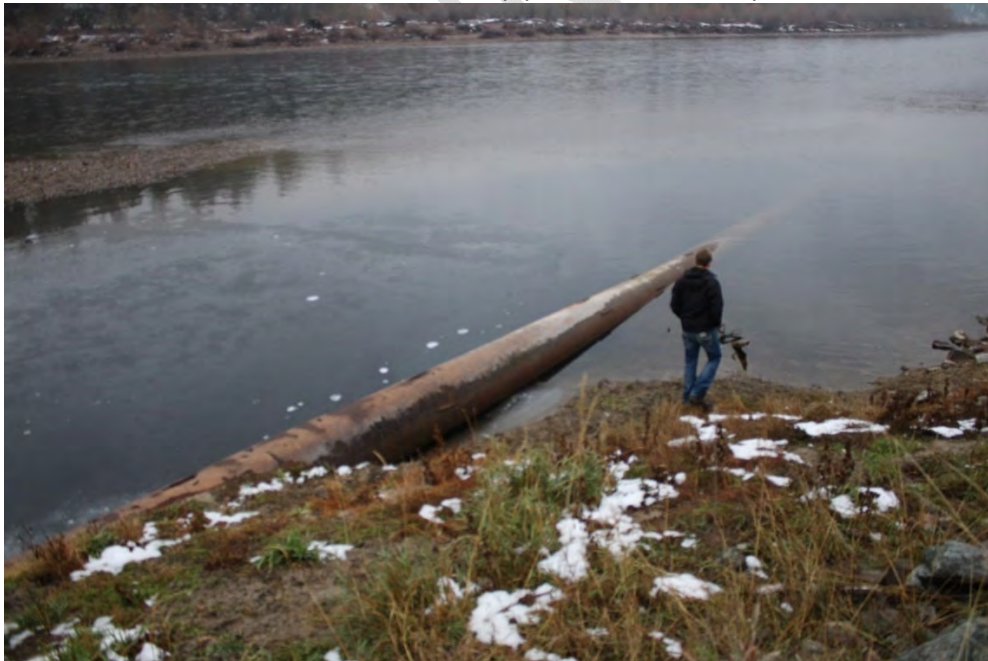
At Outfall 2 we found the ~ 3 ft. diameter pipe, see below. Amy Helena takes a closer look.

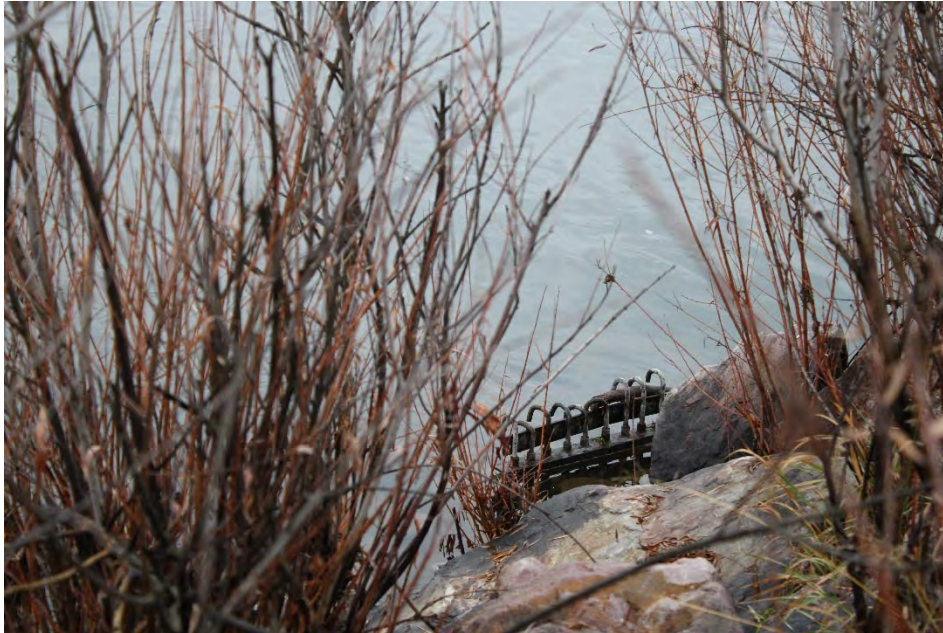
We continued to Outfall 3 where we saw the hook apparatus associated with the “diffuser” see photo below. The conditions at this point did not provide a clear view of all the pipes extending into the river. Photos on page 3 provide a clearer view.

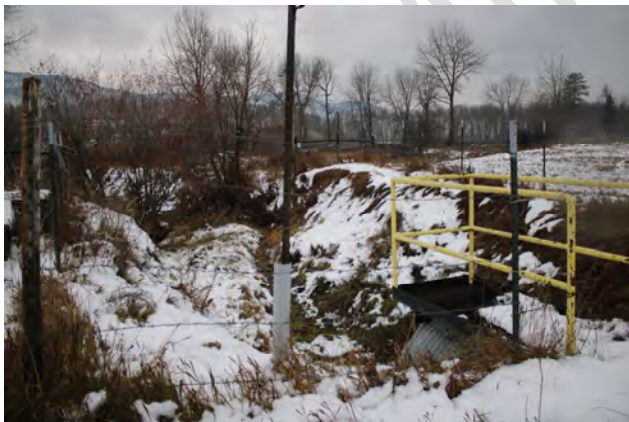
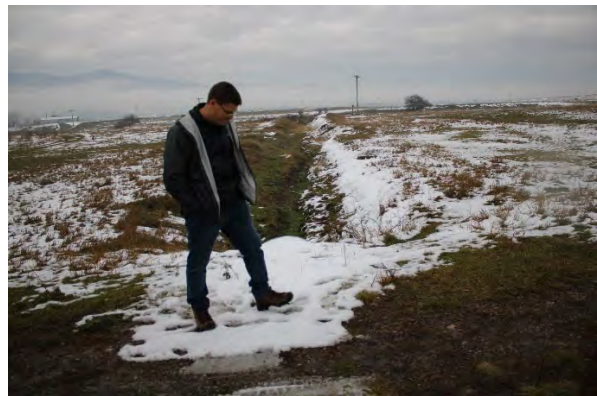
After this stop we proceeded farther north to reach Outfall 4. This outfall empties into a slough area on the west side of the two-track trail (see left photo below). The adjacent photo shows David Tooke at the outfall of the former pond area on the east side of the trail.

From a navigable-waters ownership standpoint, MT-DNRC would not own this area.
