**2023 Final Report
Beaver Creek Stream Restoration Project Phase 2
Nelson, Montana**

**Prepared by: Allison Russell
Fish Biologist, Helena Ranger District
Allison.russell@usda.gov
Date: 9/21/2023**

**Subrecipient: Lewis and Clark Conservation District
Chris Evans, District Administrator LCCD, 406-389-3884
790 Colleen Street, Helena, MT 59601
chris@lewisandclarkcd.org**

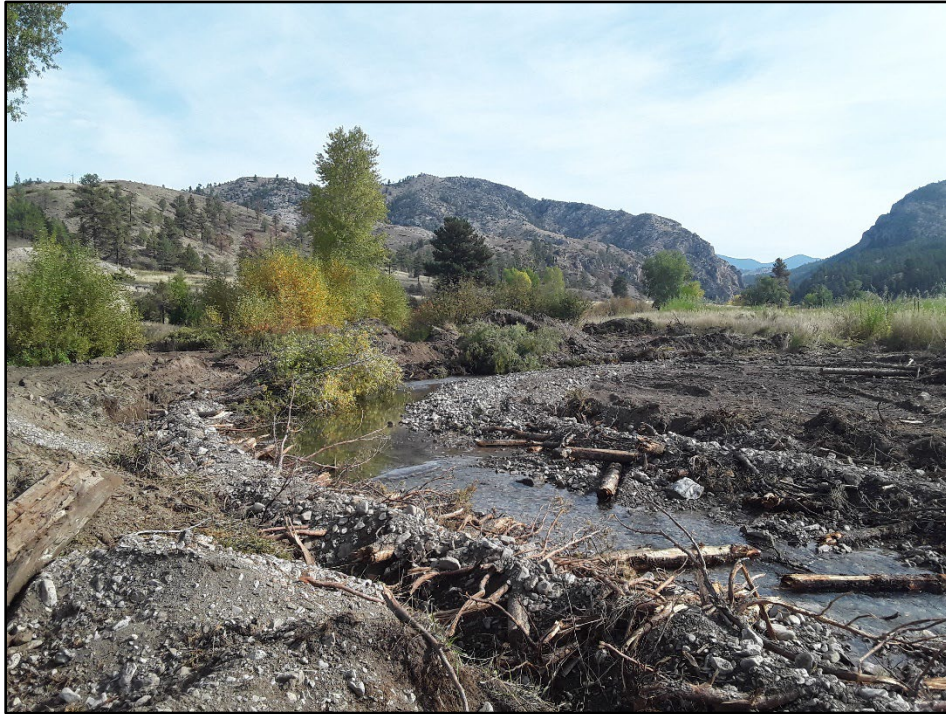
Figure 4. Top of the project area, station 47+00, open streambanks before willow placement.

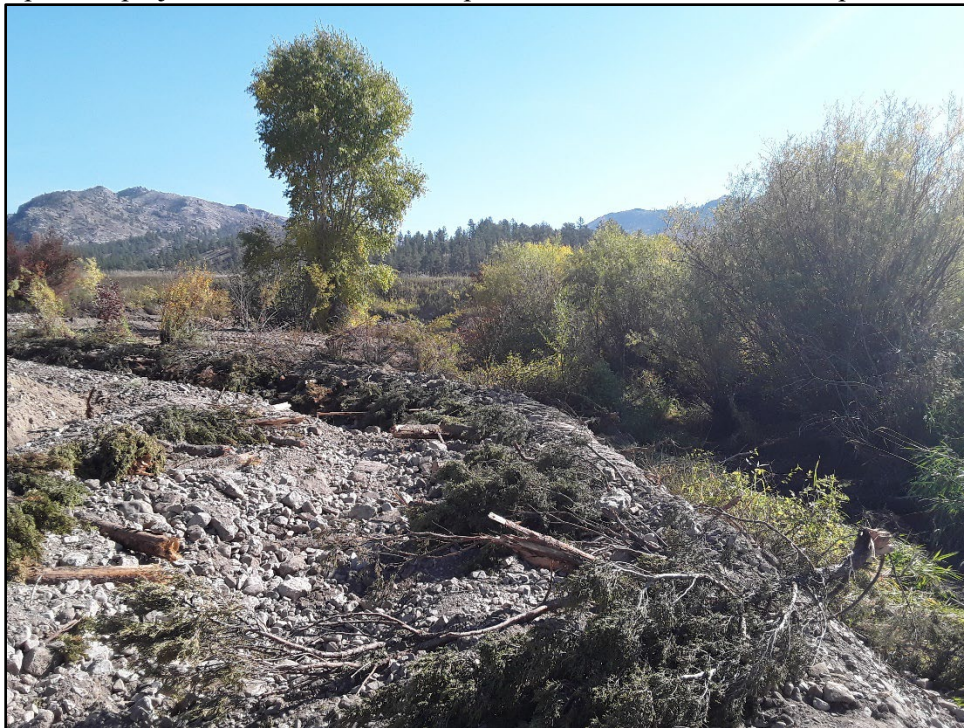
Figure 5. Channel construction at the top of the project area Station 53+00. Newly constructed channel was raised relative to the old channel (right) to increase floodplain connection and restore floodplain elevations to historic levels.

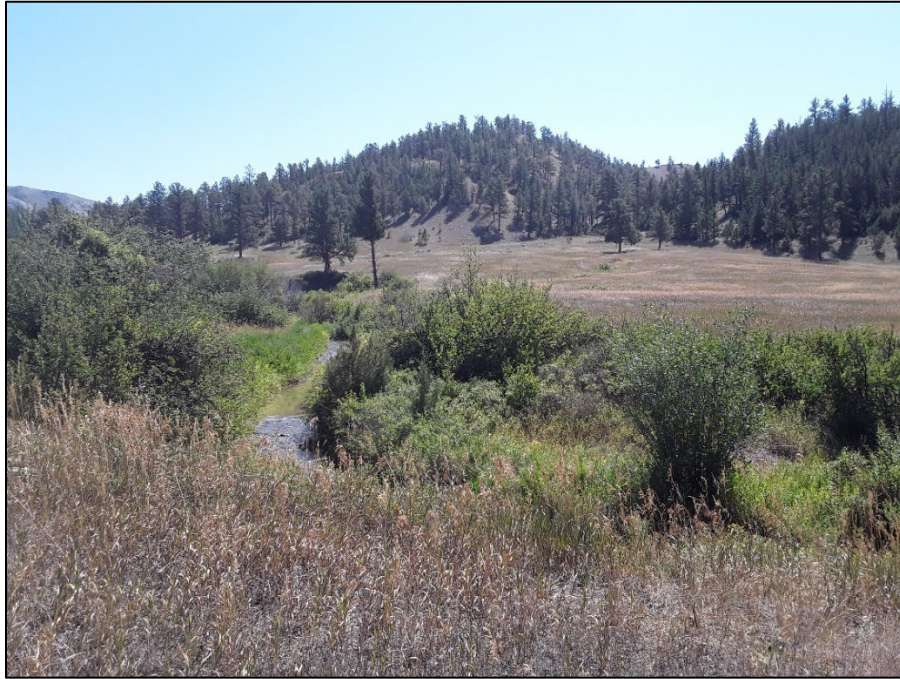
Figure 6. View from Station 72+50 before construction. Coordinates:-111.890872 46.788562

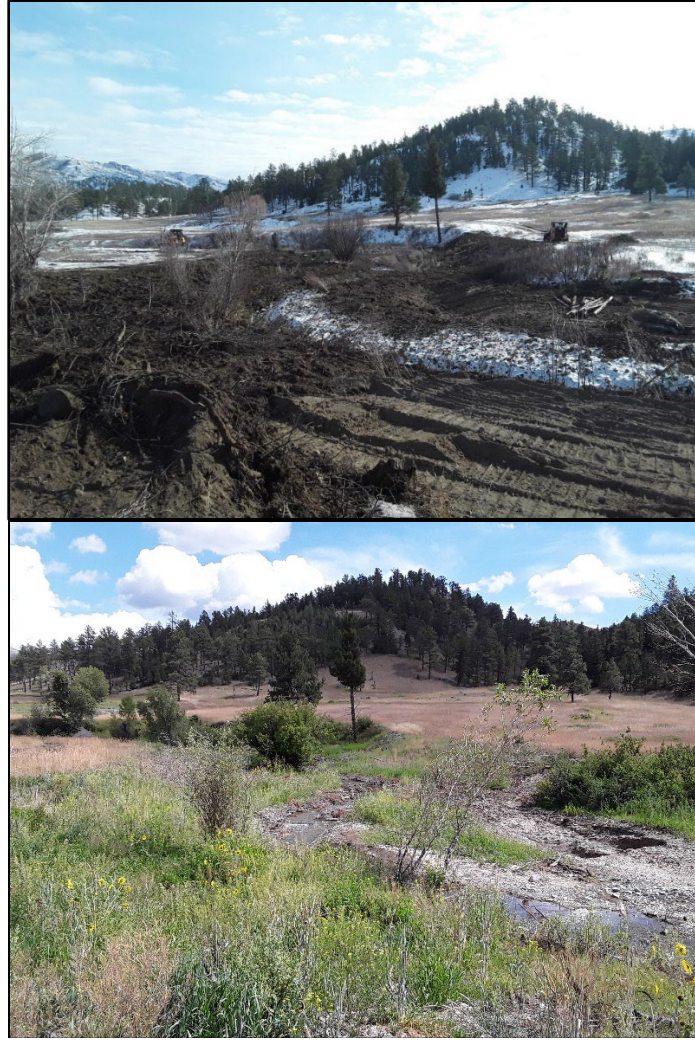
Figure 7 and 8 . View of Station 72+50 during construction looking upstream. Approximately 4,700 CY of net earthen material were moved to the repository, 9,400 CY were used to plug the old channel, creating a newly expanded and connected floodplain. Bottom picture Station 72+50 July 2023, 7 months post construction.

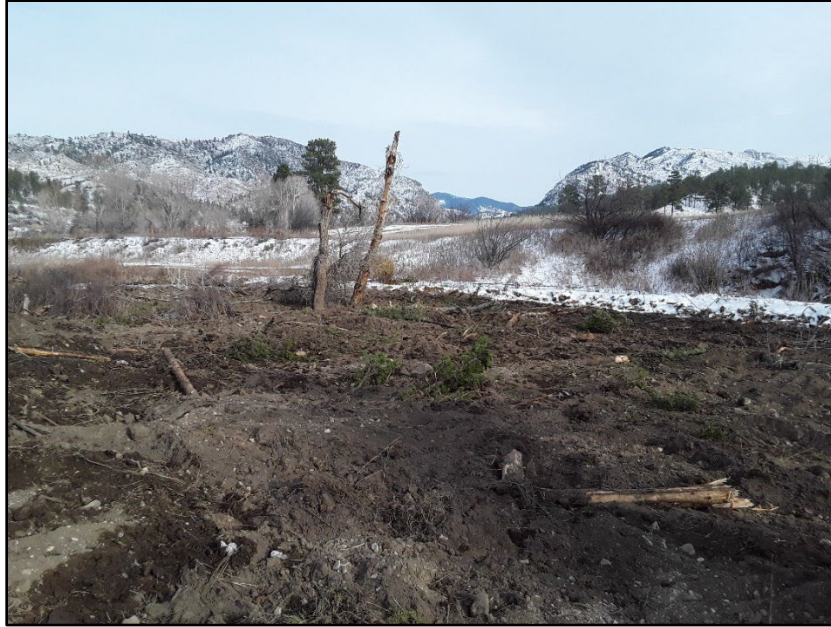
Figure 9. Completed channel and floodplain construction. The work incorporated juniper limbs buried category 2 wood to amend the soil and willow trenches were placed perpendicular to the channel. Wildlife snag pods were placed to create vertical structure inviting cavity nesters.

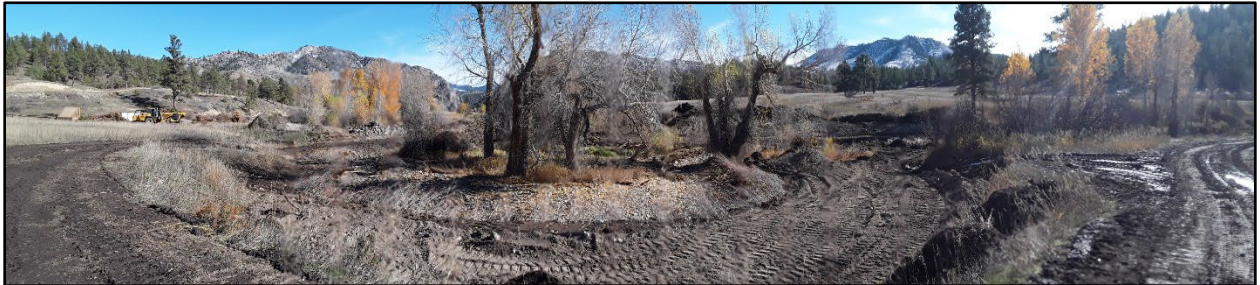
Figure 10. Compound pool complex with preserved shrub/scrub habitat, station 55+00.

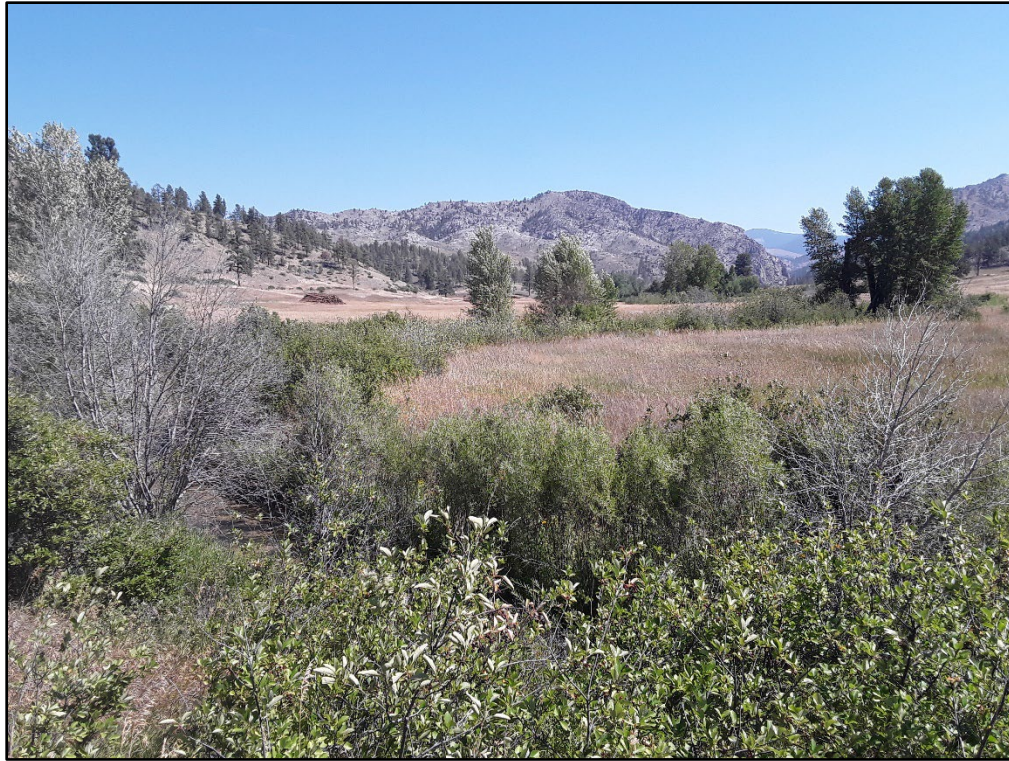
Figure 11. End of the project area, photo point 83+50. Coordinates -111.893506, 46.787645

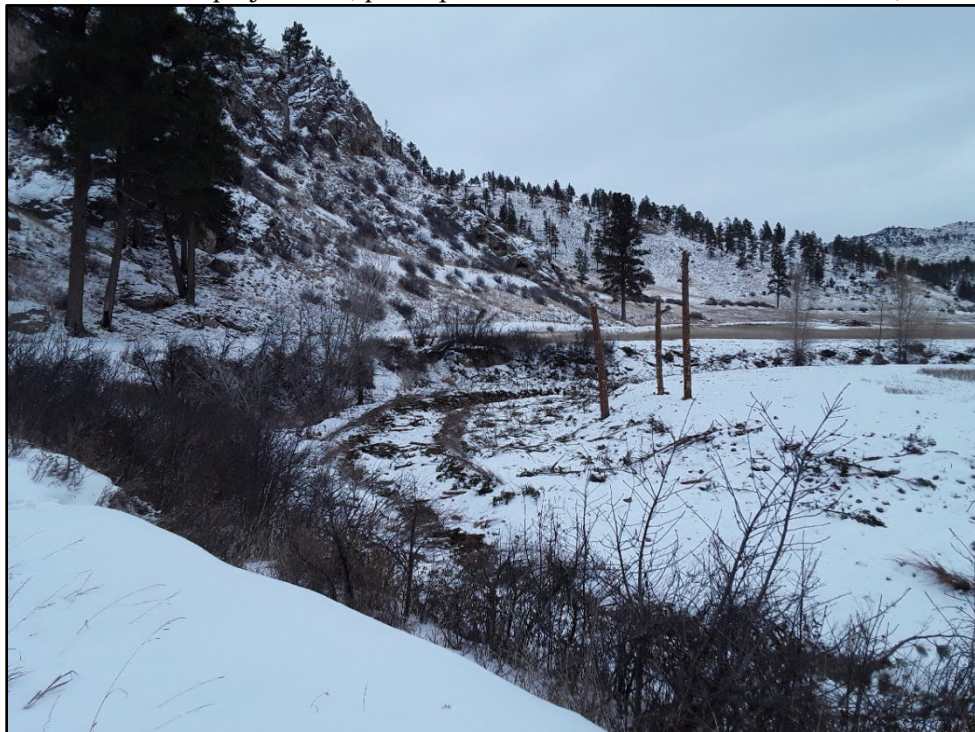
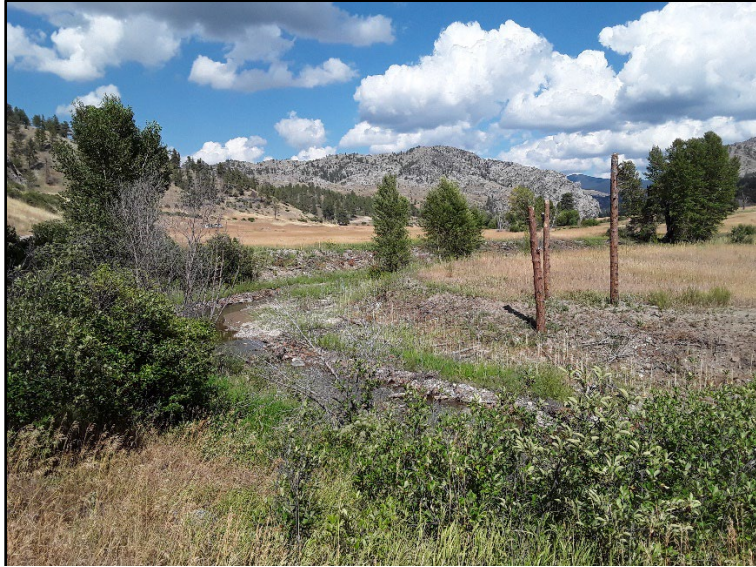
Figure 12 and 13. Photo point station 83+50 post-construction winter 2022 and July 2023.

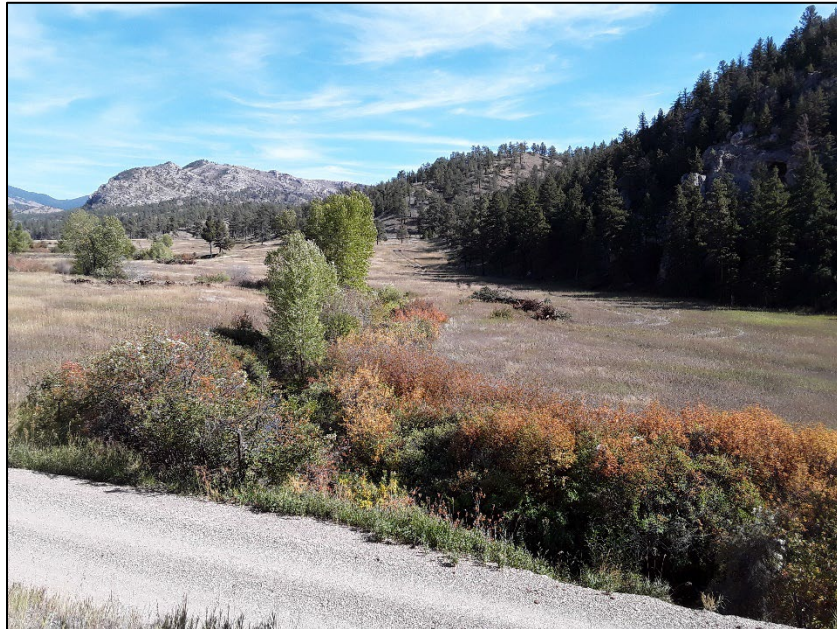
Figure 14. Photo point 81+00 pre-construction, coordinates -111.893506, 46.787645

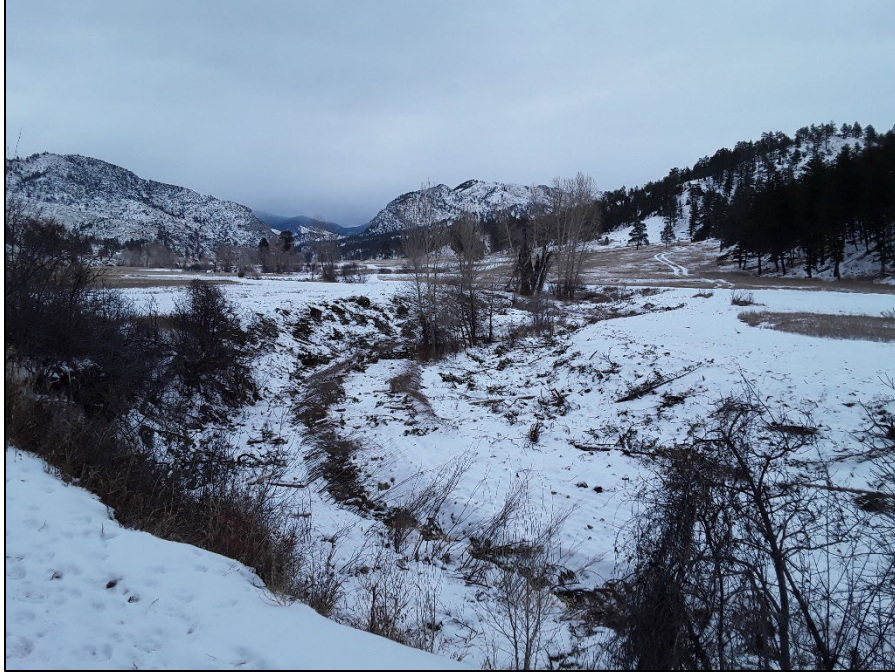
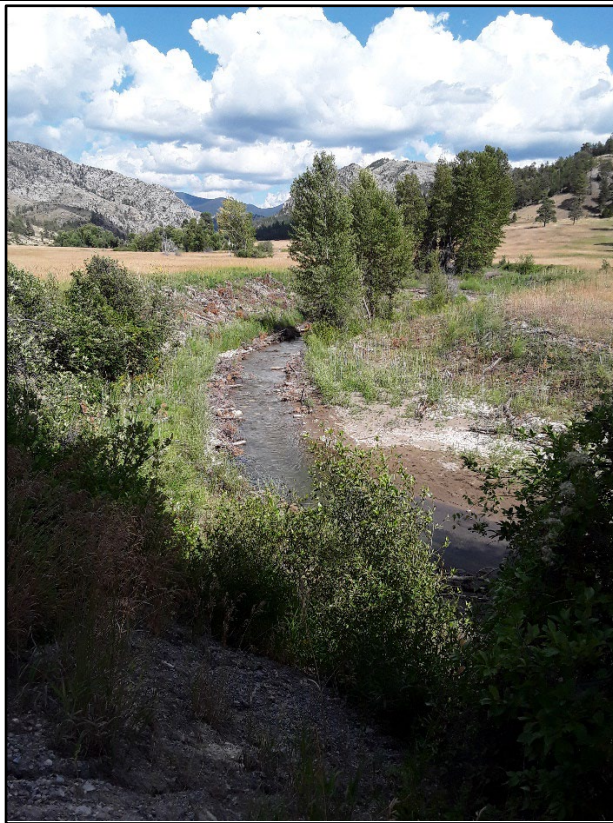
Figure 15 and 16. Photo point station 81+00 post-construction December 2022 and July 2023, -
111.893506, 46.787645
