SENATE BUSINESS & INDUSTRY
EXHIBIT NO. 6
DATE 1/21/05
BILL NO. SB 211

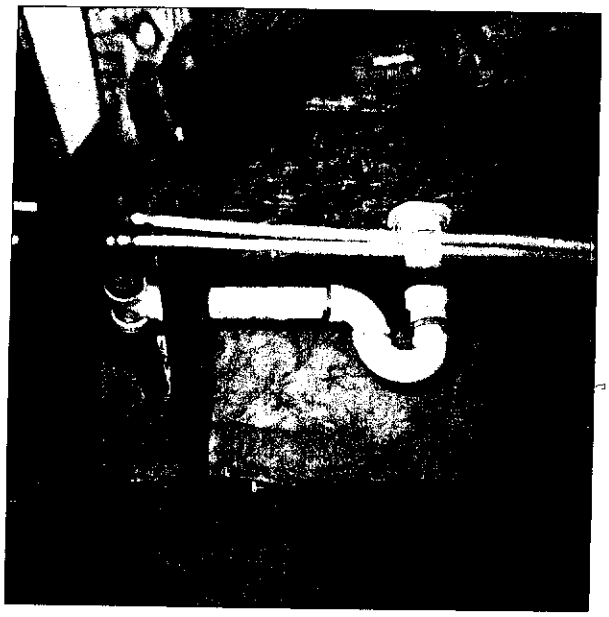
SHOWER DRAIN IMPROPERLY VENTED
VENT IS ON THE SAME LEVEL AS THE
DRAIN SO VENT WILL GET PLUGGED AND
DRAIN WON'T WORK RIGHT. DRAIN SHOULD
ALSO BE 2". THIS IS 1½"

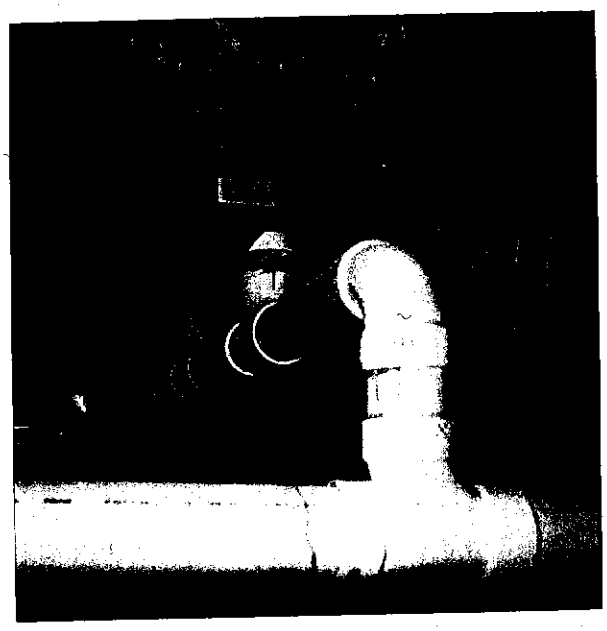
2 TOILETS BACK TO BACK IMPROPERLY VENTED. THEY ALSO TIE INTO MAIN DRAIN WITH A TEE. IT SHOULD BE A WYE OR SWEEP FITTING

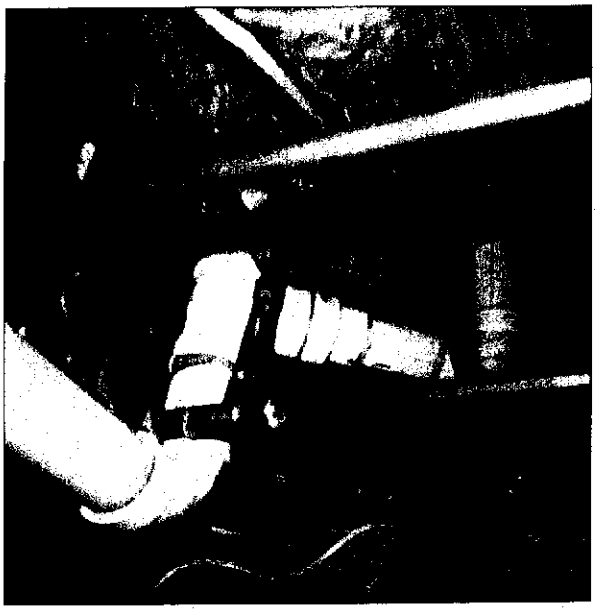
THIS IS A WASHING MACHINE DRAIN. THE VENT IS TIED IN BELOW THE FLOOR. IT SHOULD BE TIED IN ABOVE THE FLOOR.

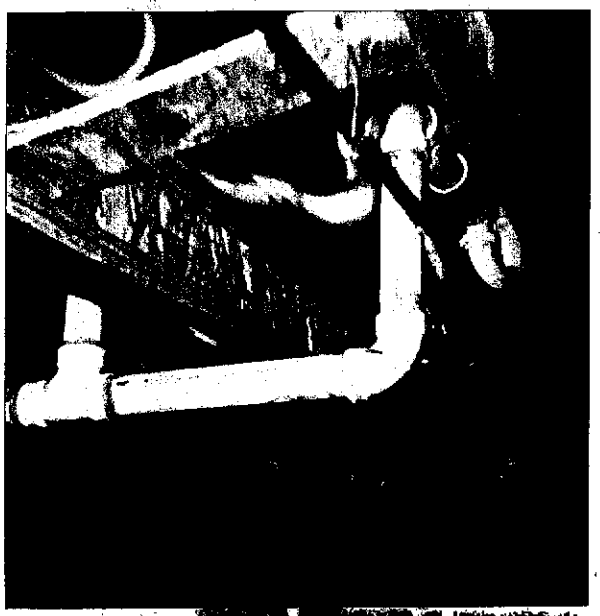
TUB DRAIN IS IMPROPERLY VENTED. IT SHOULD ALSO BE PIPED IN 2", THIS IS 1½".
