Proposed Repairs To Painted Rocks Dam

Final Environmental Impact Statement

OCTOBER 1976

Montana Department of Natural Resources and Conservation

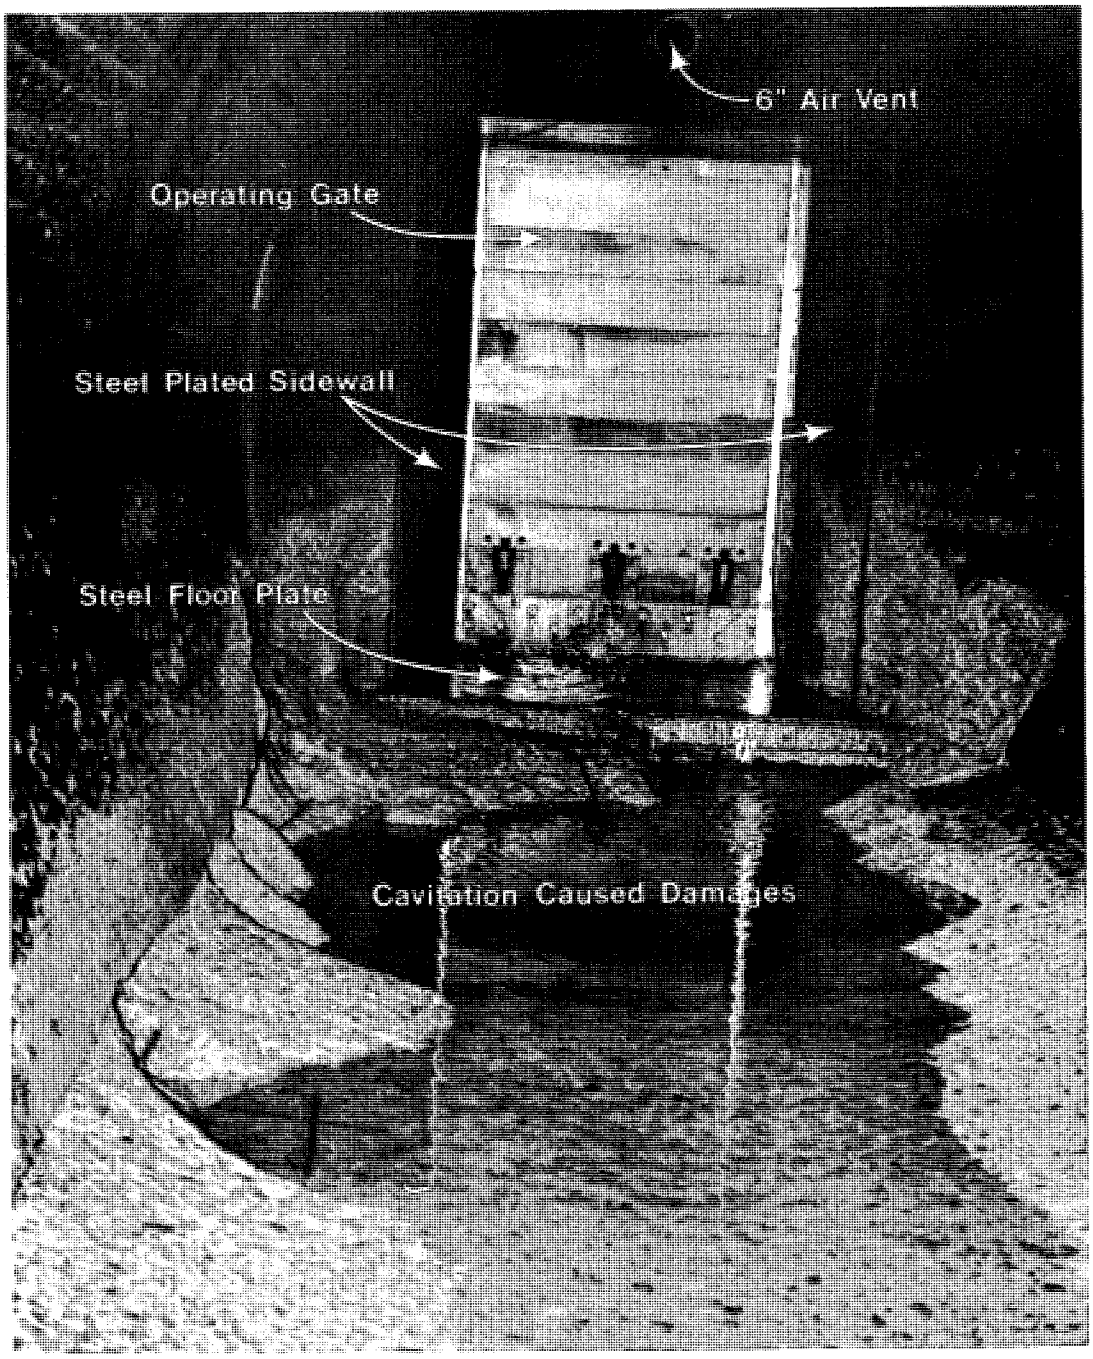
Just prior to the release of the Draft EIS, several outlet tunnel inspections were made. For the first time since November 12, 1975, the tunnel gates sealed on July 29, 1976, enabling an investigation of previously discovered cavitation damages. At that time as well as on August 3, 5, and 31, engineers observed the conditions in the tunnel which are shown in Photo 1 taken on August 5, 1976.

The outlet tunnel has undergone some increase in damage. All remaining steel plates are secure; however, the concrete underneath the section of steel plate that was torn off has continued to erode. At this point a hole, six inches deep and equally as wide, is continuing to enlarge. Another hole closer to the gate frame has appeared and is only several inches away from the upstream portion of the gate. This indicates that control with the operating gate may be lost if this cavity enlarges, making the use of the emergency gate imperative.

The large hole in the tunnel floor has stabilized at a level incorrectly reported in the Draft EIS as natural rock. It is actually a sand-cement mixture known as grout that was used during the 1954 repairs. This grout layer is several feet thick and has not eroded any deeper or wider than when it was first discovered during the September 1975 annual inspection.

Photo 1 - View from within Painted Rocks outlet tunnel looking upstream at operating gate and surrounding damage in transition area.

The DNRC intends to implement the proposed action (repairs to Painted Rocks Dam) by mid-November 1976. This action will entail repair of the deteriorating gate tower, construction of a newly designed transition area, and installation of a bypass pipeline through the outlet tunnel to provide minimal downstream flows.
