An Examination of Home Destruction

Roaring Lion Fire

Bitterroot Mountains, Montana

Jack D. Cohen, PhD
Research Physical Scientist, Missoula, MT

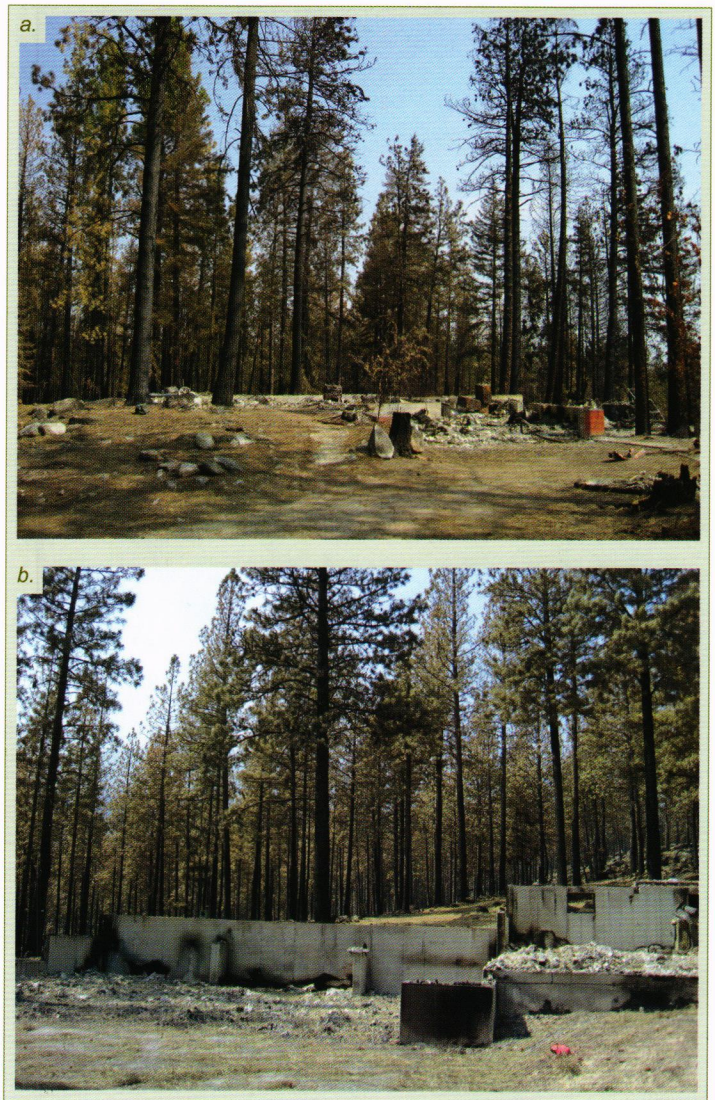
Most of the 16 destroyed houses during the Roaring Lion Fire had unconsumed tree canopies similar to the two houses in Figure 5. The remaining tree canopies and other vegetation surrounding and adjacent to the house indicate the home ignitions occurred by firebrands and flame contact from burning surface fuels and not crown fires. These conditions that included structure vulnerabilities in relation to burning materials with 10 feet of so of the structure determined the ignitions and destruction of the homes. Firebrands could have directly ignited flammable structure materials in locations such as crevices and inside corners, as well as ignited flammable debris such as needle and leaf litter, firewood on decks, and dead vegetation on and adjacent to flammable exterior materials. Surface fires spreading through continuous dead grass, needles and branches do not radiate sufficient heat to ignite wood surfaces and thus requiring flame contact for ignition.

Figure 5. Two different houses a) and b). Neither house had adjacent high intensity burning. The charred and partially consumed trees adjacent to the houses burned from the burning house. The a) house did not have forest fuel treatment; the b) house had forest fuel treatment.
