**FUNDING REQUEST FOR THE
TOWN OF STEVENSVILLE WATER REHABILITATION PROJECT**

I would like to thank George Thomas for assisting me during the sanitary survey inspection of the Stevensville water system. As a community water supply system, your facility is required to have a sanitary survey inspection every three years. These regular inspections offer us an opportunity to look for sanitary deficiencies that have the potential to cause contamination in the water system, as well as pointing out operation and maintenance concerns. Below are a few comments relating to the sanitary survey conducted on 6/25/2008.

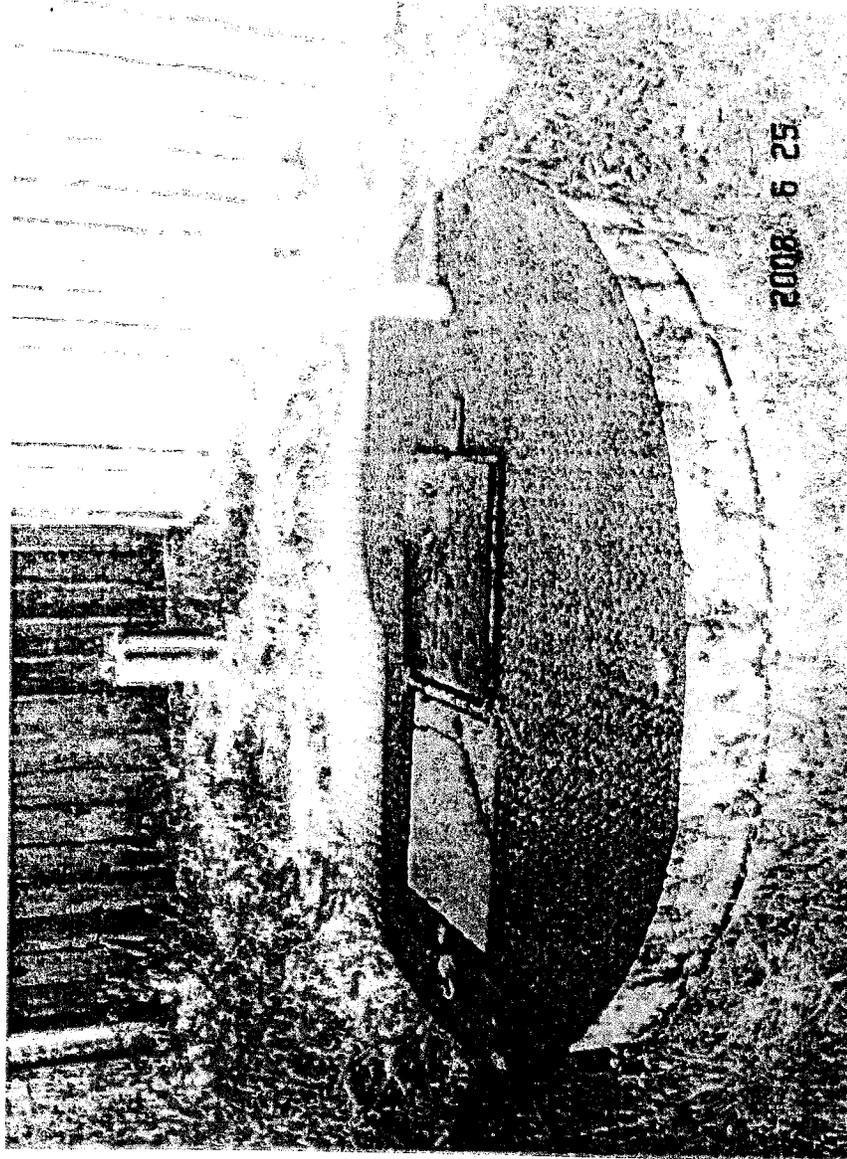
Top right: Well 2 (WL004) entry point to distribution can be seen running into the vault floor. A 2" blow-off pipe extends through the wall and terminates in a nearby ditch. This blow-off outlet is currently capped.

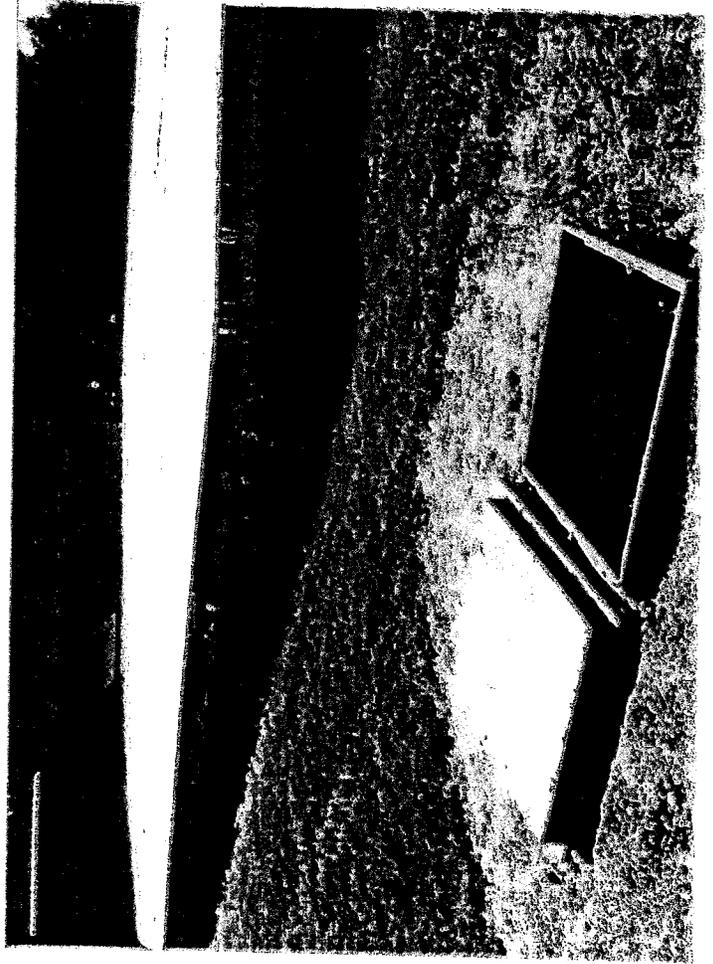
Bottom left: TP001, bypass structure, ST001 and a meter vault where a chlorine booster pump injects water leaving ST001 as it enters distribution.

NOTE: System doesn't know for sure where the bypass or ST001 overflow outlets are located, or if they're screened.
