PRELIMINARY ALIGNMENT REVIEW

Makoshika State Park
Radio Hill Road Reconstruction

Glendive, Montana

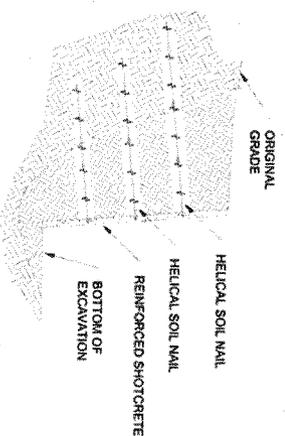
Fig. 1 – Example of Soil Nailing

In order to achieve a long-term solution, the adjacent areas that are currently exhibiting signs of failure will need to be stabilized. This stabilization will likely involve a combination of stone or concrete columns, soil nailing/pinning, and surficial anchoring with netting. Figures 1 and 2, shown below, illustrate the mechanics of soil nailing and micropiles. According to the Geotechnical Engineering Report, these stabilization methods include:
