CHECKLIST ENVIRONMENTAL ASSESSMENT

Project Name: Missile Pond Dam Breach	Proposed Implementation Date: Winter 2013
Proponent: Montana DNRC, Trust Land Management Division	
<p>Type and Purpose of Action: The Missile Pond Reservoir is a high hazard dam located ~ 2000 feet upstream of US Highway 191, 1 mile north of the Town of Judith Gap. The dam was constructed in 1964 with soils excavated from the neighboring US Air Force facility. The dam has been inspected by the DNRC dam safety program and found to be structurally unsound and in danger of failure. The DNRC dam safety program has ordered the Trust Land Management Division to remove, breach or repair the dam by March 1, 2013. The dam provides a public fishery which will be lost as a result of dam breaching.</p> <p>The planned breach will consist of the removal of a portion of the existing embankment. The side slopes of the breach will be excavated to a stable grade given the soil type (2:1 or flatter). Riprap will be used to armor portions of the breach as necessary. It is expected that springs in the reservoir bed will maintain some amount of pooled water post breach.</p> <p>(A design Plan and Profile sheet is attached)</p>

Loc

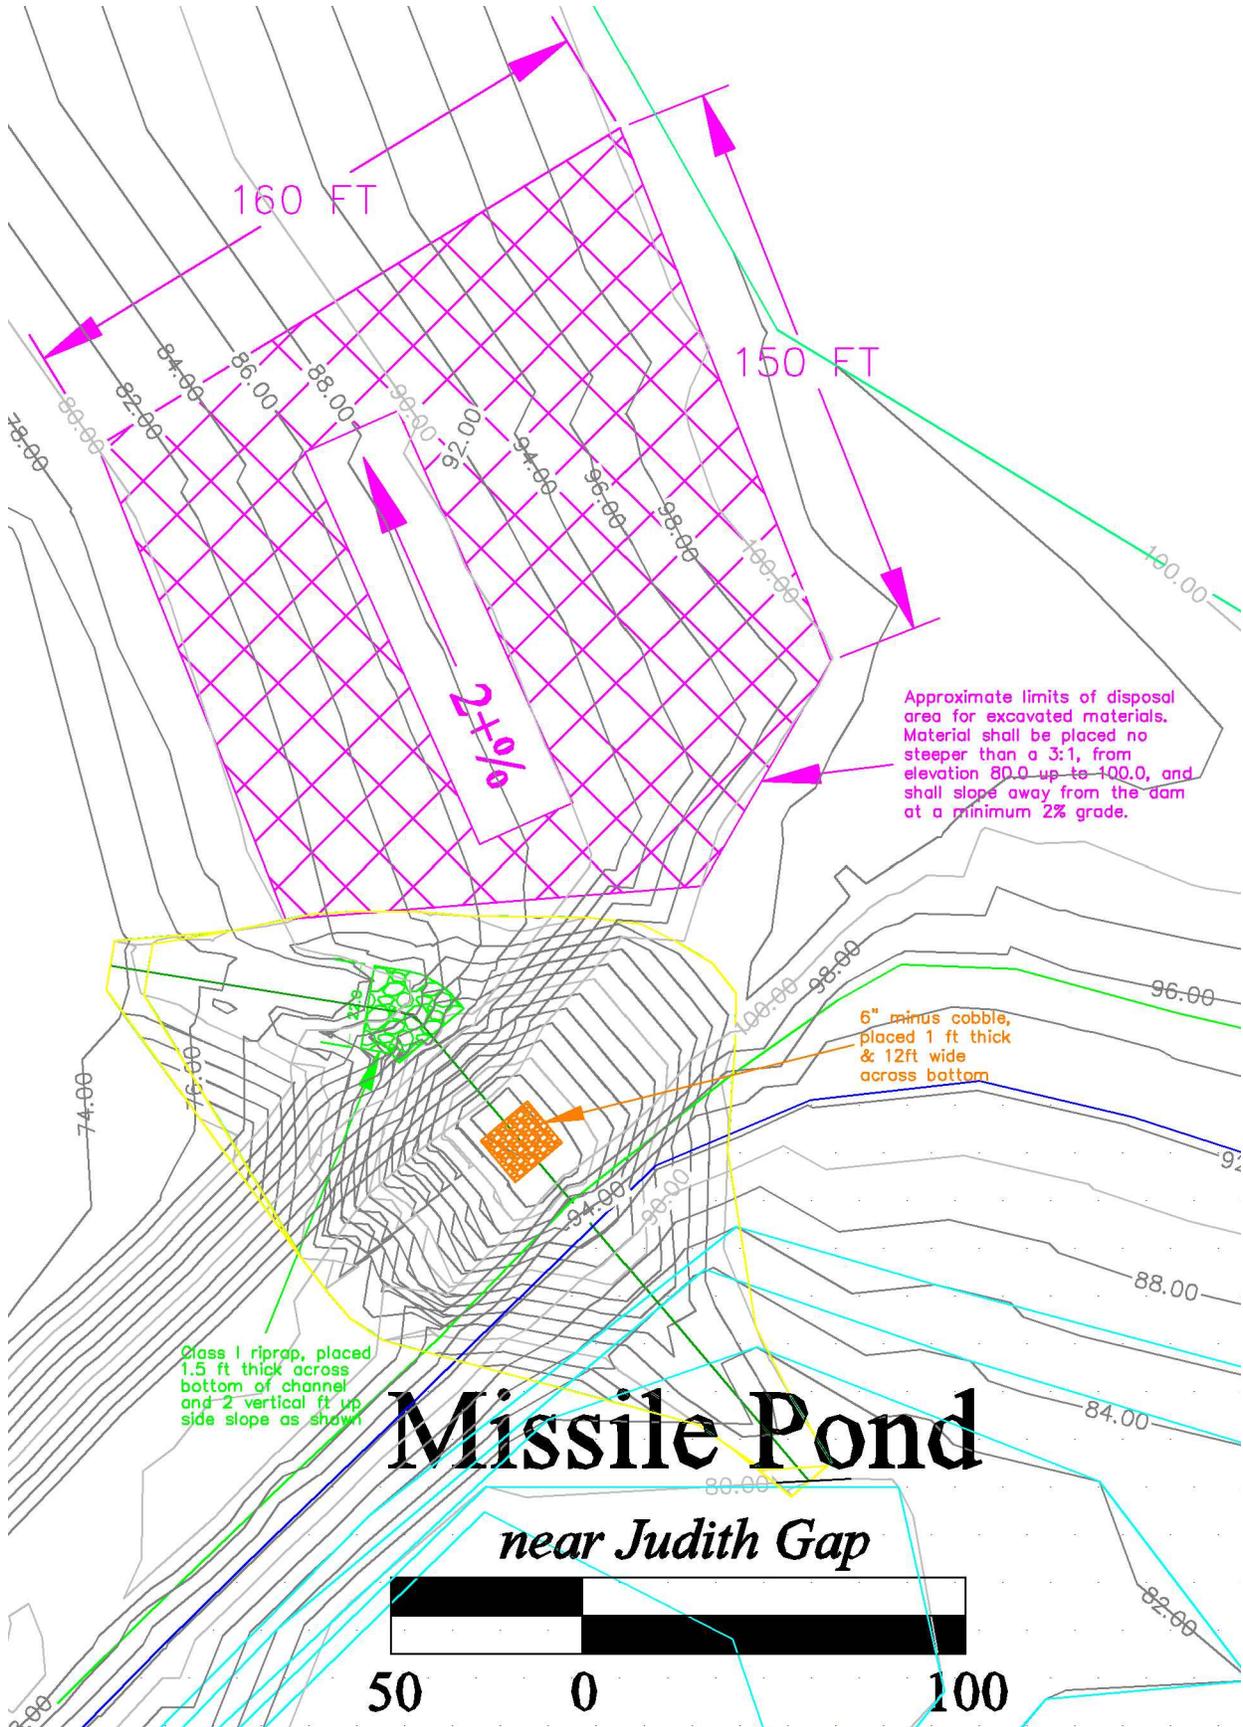
Missile Pond

Approximate limits of disposal area for excavated materials. Material shall be placed no steeper than a 3:1, from elevation 80.0 up to 100.0, and shall slope away from the dam at a minimum 2% grade.

6" minus cobble, placed 1 ft thick & 12ft wide across bottom

Class 1 riprap, placed 1.5 ft thick across bottom of channel and 2 vertical ft up side slope as shown
