Subject: Programmatic Categorical Exclusion (PCE) Concurrence Request
BR 9003(49)
Milk River-4 M W of Zurich
CN: 6290000

Milk River – 4M W of Zurich

Preliminary Field Review Report

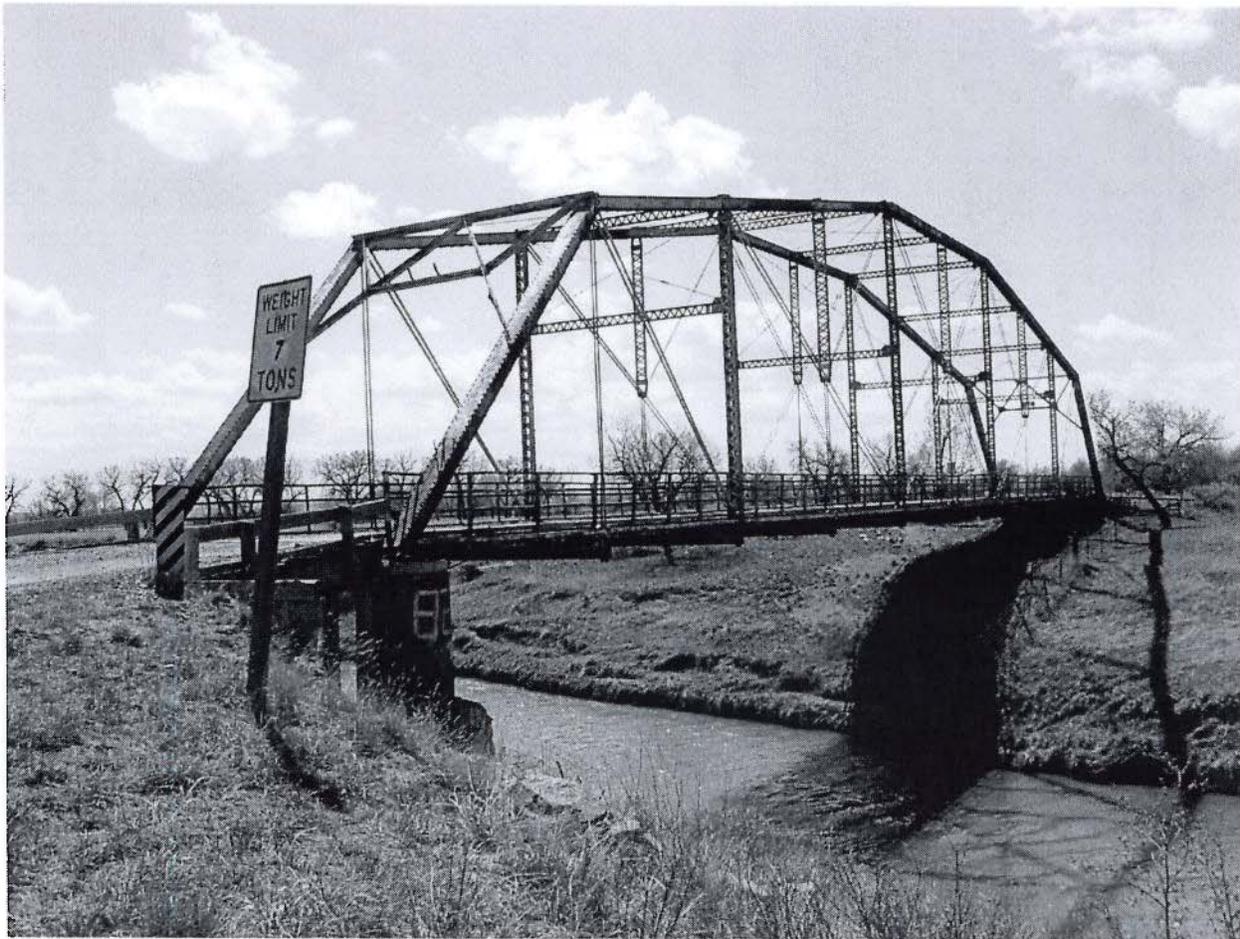
Year Built	1910
Inventory Number	L03325000+04001
Length	221.0 feet
Width (Rail to Rail)	16.5 feet
Number of Spans	2
Span Lengths	21.0 feet, 200.0 feet
Bridge Rail Type	Metal rail with timber curbs
Superstructure Type	Timber stringer approach span, steel truss main span
Substructure Type	Concrete, timber piles
Sufficiency Rating	26.0
Structure Status	Structurally deficient and eligible for replacement

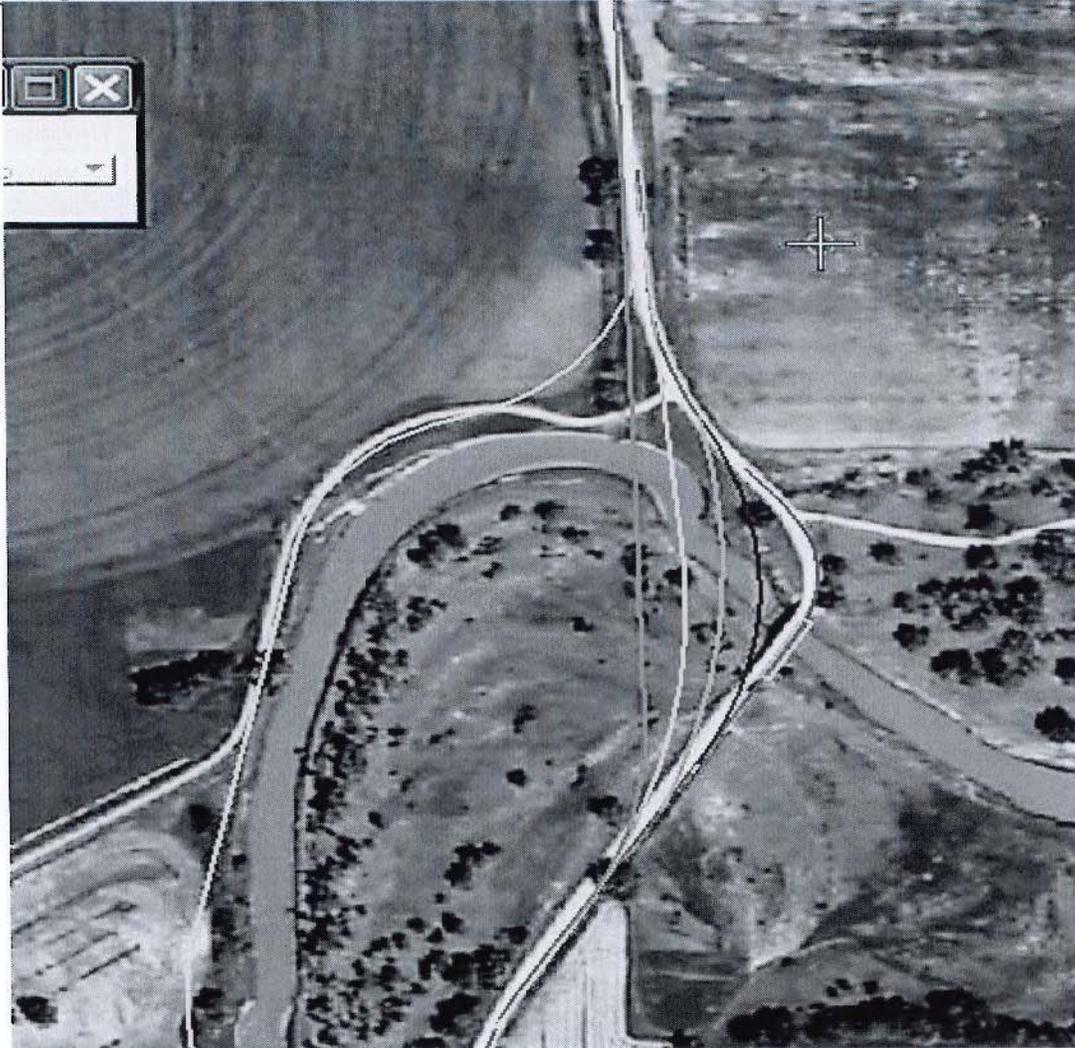
Figure 1: Proposed Horizontal Alignments

- b. **Horizontal Alignment.** A new curved horizontal alignment is proposed upstream and adjacent to the existing bridge and roadway. (See Figure 1)
- c. **Vertical Alignment.** Unless a grade raise is required to meet minimum low beam elevation, the new roadway profile grade will generally match existing.
