September 2022  
Water Policy Interim Committee

REPORT TO THE 68TH MONTANA LEGISLATURE

# **A CONSTANT REWORKING: EROSION AND THE LOWER FLATHEAD RIVER (SJ 28)**

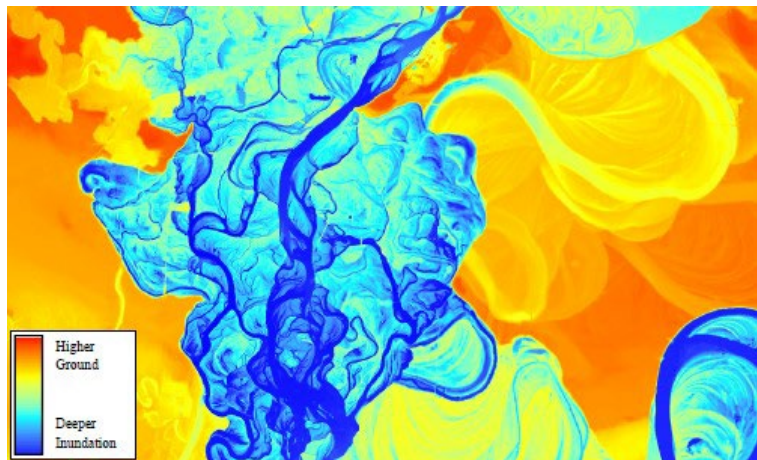
**INUNDATION MODEL, SHOWING APPROXIMATE FLOOD-PRONE AREAS ALONG A SECTION OF THE FLATHEAD RIVER. (FLATHEAD RIVER CHANNEL MIGRATION ZONE MAPPING, 2009)**

Floods are common. For example, the 1964 flood inundated hundreds of homes and 20,000 acres under 4 feet of water.<sup>10</sup> Other major floods occurred in 1894, 1928, and 1948.<sup>11</sup>

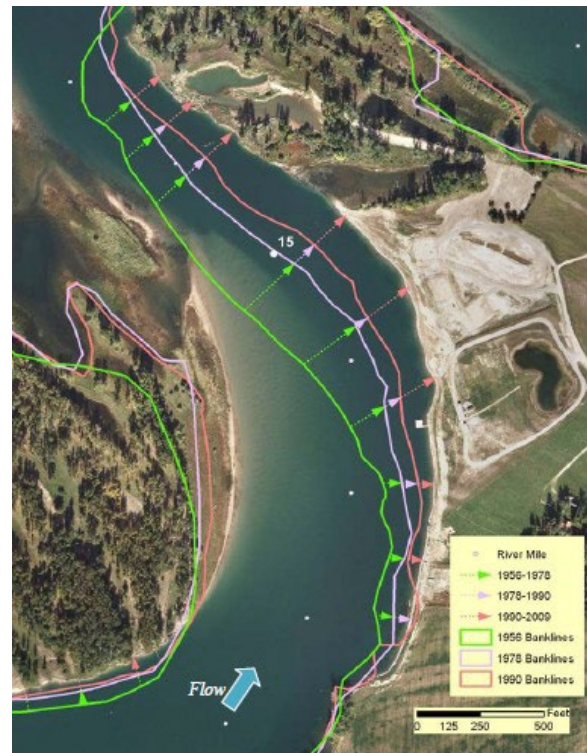
**EROSION RATES ALONG A SECTION OF THE FLATHEAD RIVER. (FLATHEAD RIVER CHANNEL MIGRATION ZONE MAPPING, 2009)**

A 2009 study of the river channel in the accompanying figure measured the meander or migration of the river due to erosion. The erosion hazard area measured observed migration rates between 1956 and 2009. The migration rate for this lower reach of the Flathead River varies between approximately 1 to 4 feet per year.<sup>22</sup> This migration rate may be used to estimate future migration and to delineate erosion hazard area buffer zones.<sup>23</sup>

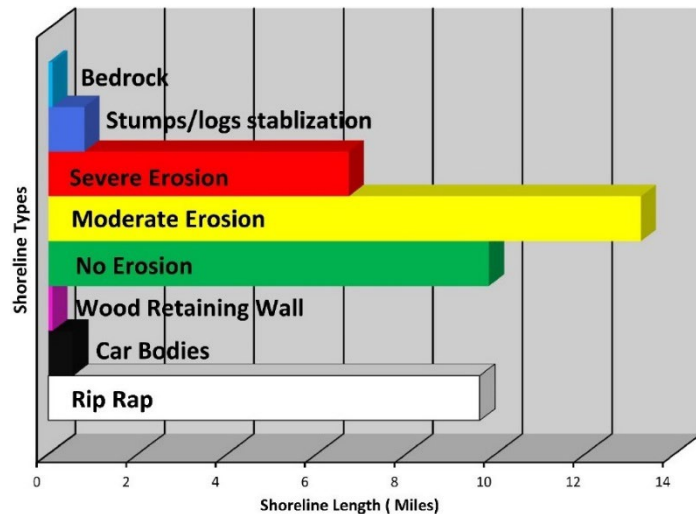
**EROSION AND EROSION CONTROL ON THE FLATHEAD RIVER FROM HIGHWAY 35 TO FLATHEAD LAKE. (FLATHEAD CONSERVATION DISTRICT, 2022)**

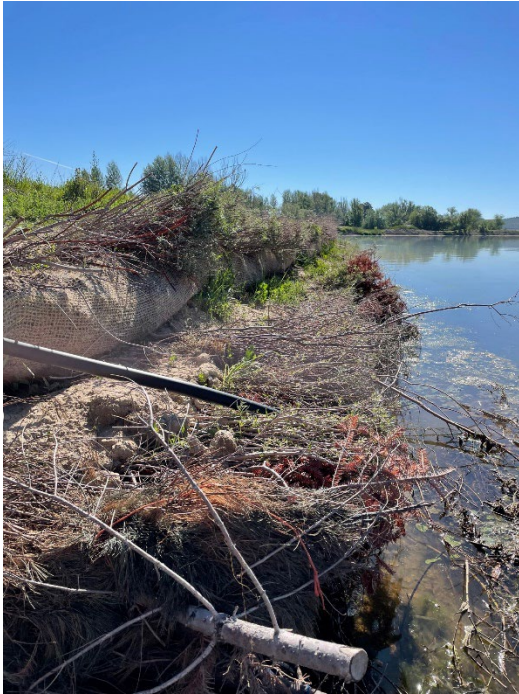
**WILLOW PLANTINGS AT LAKE HELENA. (STAFF PHOTO)**

The Water Policy Interim Committee toured two erosion control projects in and near the Helena Valley in July 2022. Committee members visited a site on Lake Helena and another at Spokane Creek. Both projects used bioengineered methods to stabilize banks and shoreline.<sup>36</sup>
